# EERI Earthquake Reconnaissance Report: M7.1 Anchorage Earthquake on November 30, 2018

Wael M. Hassan, John Thornley, Janise Rodgers, and Christopher Motter

July 2021

*A product of the EERI Learning from Earthquakes Program*

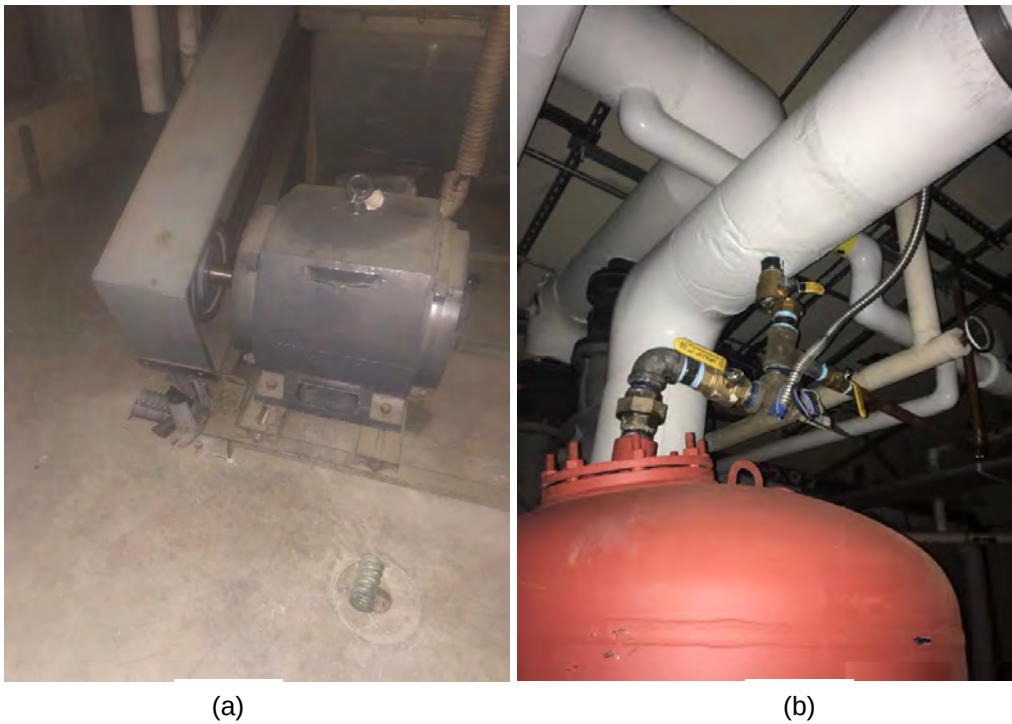
In addition, a few Anchorage schools had inadequately restrained air-handling equipment that moved or fell from vibration isolators. At Bartlett High, vibration isolators for several pieces of equipment failed (see Figure 6.24). Several gas leaks occurred, but Anchorage schools had automatic seismic gas shutoff valves, installed with Federal Emergency Management Agency (FEMA) mitigation grant funding several years ago, which prevented major problems from occurring because of gas leaks or broken gas pipes.

Figure 6.24. (a) Broken nonseismic vibration isolator, Bartlett High; (b) broken pipe connection to unbraced hot water generator, Bear Valley Elementary (photos: ASD).

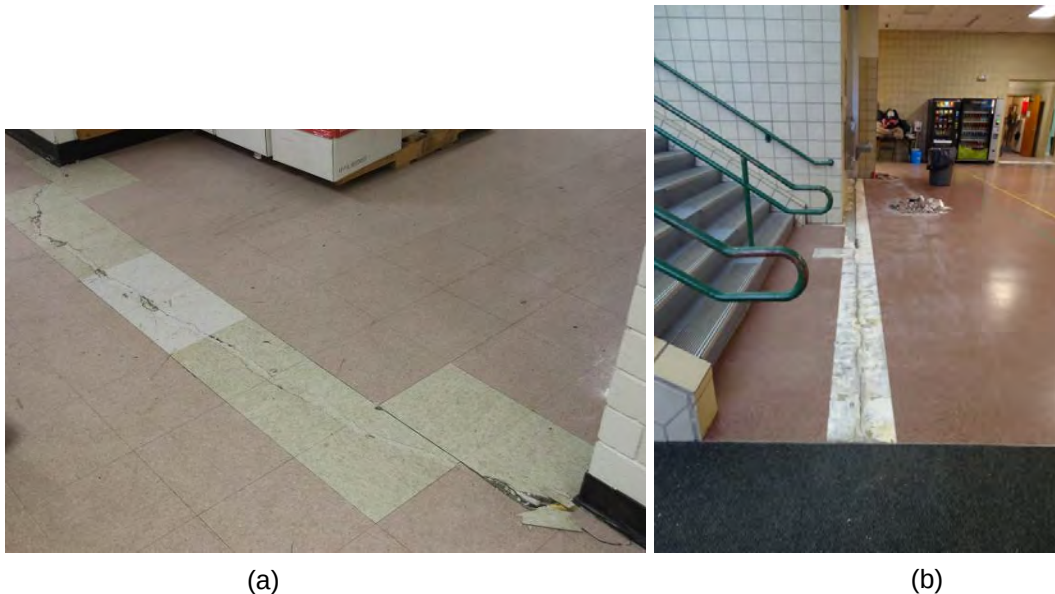
Damage to nonstructural flooring was observed in multiple schools, including schools in Eagle River, Mat-Su, and South Anchorage. An example of cracking in floor tiles is shown in Figure 6.25. In some cases, damage in floor finishes may have resulted from ground movement. Tile failure near seismic joints was noticed in several structures, including schools throughout the region. Floor finish failure should be viewed with special caution as it might imply diaphragm failure or local slab damage.

Figure 6.25. Damage to tile floors at (a) Eagle River Elementary and (b) Colony Middle. At Colony Middle, floor tiles were installed over a seismic joint at the lowest floor (photos: (a) Chris Motter and (b) Janise Rodgers).

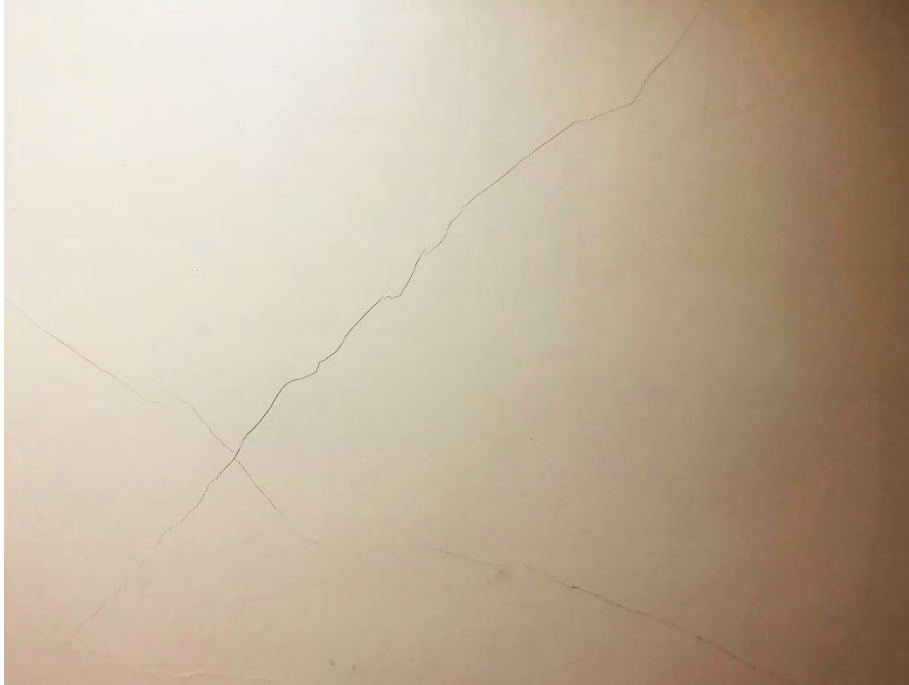
Diagonal shear cracks in concrete core and structural walls appeared in many locations at first and second stories of the main patient building at one of the Anchorage hospitals (Figures 7.2, 7.3, 7.4, and 7.5). The crack width was minor, on the order of 1/32 to 1/16 of an inch. However, crack length varied from a few inches to 6 feet, extending across nearly two-thirds of the wall height. Shear cracks appeared as diagonal or cross-shaped diagonal cracks. There was no clear evidence of crack penetration across wall thickness, despite apparently good alignment of cracks on both faces of

*Figure 7.2. Concrete core wall cross-shaped shear cracks in main building of an Anchorage hospital. These cracks are sample of many similar cracks at different concrete shear walls at level 1 of the hospital (photo: Wael Hassan).*

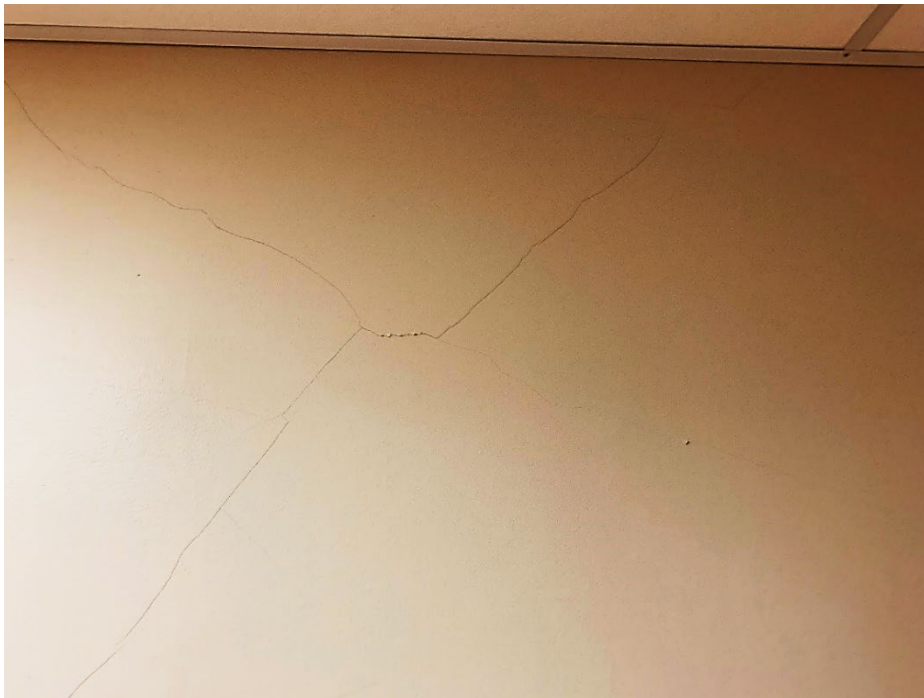
*Figure 7.3. Concrete shear wall cross-shaped shear cracks in the main building of an Anchorage hospital (photo: Wael Hassan).*

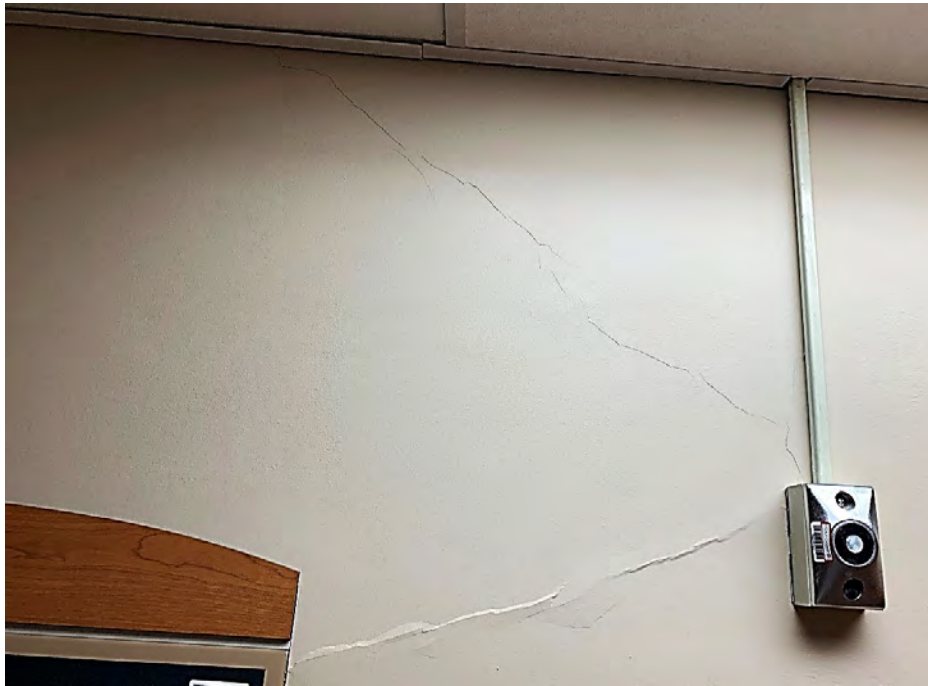
Figure 7.5. Concrete core wall diagonal shear cracks in the main building of an Anchorage hospital (photo: Wael Hassan).

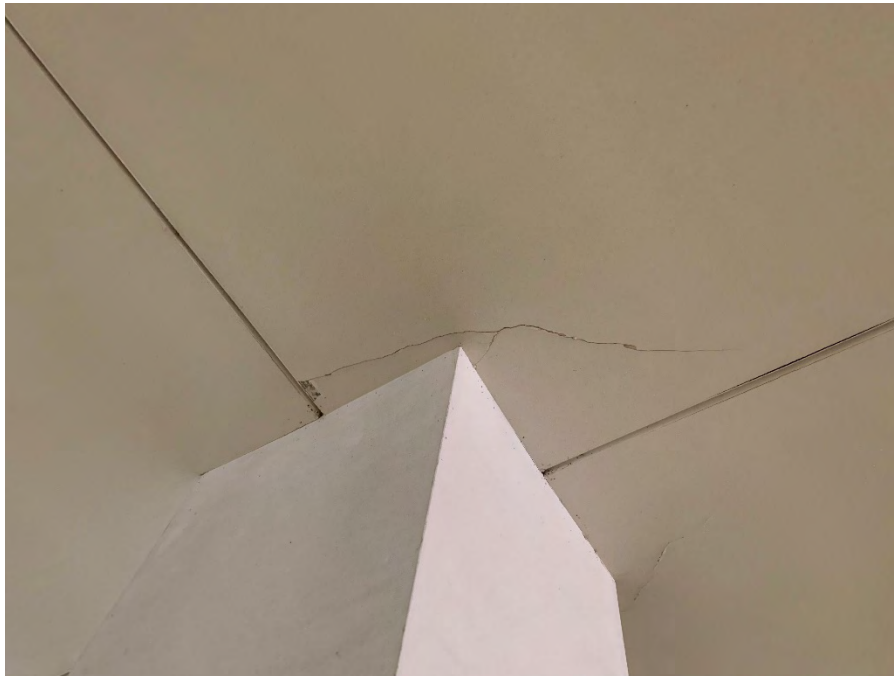
Expansion and seismic joints at all three Anchorage hospitals experienced light-to-moderate damage as per the design intent, mostly to the joint finishes, protecting structural components efficiently (Figure 7.6). At one of the parking floors at the ground level of one hospital, there were gypsum ceiling cracks above exterior concrete columns, which might have implied hidden structural damage in the floor diaphragm (Figure 7.7). Some minor flexural cracks appeared in spandrels and exterior columns of the same building (Figure 7.8).

*Figure 7.7. Gypsum-finish cracking above a concrete column in an Anchorage hospital parking structure might imply hidden diaphragm or concrete slab damage. This crack was typical above many exterior columns (photo: Wael Hassan).*

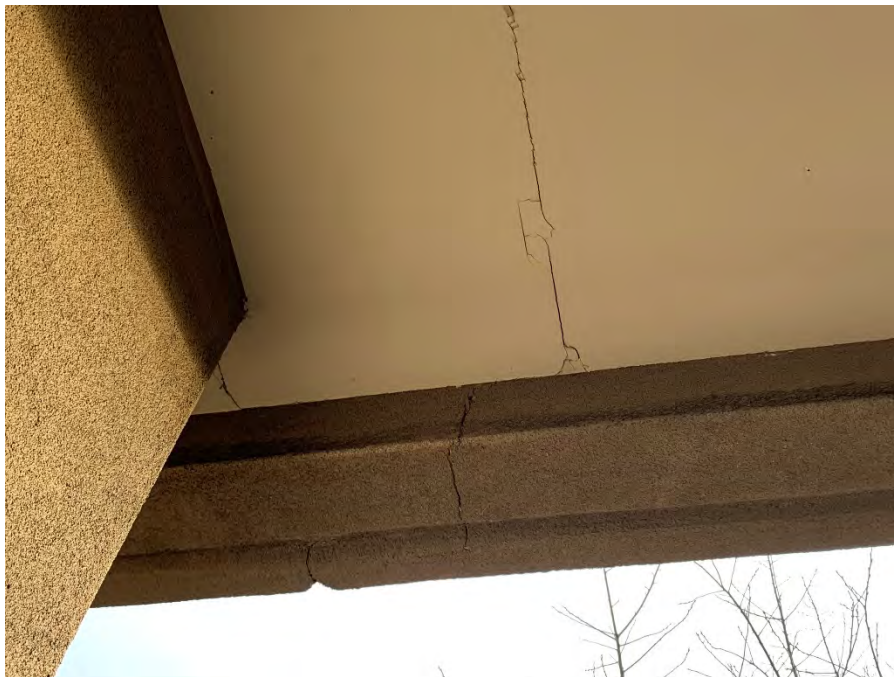
*Figure 7.8. Flexural cracking in spandrel concrete in an Anchorage hospital's parking structure. Ceiling-finish cracking here might imply hidden concrete slab damage (photo: Wael Hassan).*

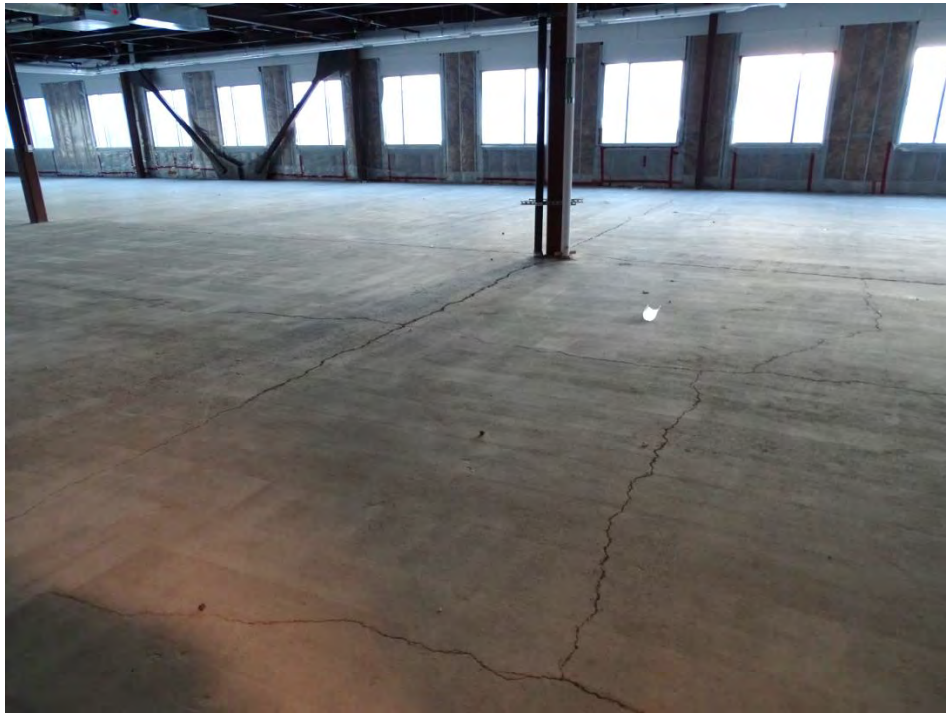
At Mat-Su Regional, no significant structural damage was reported to the hospital or the neighboring MOB 1. MOB 2 experienced minor flexural cracking of the concrete slab on metal decking longitudinally along beams and in the slabs (Figure 7.9); reconnaissance team members were told this cracking occurred because of the earthquake. This cracking was visible in an unfinished floor that allows for future expansion. It is unclear whether the cracks were present prior to the earthquake and were widened by it or whether they were only due to the earthquake response of the building. Similar cracking appeared in mechanical-room slabs in both major Anchorage hospitals, BBA, and Mat-Su Valley Providence Cancer Center and was similarly attributed to the earthquake (Figure 7.10).

Figure 7.9. Slab cracking viewed from the second floor of Mat-Su Regional MOB 2, attributed by building personnel to the earthquake (photo: Janise Rodgers).

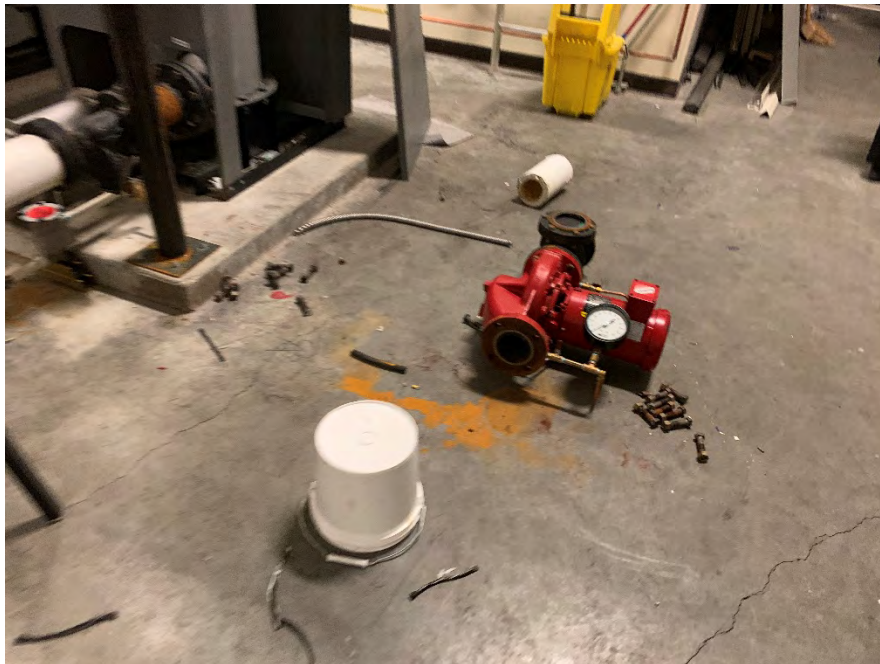
Figure 7.10. Slab cracking viewed from the fourth-floor mechanical room in a hospital in Anchorage, attributed by building personnel to the earthquake (photo: Wael Hassan).

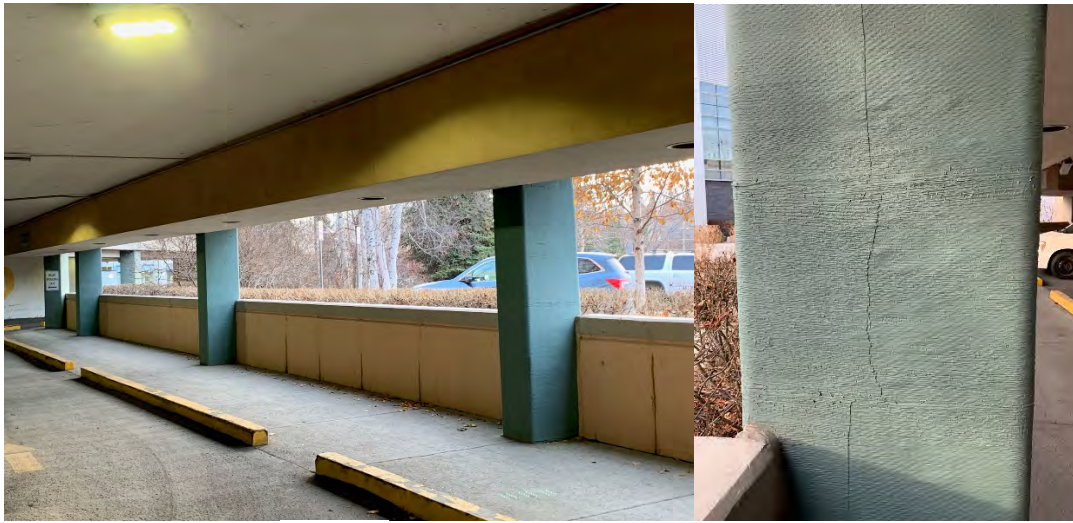
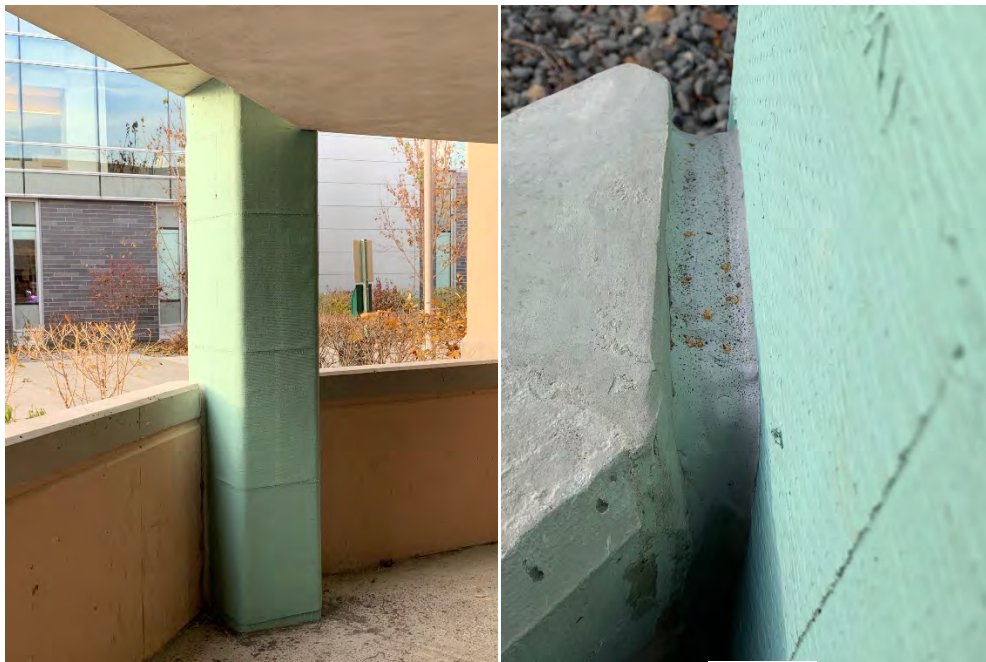
A good practice lesson worth mentioning is the observation by the structural retrofitting engineer that Parking Structure PS2 at PAMC had concrete parapets connected to their adjacent columns throughout the building, creating short/captive columns that could have possibly failed. Besides fiber-reinforced polymer (FRP)-retrofitted concrete columns, a main component of the retrofit was to isolate the parapets from columns via elastic material (Figure 7.13). The FRP columns did not show any sign of debonding. Some flexural and flexural shear cracks appeared in some of the column tops at PS2, as well as unconfirmed shear wall cracks and concrete parapet shear cracks appearing (Figure 7.14).

Figure 7.13. (a) PAMC Parking Structure 1, with building retrofitting via (b) FRP wrapping. (c) No signs of debonding were observed following the earthquake. The retrofitting project included (d) separating the concrete parapet from the column with elastic material to avoid a short-captive-column condition. (photos: Wael Hassan).

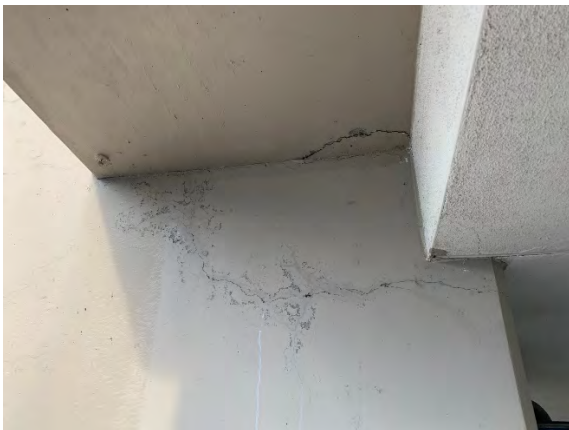
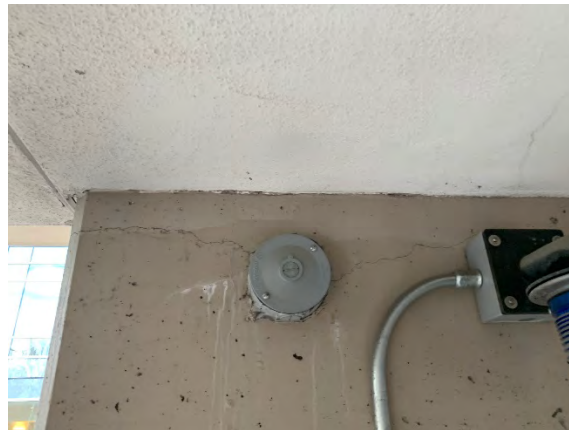
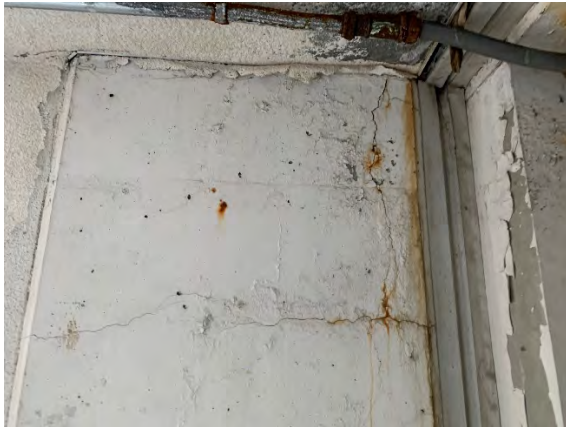
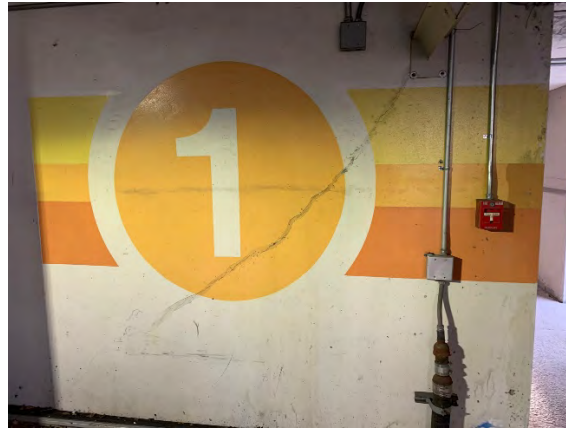
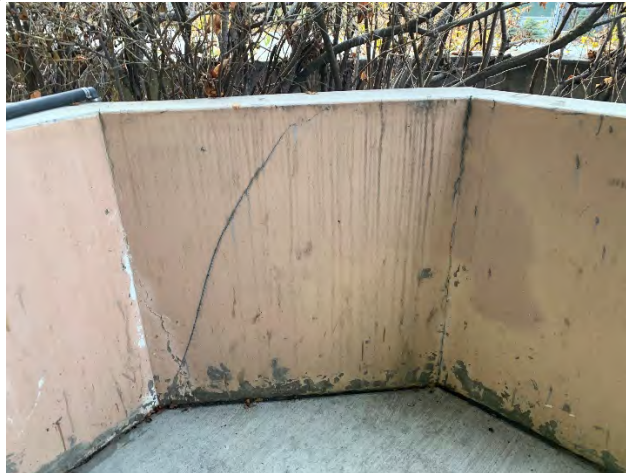
*Figure 7.14. PAMC Parking Structure 1, with (a, b) flexural shear and flexural cracks in concrete columns, a (b) flexural and bond crack/water leak at a concrete expansion-joint column, a (c) concrete shear wall crack not confirmed to be due to this quake, and a (d) concrete parapet shear crack. (photos: Wael Hassan).*

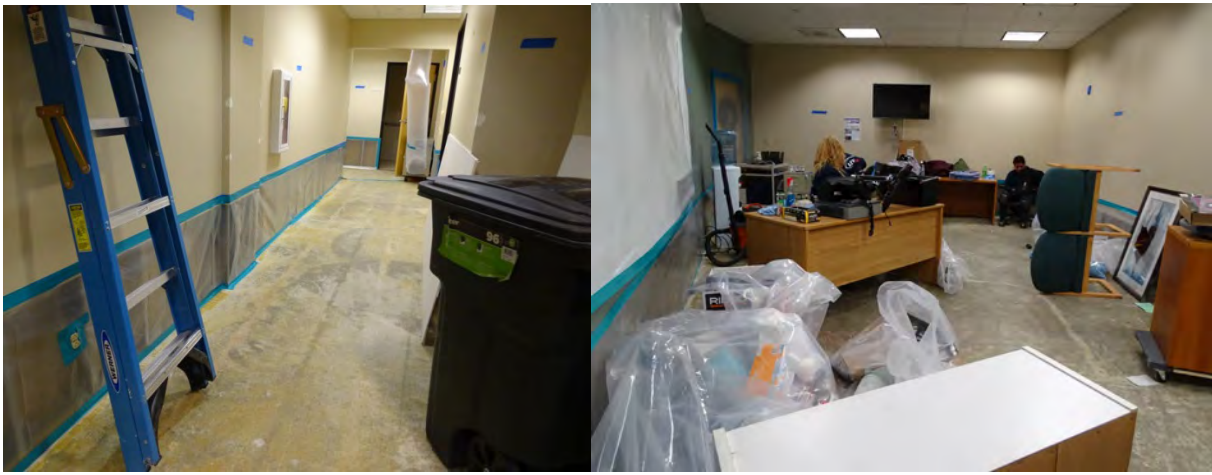
MOB 1 at Mat-Su Regional had domestic water and glycol leaks, including a leak in the mechanical penthouse and a water leak on the fourth floor, that caused flooding down to the first-floor outpatient surgery center and other specialty areas in the building, including the cancer center. Extensive cleaning and remediation were required, including the removal of floor finishes and drywall, as shown in Figure 7.16. This remediation was ongoing during the EERI Team reconnaissance visit on December 11. At Mat-Su Regional's Wasilla clinic location, glycol lines in the ceiling broke and inundated the top floor.

Figure 7.16. Remediation of damage due to water and glycol leaks at Mat-Su Regional MOB 1 on December 11 (photos: Janise Rodgers).

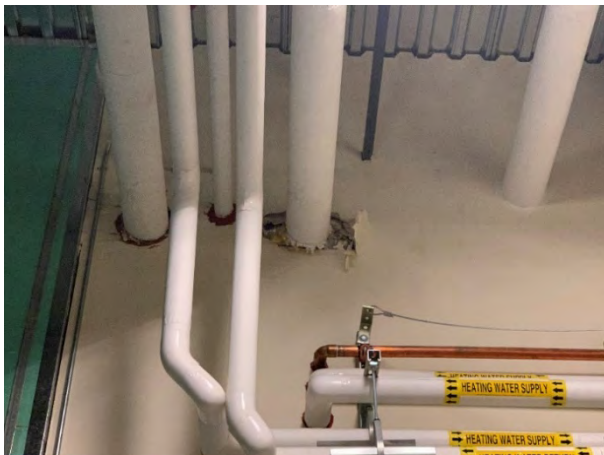
*Figure 7.17. (a) Damage to partition wall due to pipe movement that caused a lack of clearance; (b) water-pipe leak at Anchorage hospital; (c) water-pipe damage at Anchorage hospital; (d) elevator out of service due to water leaks inside the shaft, counterweight damage, or dislocation (photos: Wael Hassan); and (e) duct connection failure at PAMC (photo: PAMC).*

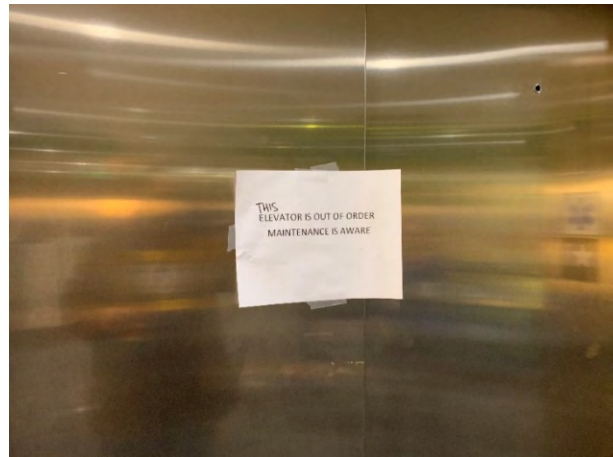
(d)

PAMC experienced water damage at isolated locations because of sprinkler-head failures. The most significant was in main patient building, Tower D, the oldest on campus. The fourth-floor fire suppression system experienced sprinkler and pipe connection damage that led to flooding an area of 20 by 12 feet, with 2-inch average water depth in the floor below and heavy water damage to the ceiling (Figure 7.17). The water leaked into one of the elevator shafts, leading to the elevator malfunctioning.

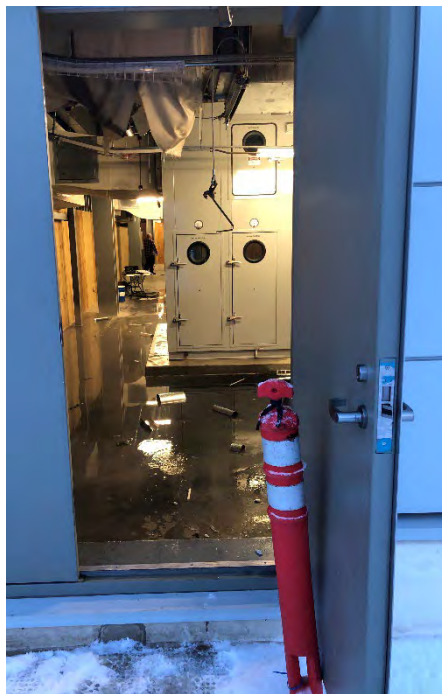
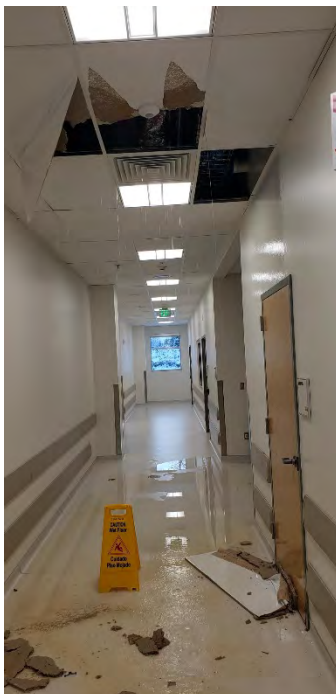
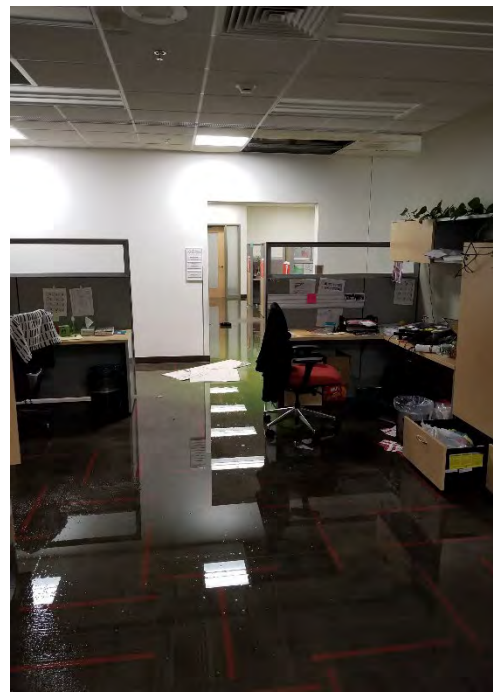
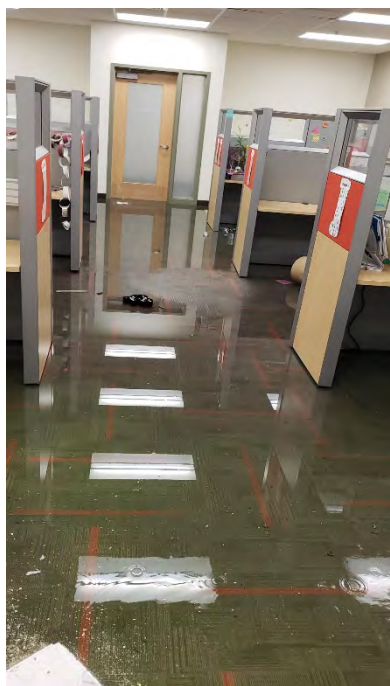
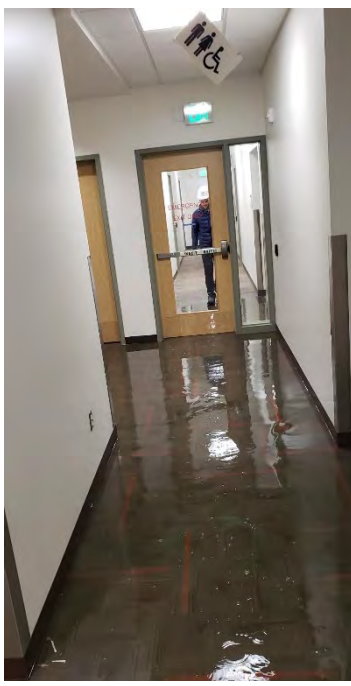
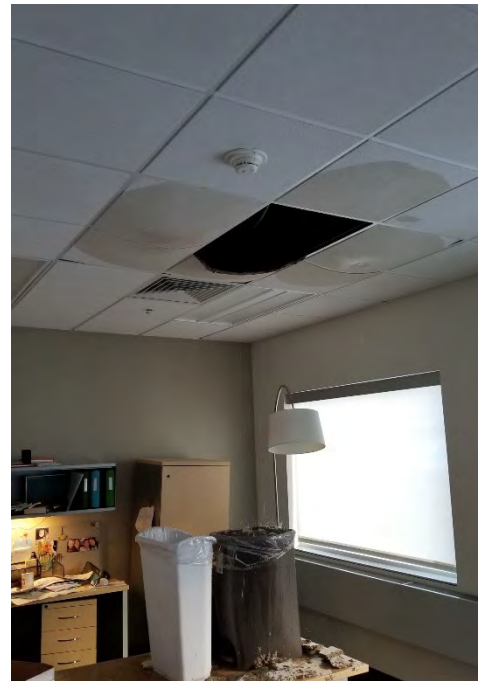
The BBA suffered serious rigid-connection water-pipe damage and heat-exchanger rigid-union connection damage in the penthouse mechanical room that led to severe glycol and water flooding, covering large areas of the second floor level below, damaging the ceiling significantly and penetrating to the first floor (Figures 7.18 and 7.19). A 3-inch cast-iron drain piped throughout the building was connected with no-hub fittings, and many of these fittings pulled apart. Of highest concern were the fittings connecting the floor drains of the penthouse, as well as the roof drains. These pipes drained the water and glycol from the penthouse through the drop ceilings onto the second floor. This resulted in damage to ceilings, walls, floors, five computers, and four phones. In the process of drying leaked water and glycol in the BBA, 1,400 gallons of water were pumped out.

**Figure 7.18.** Water damage at BBA: (a) mechanical-room flooding, water leak in (b) ceiling and second-floor hallway and (c) office, 2-inch-deep water flood in (d) offices and (e) hallway, and (f) ceiling damage (photos: BBA).

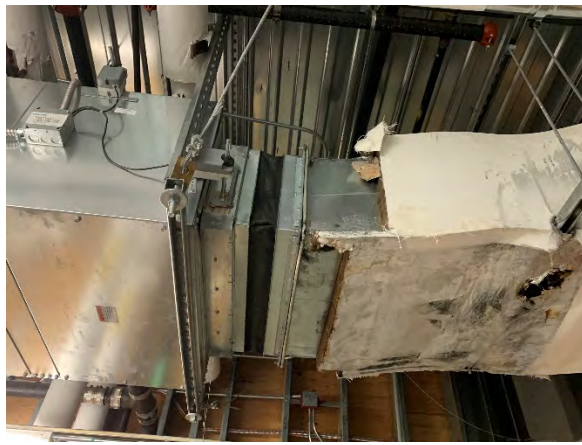
*Figure 7.19. Mechanical room at BBA: (a) air-duct connection failure, (b) heat-exchanger connection damage, (c) heat-exchanger glycol flooding and damage, (d) stiff-pipe connection failure, (e) water-pipe damage due to collision with stiff out-of-plane steel members, and (f) stairwell drywall damage (photos: Wael Hassan).*

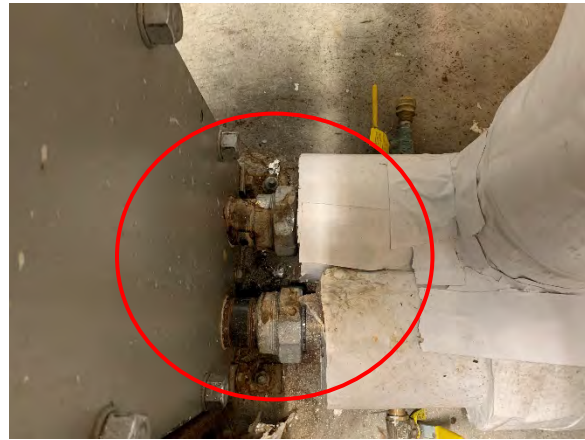
(b)

BBA suffered heavy electrical hardware damage in the flooded segments of floors, along with many heating, ventilation, and air conditioning (HVAC) and mechanical fixtures with moderate damage due to rigid connections in the mechanical room. These included heat-exchanger union connection failure, leading to a massive glycol leak, rigid-water-pipe connection failure, air-duct connection failure, and damage of pipes due to collision with a system in a different plane (Figures 7.19 and 7.23). All lighting units were destroyed in the penthouse mechanical room. A sprinkler was damaged in the mechanical room because of hitting an air unit. Cast-iron-roof drainpipes were damaged or disconnected, allowing runoff water into the penthouse. Variable-air-volume units in four different locations on the second floor, the radiator segments of the heating systems, had splits in the pipe, leading to water venting onto the drop ceiling and then the floor. These were isolated by using valves as they were discovered, but water was vented, causing damage to ceiling tiles, drywall, and several pieces of computing equipment and phones. Several components of the fire suppression systems were damaged because of water leaking throughout the building. Because of water runoff, two fan motors were damaged in the “walk-in blood-storage freezer” as a result of water infiltration and subsequent freezing, which caused them to fail. One concern BBA staff expressed was that many systems did not restore service efficiently after the initial assessment that they had no damage.

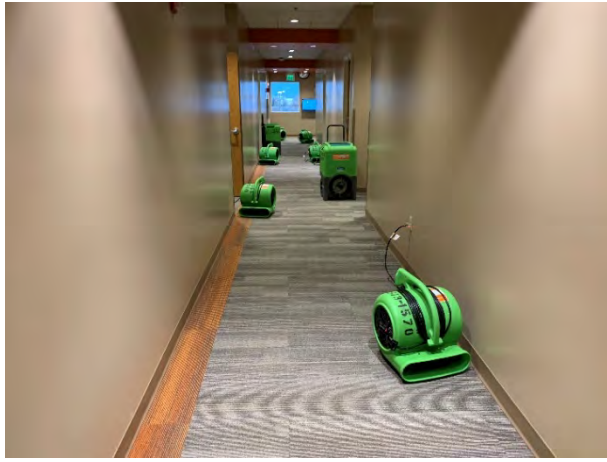
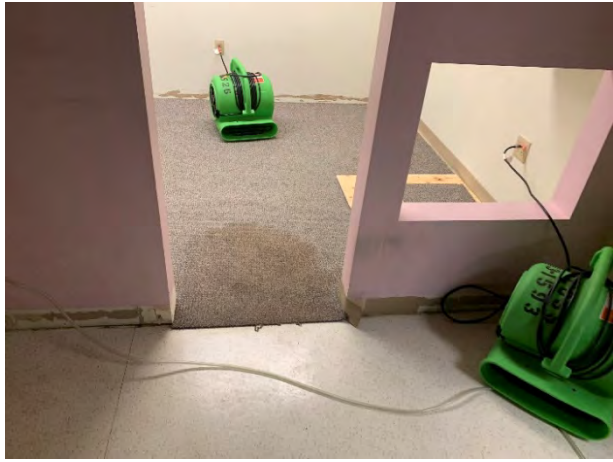
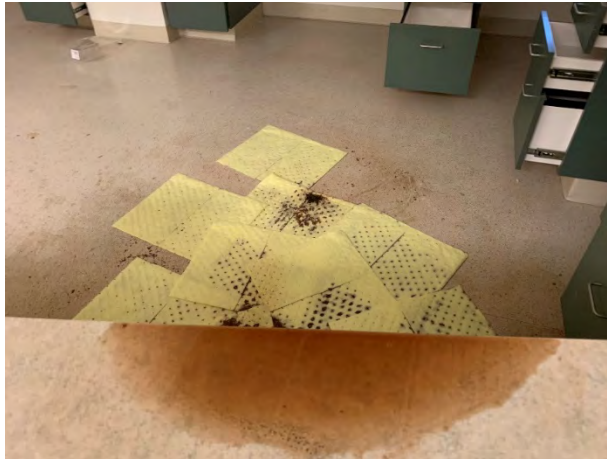
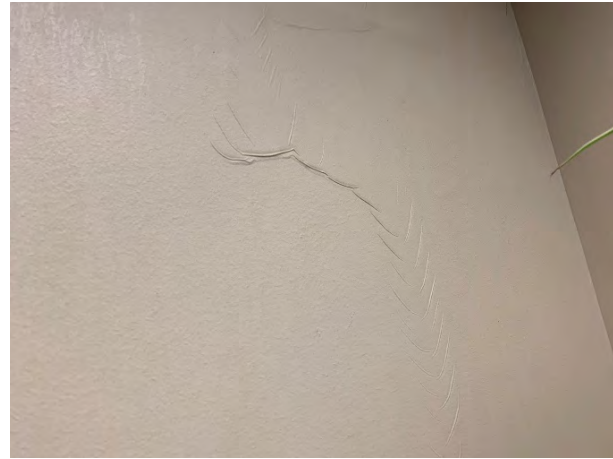
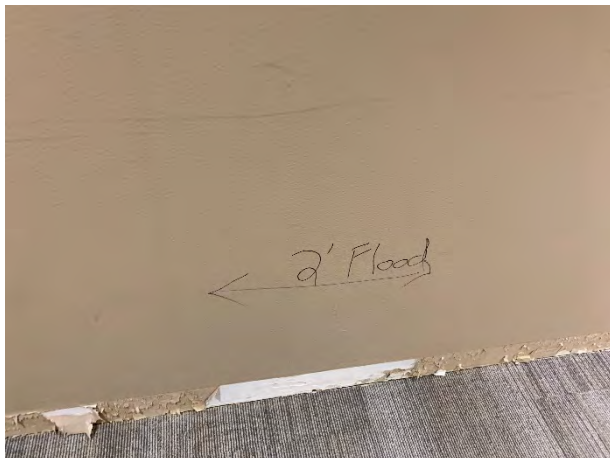
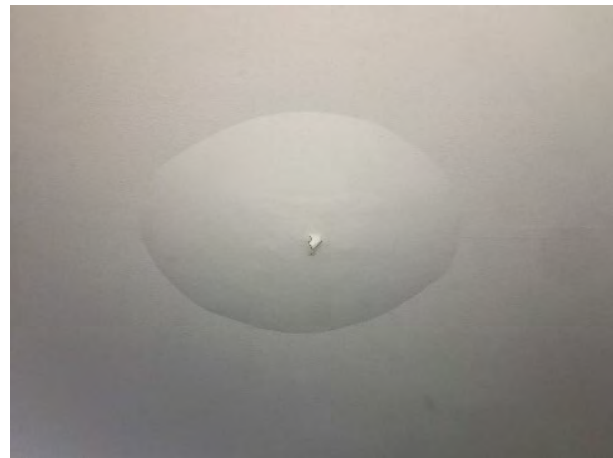
*Figure 7.20. Water damage impacts at Anchorage hospitals: (a, b) air blowers used to dry major flooding, water leaks on (c) floors and (d) walls, (e) flood-extension marking, and (f) a water leak from fourth-floor failed sprinklers at PAMC (photos: Wael Hassan).*

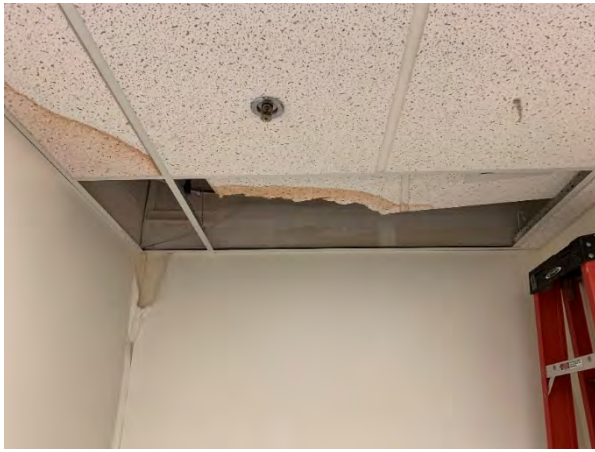
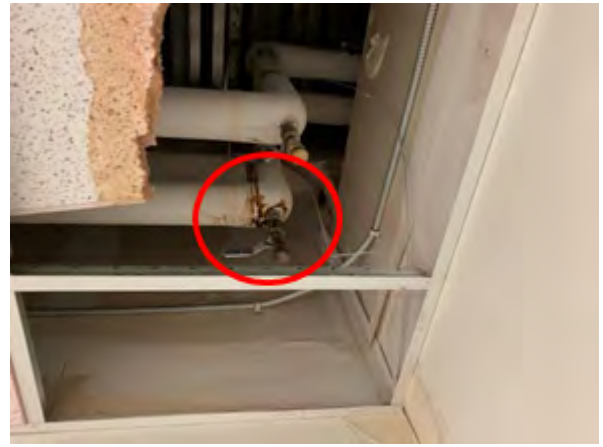
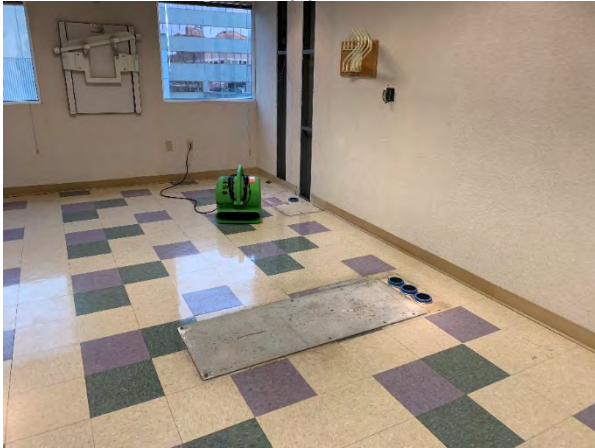
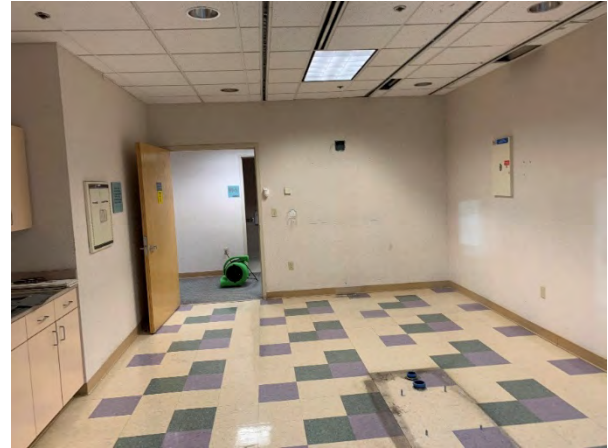
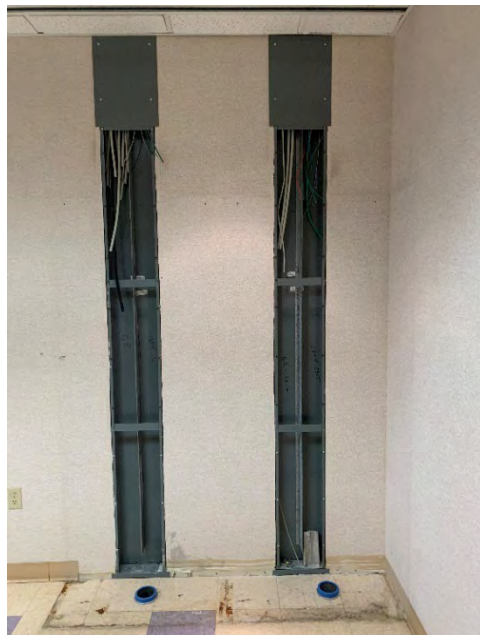
In one of the hospitals in Anchorage, the heavy water damage affected operations of some areas, such as radiology and imaging outpatient facilities by causing damage to significant electric wiring and panel hardware and leading to movement of the computed tomography (CT), magnetic resonance imaging, or X-ray units to off-campus locations (Figures 7.20 and 7.21). In another hospital, water flooding resulted in electrical short circuits and electrical panel damage, triggering fire alarms right after the earthquake (Figure 7.22).

Figure 7.21. (a) Water damage to the ceiling and (b) a broken water pipe at an Anchorage hospital, (c, d) water flooding of the radiology facility at an Anchorage hospital (scanning equipment was affected and moved to an off-site location), and (e) damage to entire electrical wiring due to water flooding (photos: Wael Hassan).

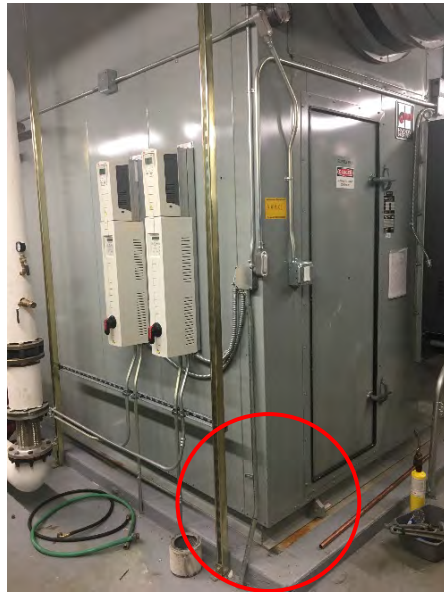
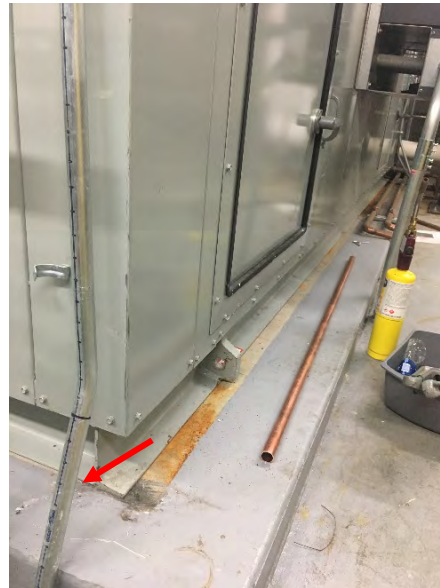
Figure 7.22. (a) Mechanical unit sliding in an Anchorage hospital with (b) detail shown; (c) the same hospital mechanical room with water-boiler connection failure due to boiler sliding with (d) detail shown; and (e) triggering of a fire alarm caused by an electrical panel short-circuiting at the floor below because of water damage from the boiler above (photos: Wael Hassan).

Some elevators were out of service in the three Anchorage hospitals for various reasons, such as seismic sensor shut-off, water leakage, or counterweight damage or dislocation. In the case of Patient Tower D in PAMC, the water leak caused one elevator to malfunction with two people inside, and these individuals were rescued after the earthquake. The water leak through that elevator went as far as the ground level. The other elevators in Tower D were out of service because of counterweight problems. Elevators of Parking Structures 2 and 4 at PAMC also suffered counterweight damage. In one of Anchorage's hospitals, an unrestrained heavy mechanical unit slid a few inches, causing pipe damage (Figure 7.22).

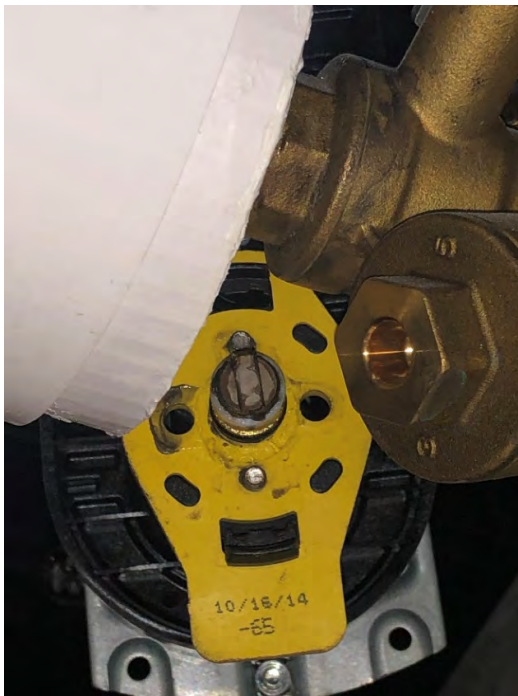
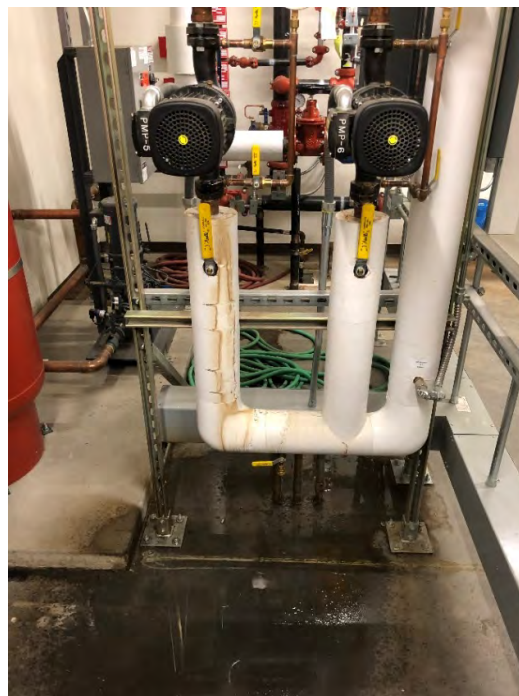
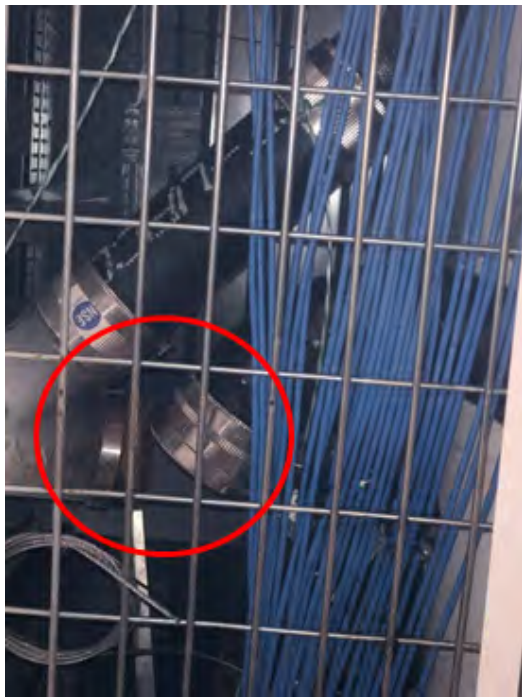
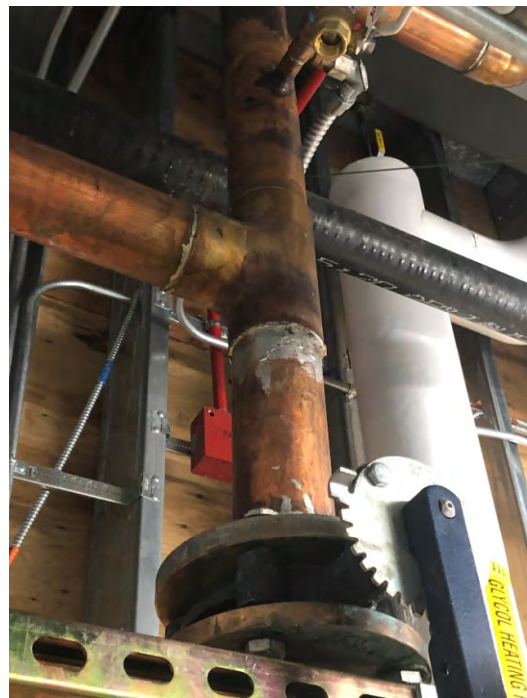
Figure 7.23. Glycol pipe (a) connection failure and (b) leak at BBA mechanical room, (c) air-duct connection damage at BBA's second floor, and (d) pipe connection failure at the BBA mechanical room (photos: BBA).

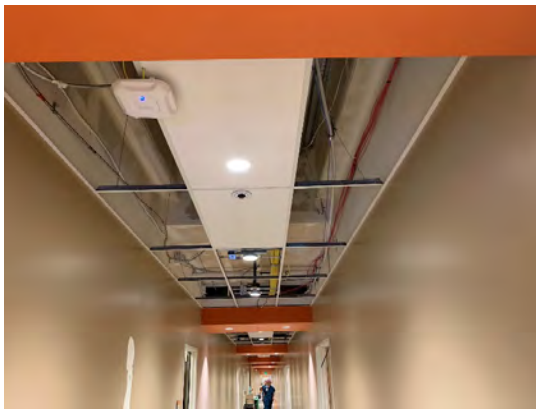
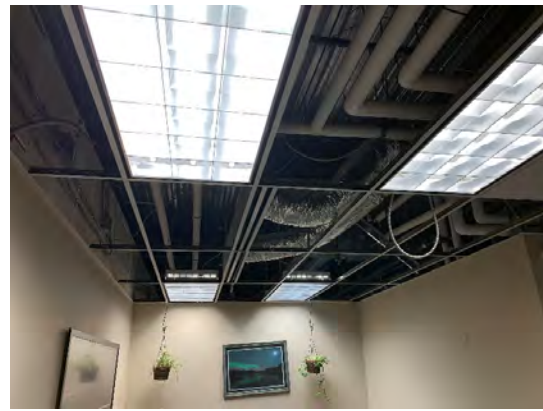
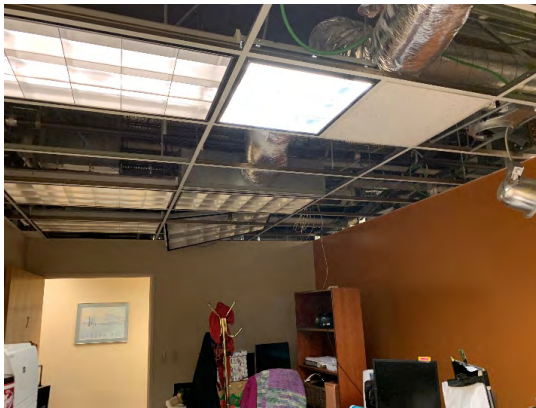
At Mat-Su Regional's urgent care clinic in Wasilla, ceiling tiles fell, and gypsum wallboard cracked. Figures 7.24, 7.25, 7.26, 7.27, and 7.28 show sample ceiling and wall damage from Anchorage hospitals. Ceiling tile and grid damage due to shaking was common at many hospital campus buildings. Ceiling tile damage due to water flooding and glycol leaks was evident in hospitals in Anchorage and in the BBA. For example, the BBA lost nearly 600 ceiling tiles, primarily because of water and glycol flooding. Sprinkler-head shearing and damage to ceiling tiles was widespread in this earthquake in nearly all hospital buildings (Figures 7.24 and 7.26). Significant cracking in stairwell drywall was very common in all hospital buildings in Anchorage (Figure 7.27). Vertical, horizontal, and diagonal cracking in sheetrock and cracking around openings was also widespread. Thousands of cracks could be traced in one hospital building. The cost of repairing these cracks could be significant because of the large number and the need for scaffolding in many cases of high bays. In an actively seismic region like Alaska, the use of brittle drywall/sheetrock finishes may need to be revisited.

Figure 7.24. Patient building ceiling damage in the (a) hallway and (b) clinic due to water flooding in an Anchorage hospital, (c) office-space ceiling damage due to water in an Anchorage hospital, (d) sprinkler-head damage and ceiling tile damage in patient building (photos: Wael Hassan), (e) drop-ceiling damage at PAMC PS1 (photo: PAMC), and (f) heavy ceiling tile damage at an Anchorage hospital (photo: Wael Hassan).

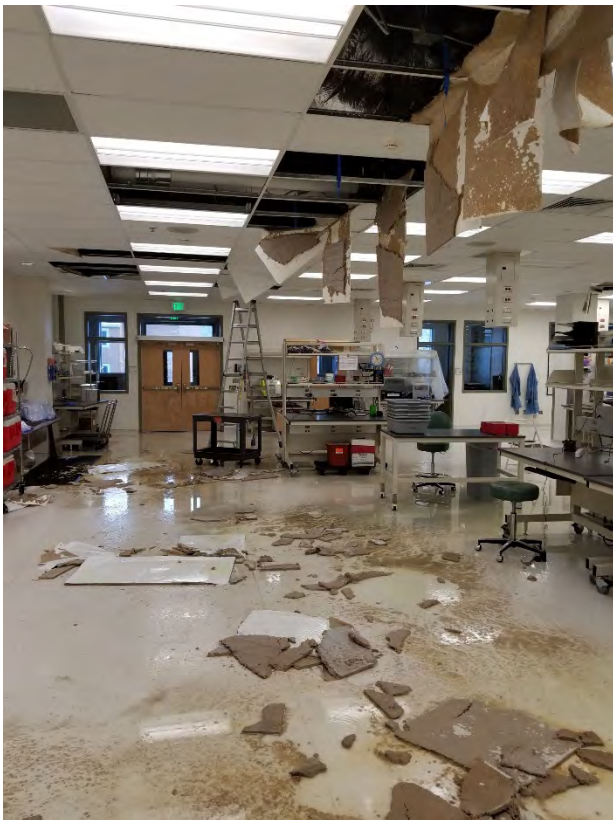
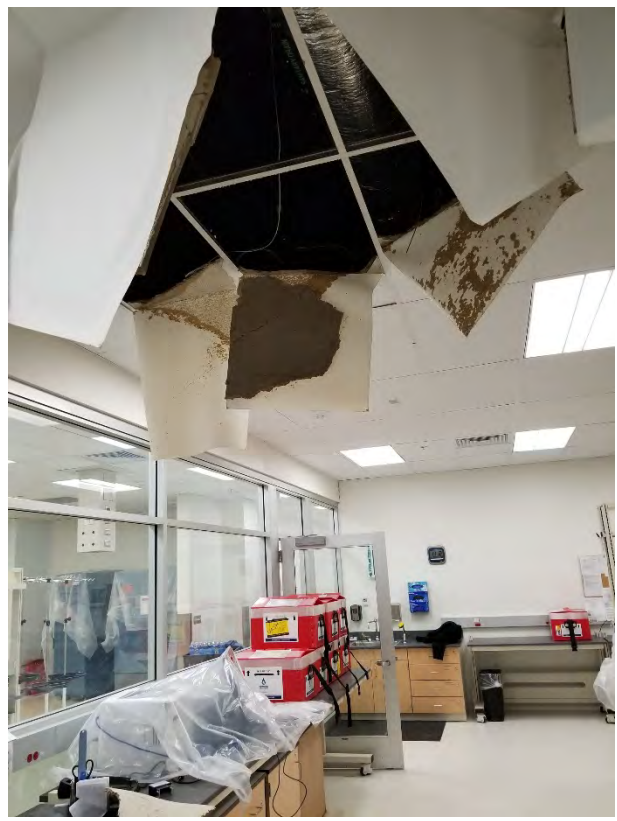
Figure 7.25. Laboratory ceiling damage due to water flooding at BBA (photos: BBA).
