# EERI Earthquake Reconnaissance Report: M7.1 Anchorage Earthquake on November 30, 2018

Wael M. Hassan, John Thornley, Janise Rodgers, and Christopher Motter

July 2021

*A product of the EERI Learning from Earthquakes Program*

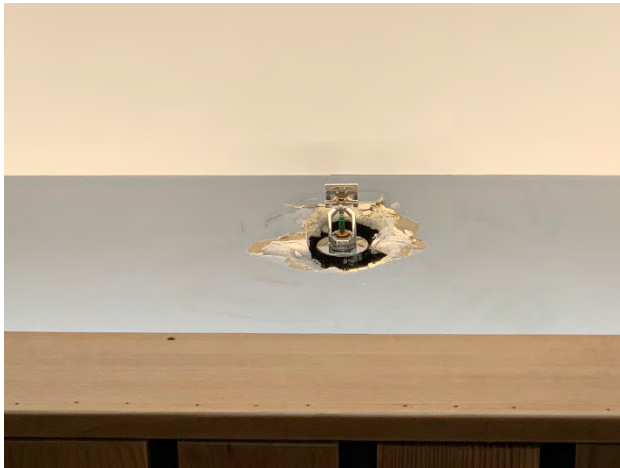
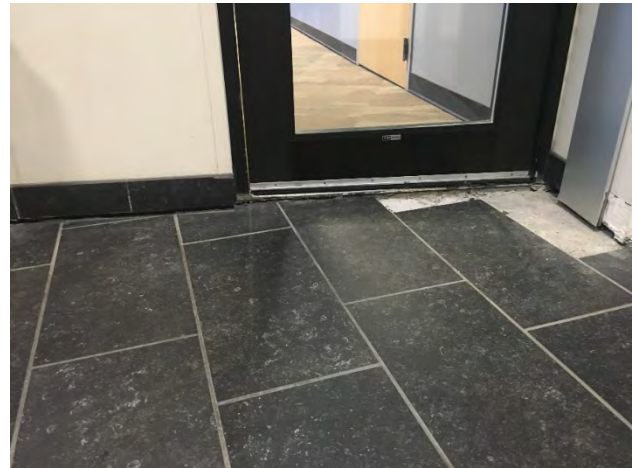
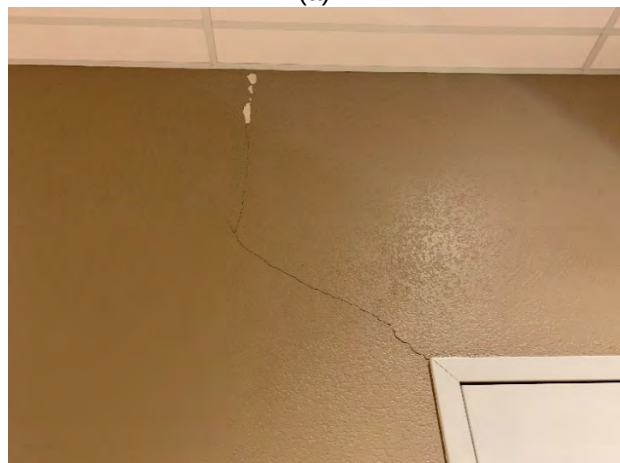
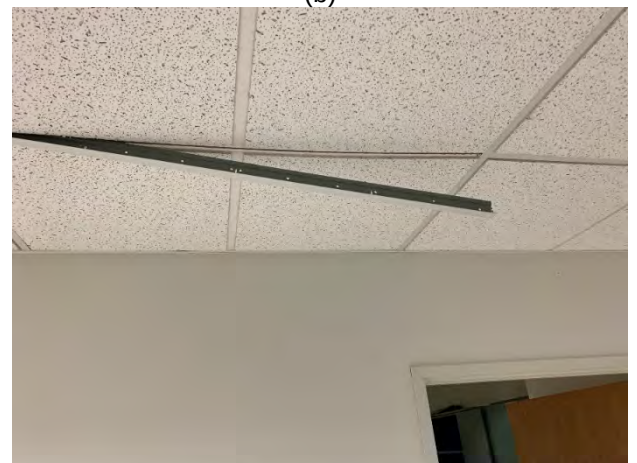
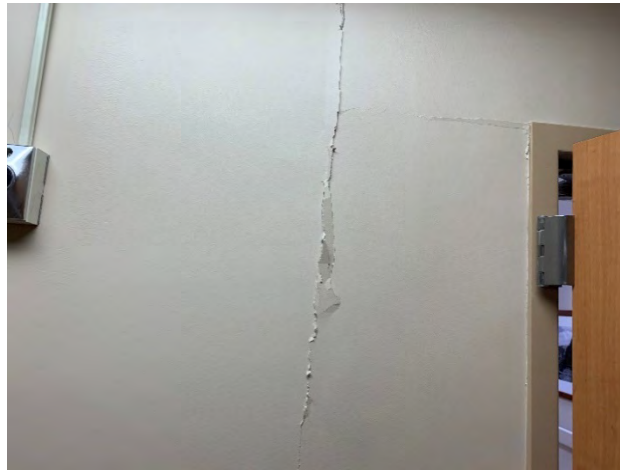
Figure 7.26. (a) Sprinkler head–damaged drop ceiling at PAMC Sky Bridge, (b) floor damage due to ground failure at an Anchorage hospital, (c) typical sheetrock wall damage in all three Anchorage hospitals, (d) ceiling grid failure, and (e) typical diagonal wall crack around openings (photos: Wael Hassan).

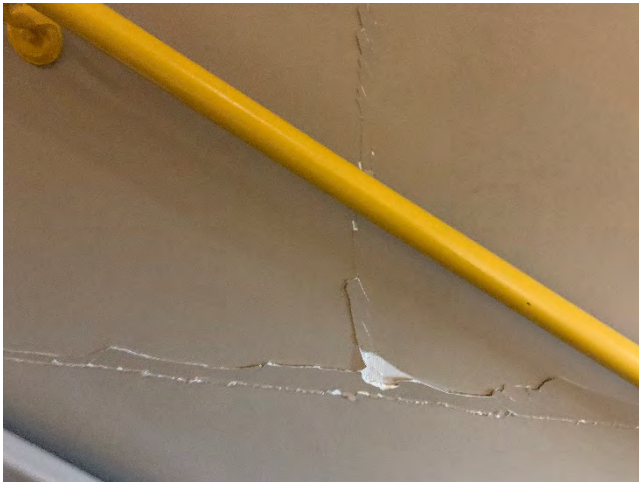
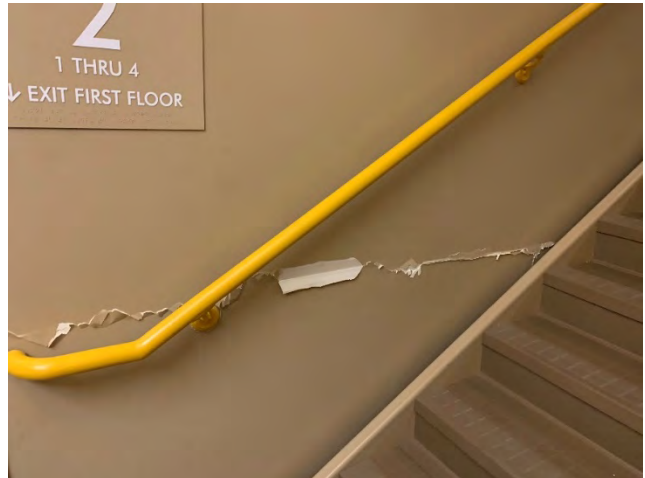
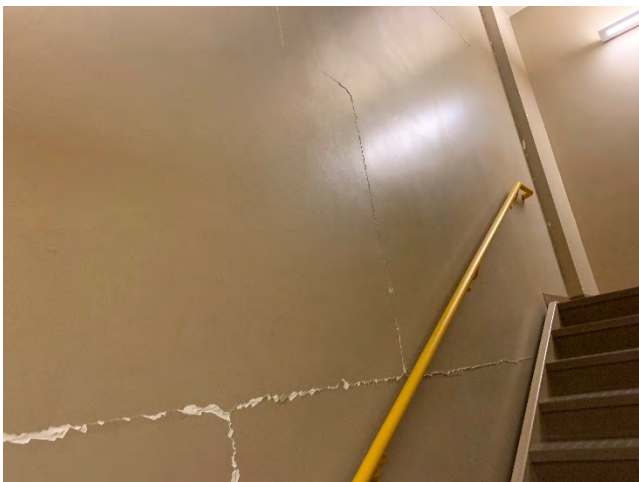
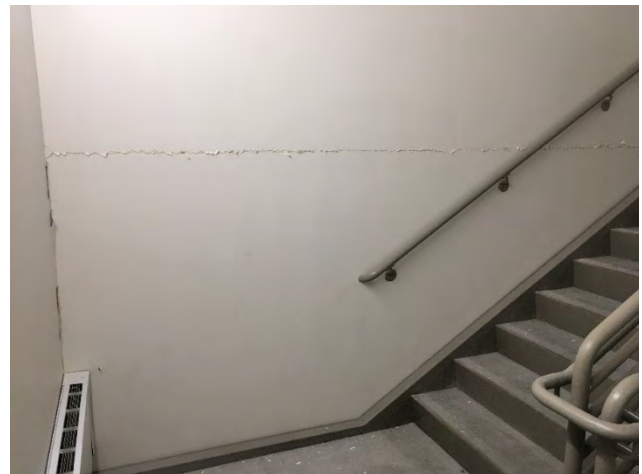
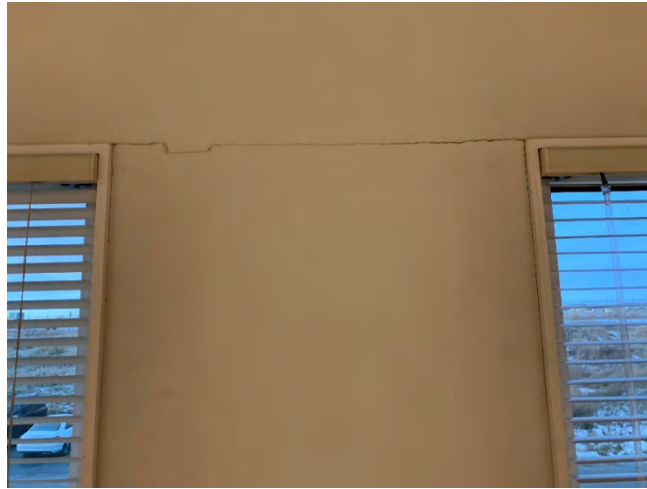
Figure 7.27. (a–d) Typical stairwell sheetrock damage in Anchorage hospitals, which was common in all hospital and office buildings, and (e) typical wall panel crack (photos: Wael Hassan).

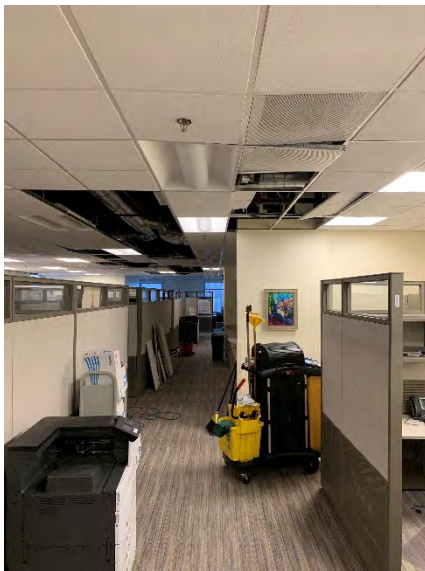
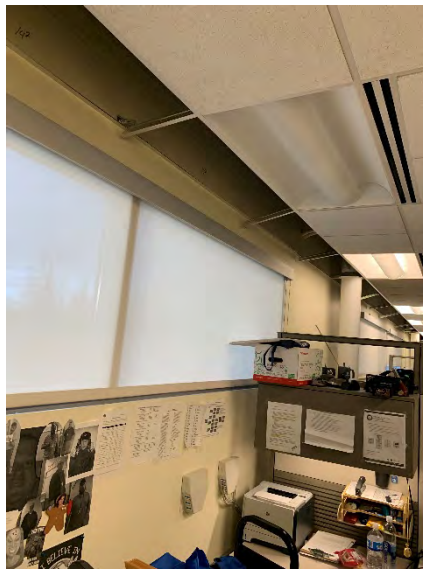
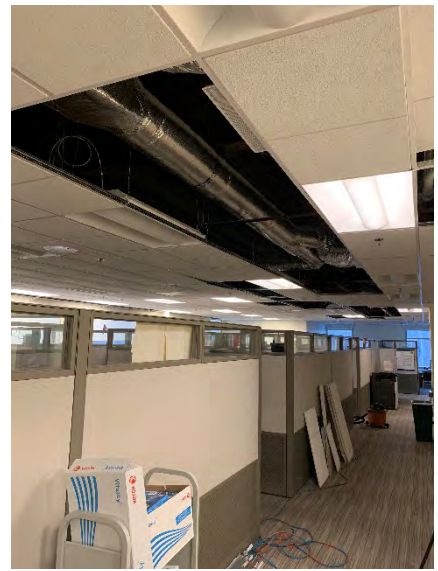
Figure 7.28. VA Hospital in Anchorage, nonstructural ceiling damage (photos: Erol Kalkan).

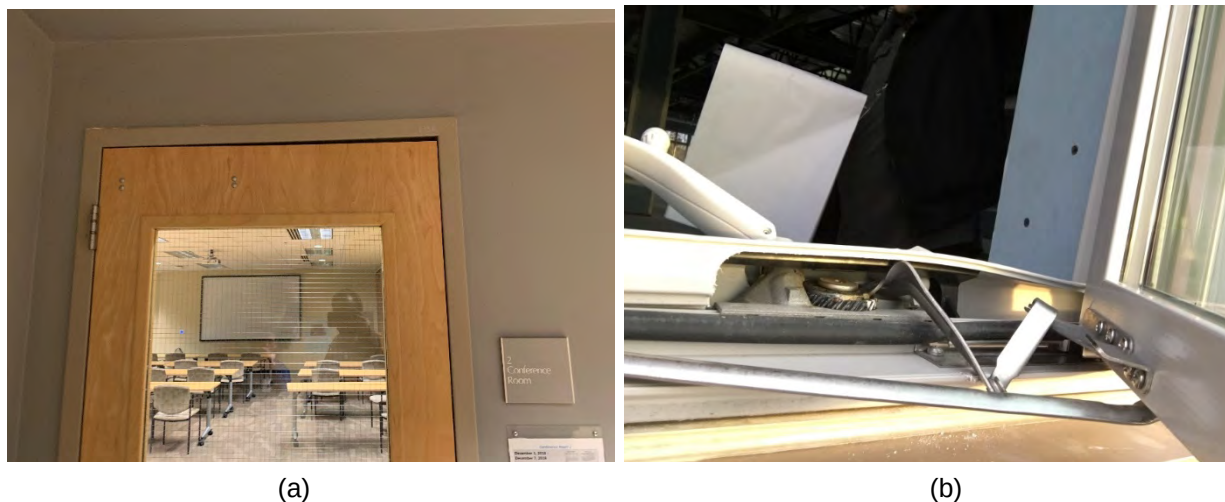
Floor damage due to soil failure occurred at some locations in one of the hospitals in Anchorage. Many door jams and window mechanical systems were damaged because of permanent deformations (Figure 7.29).

Figure 7.29. Examples of (a) door jamming and (b) window system failure in Anchorage hospitals (photos: Wael Hassan).

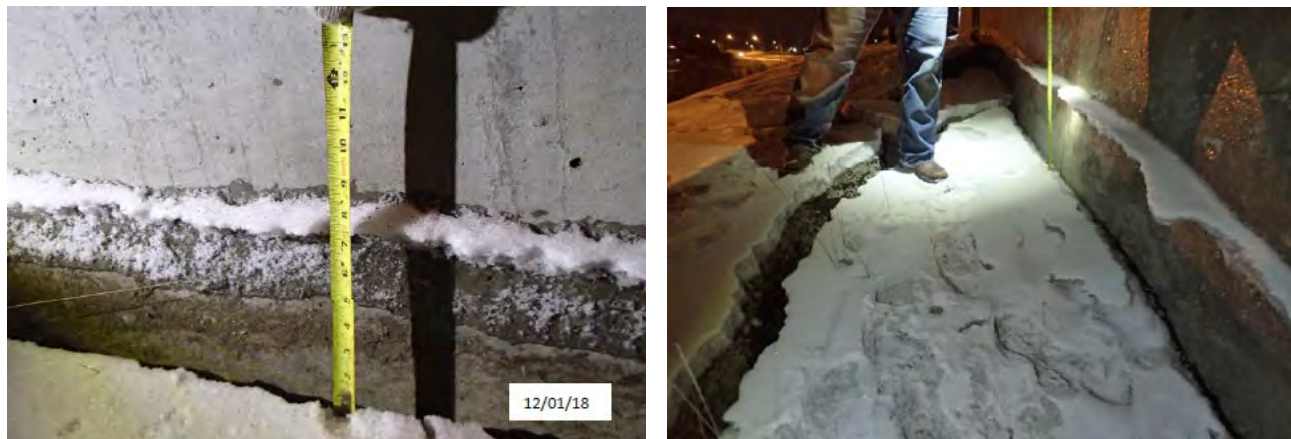
Figure 8.4. A 16-inch wing wall settlement of a bridge (photos: Nick Murray and Ben Still).

Structural damage due to ground failure was common. This was manifested in abutment cracks (hairline to about 0.5 inches wide), approach settlement, settlement of abutments, wing wall settlement, soil cracks, hider wall cracks, culvert failure, rail misalignment, and slope tension cracks. In one incident, damage to a corrugated-metal-pipe pedestrian undercrossing was caused by waterline breakage. Settlement of soil was common and reached 16 inches in one case (Figure 8.4).

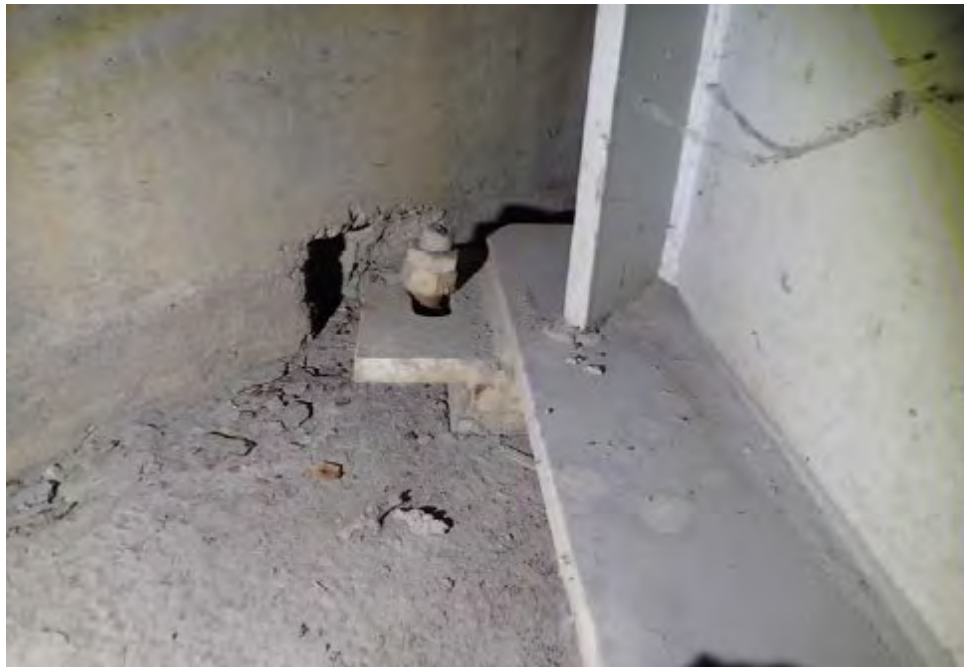
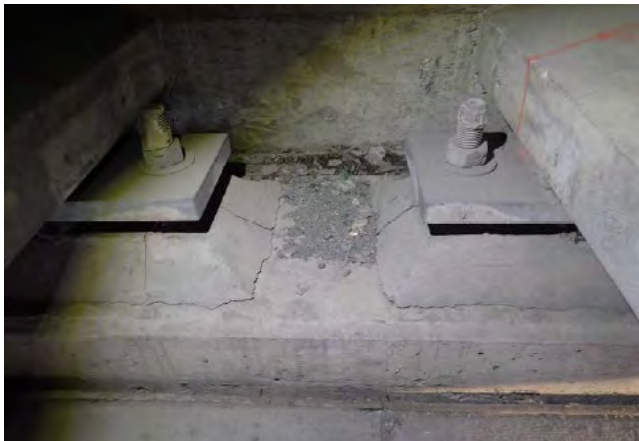
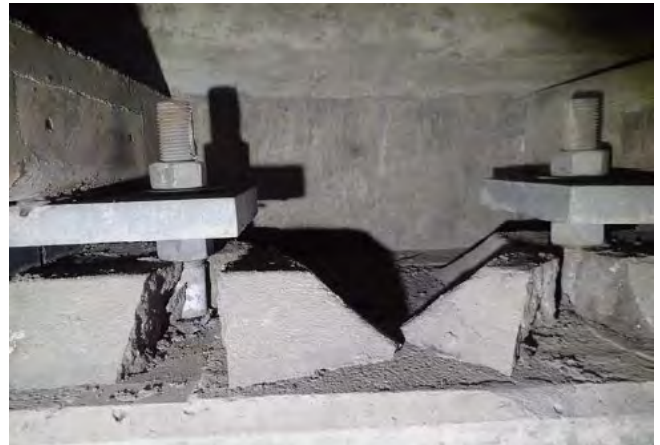
Figure 8.5. (a) Anchor-bolt bending and (b, c) grout-pad splitting and damage (photos: Nick Murray and Ben Still).

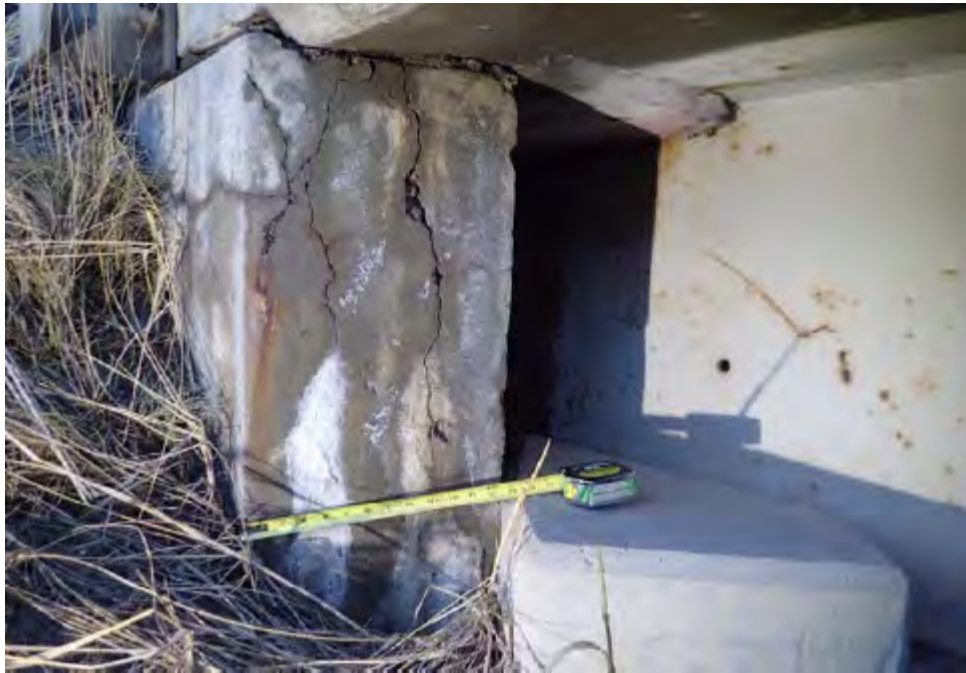
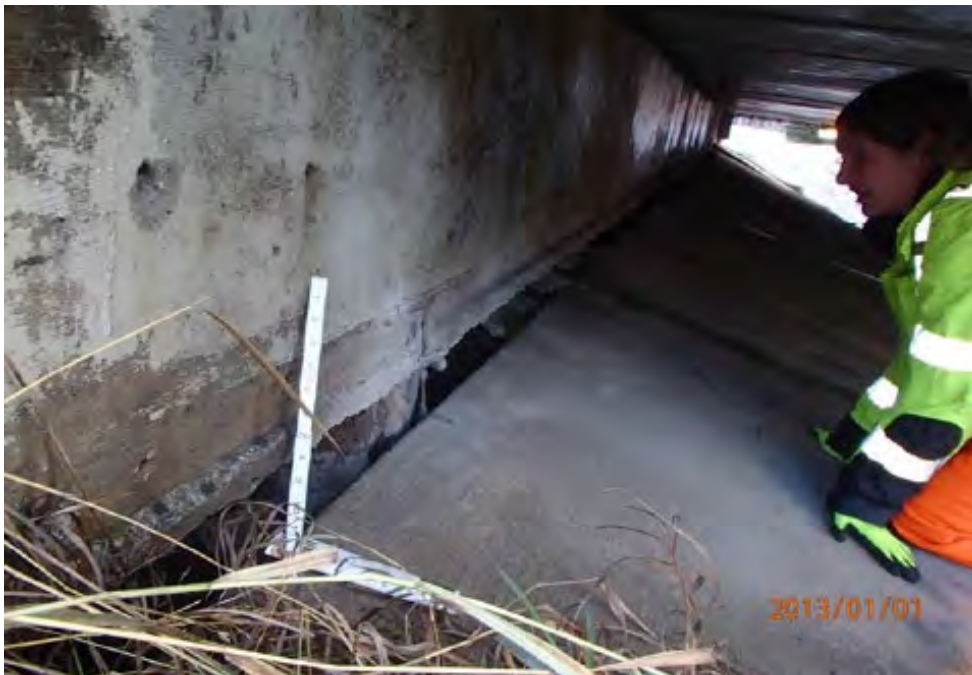
Figure 8.6. (a) Wing wall cracks (photo: Nick Murray and Ben Still) and (b) concrete-embankment-panel settlement (photo: Sara Manning and Ben Fetterhoff).

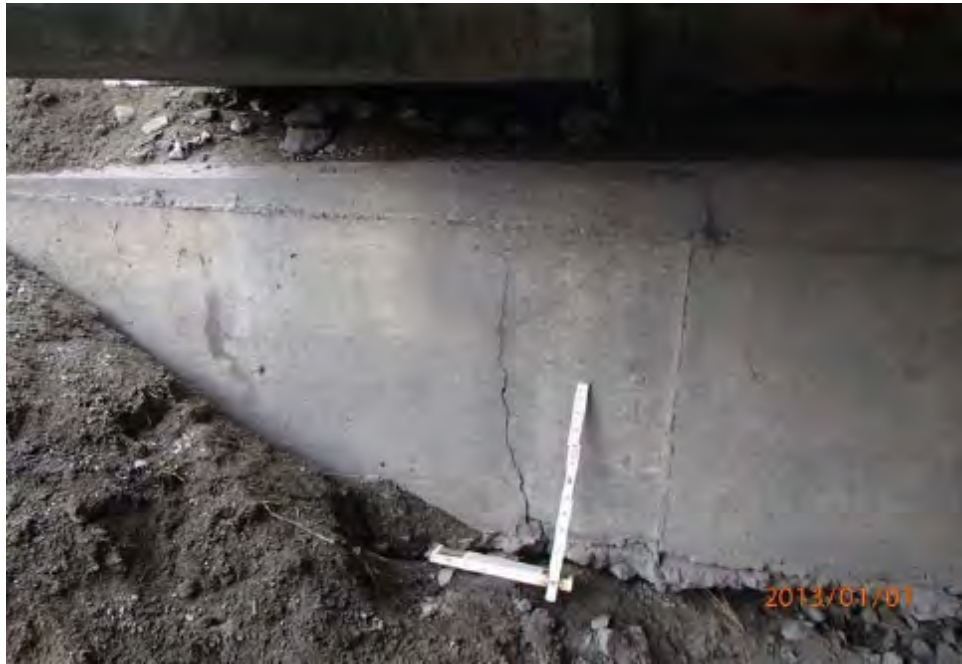
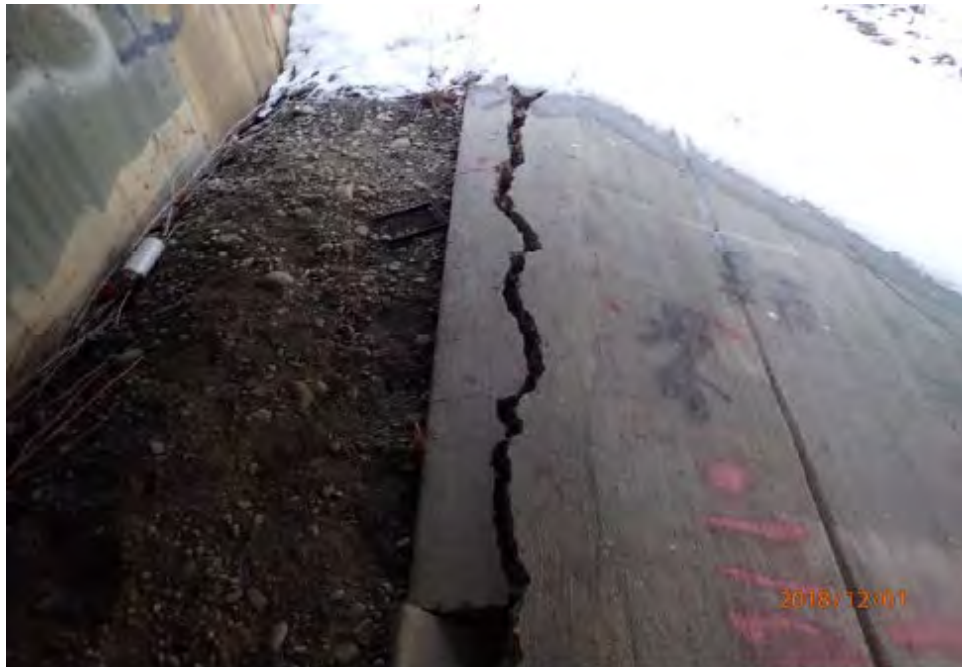
Figure 8.8. (a) Abutment cracking (photo: Jesse Escamilla and Ben Fetterhoff) and (b) cracked concrete sloped panels (photo: Sara Manning and Fred Paulsen).

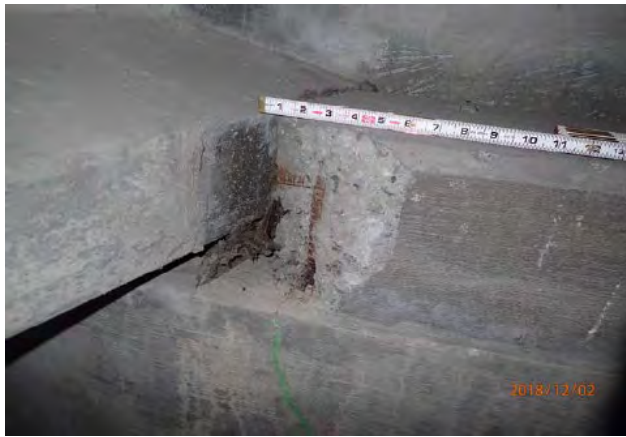
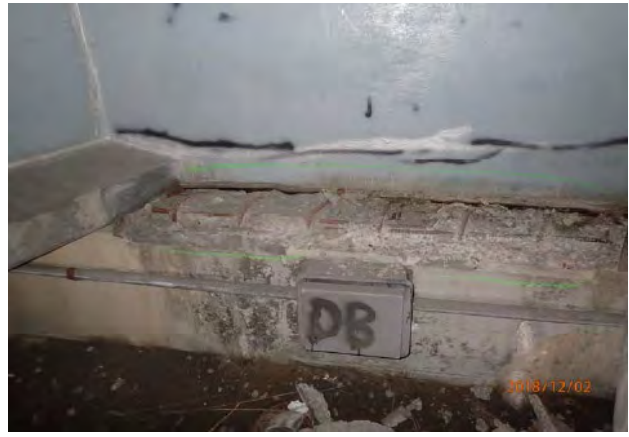
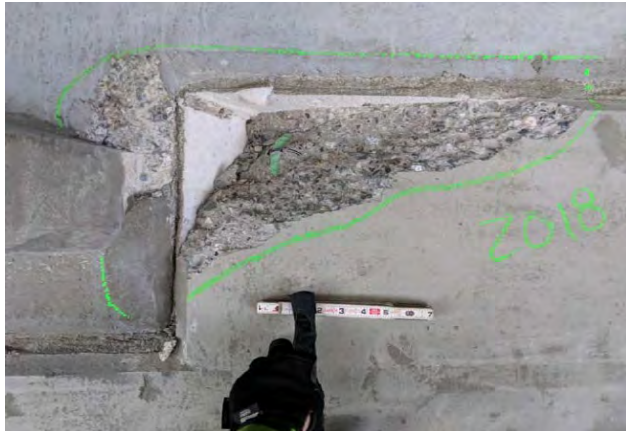
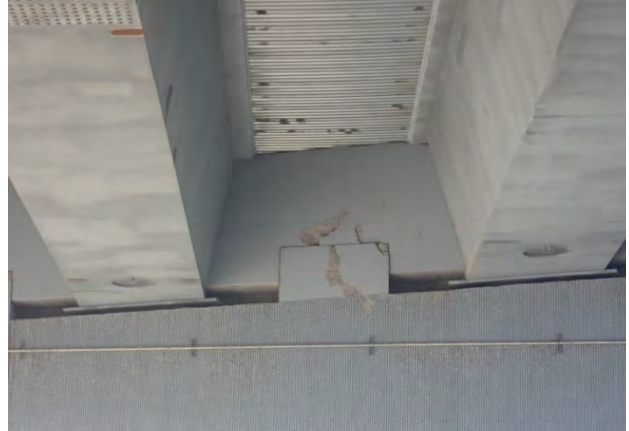
Figure 8.9. Shear key damage (photos: ADOT&PF).

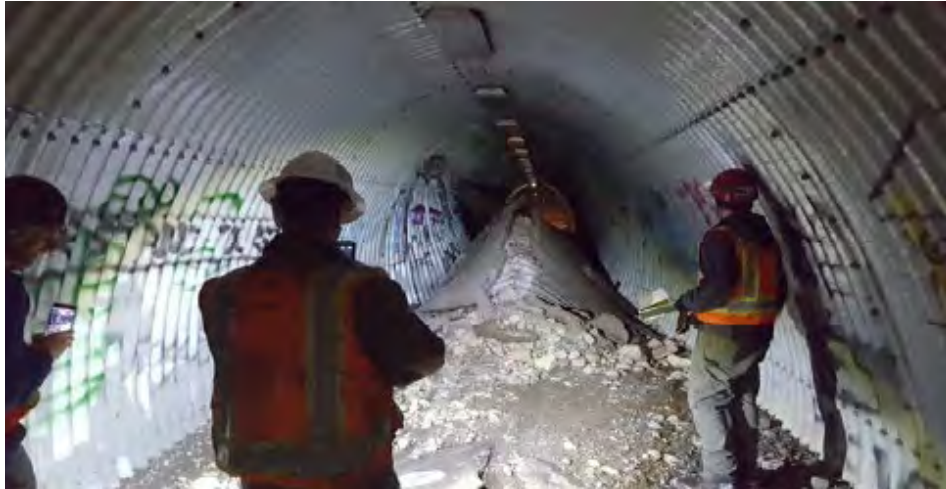
Figure 8.11. Culvert damage (photo: Jesse Escamilla and Ben Fetterhoff).

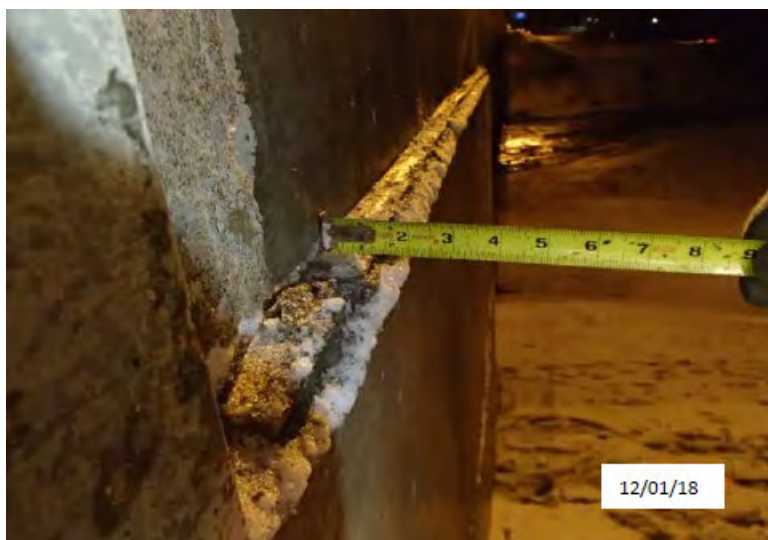
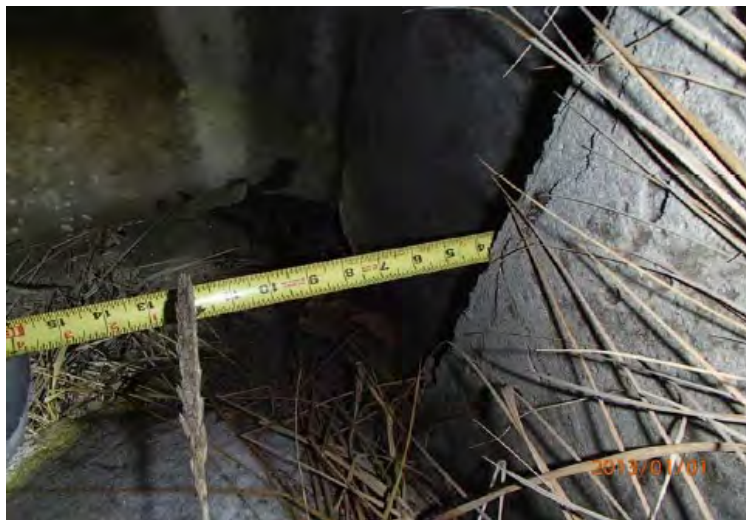
Figure 8.12. (a) A 2.5-inch lateral displacement of a bridge (photo: Nick Murray and Ben Still) and (b) diaphragm longitudinal displacement (photo: Jesse Escamilla and Ben Fetterhoff).

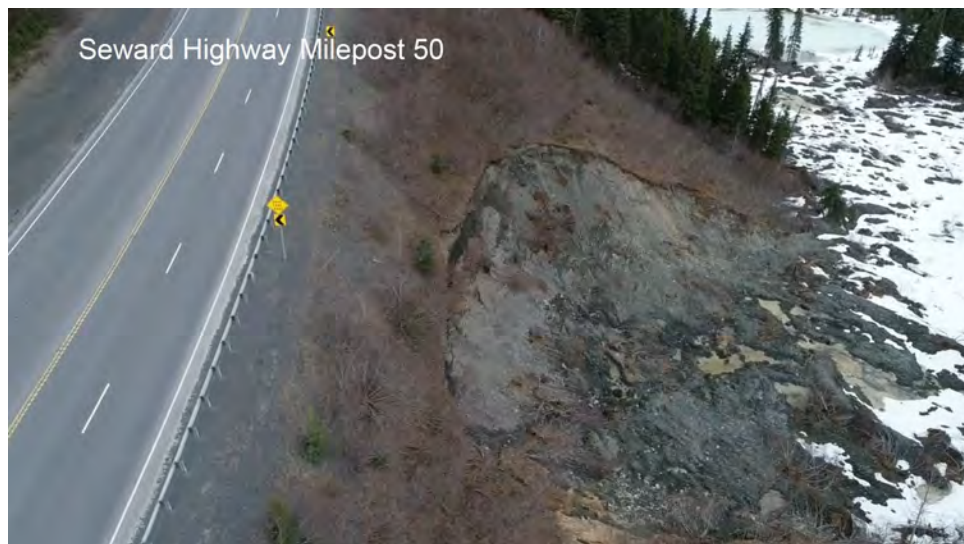
Figure 8.18. Seward Highway milepost 50 damage (source: Thornley, 2019).

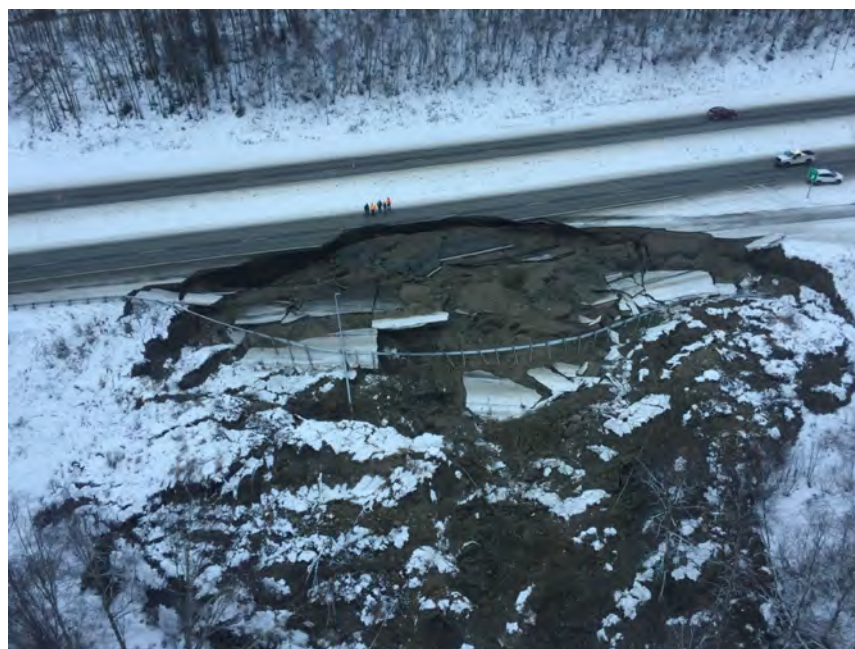
Figure 8.19. Damage to Glenn Highway at Mirror Lake (source: Thornley, 2019).

- There was a rockslide on Richardson Highway, but it remained open.
- Extensive damage, including slope failures, was reported on Glenn Highway between mile points 23 and 25 (Eklutna to Mirror Lake), which led to road closure with one-lane detours in each direction. Passage of long combination vehicles was not deemed practical. Repairs were completed, and the road was reopened on December 5.

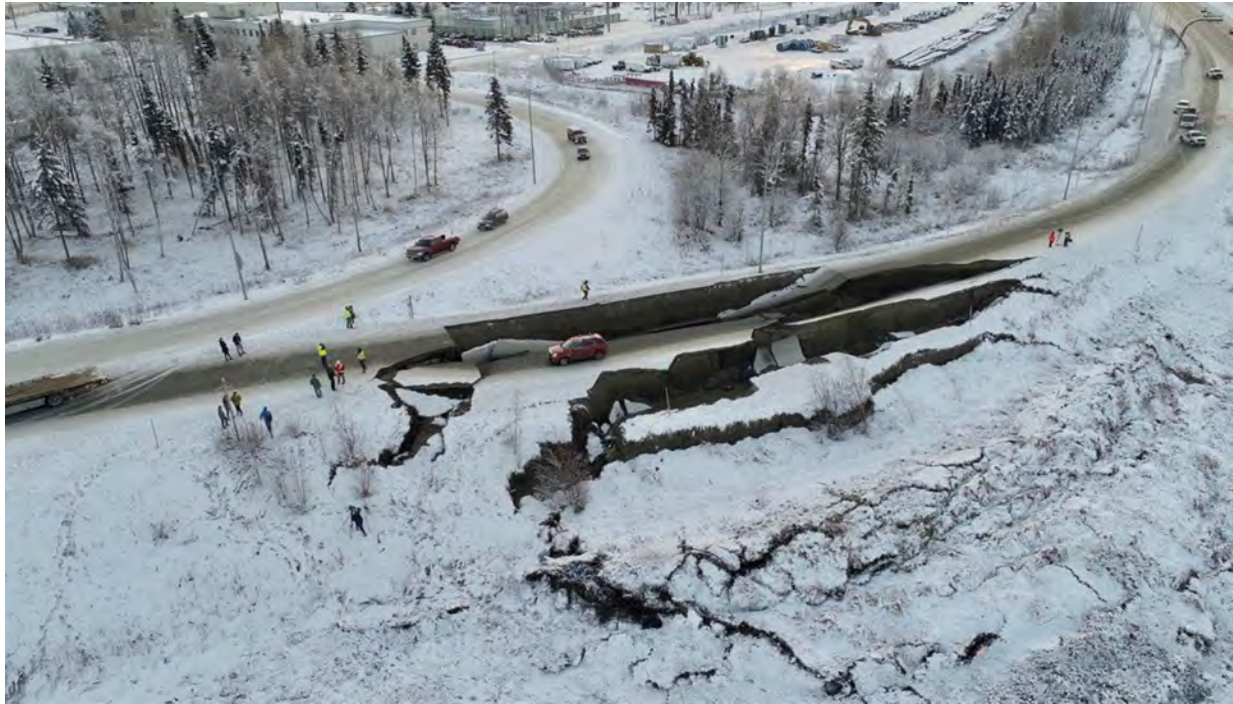
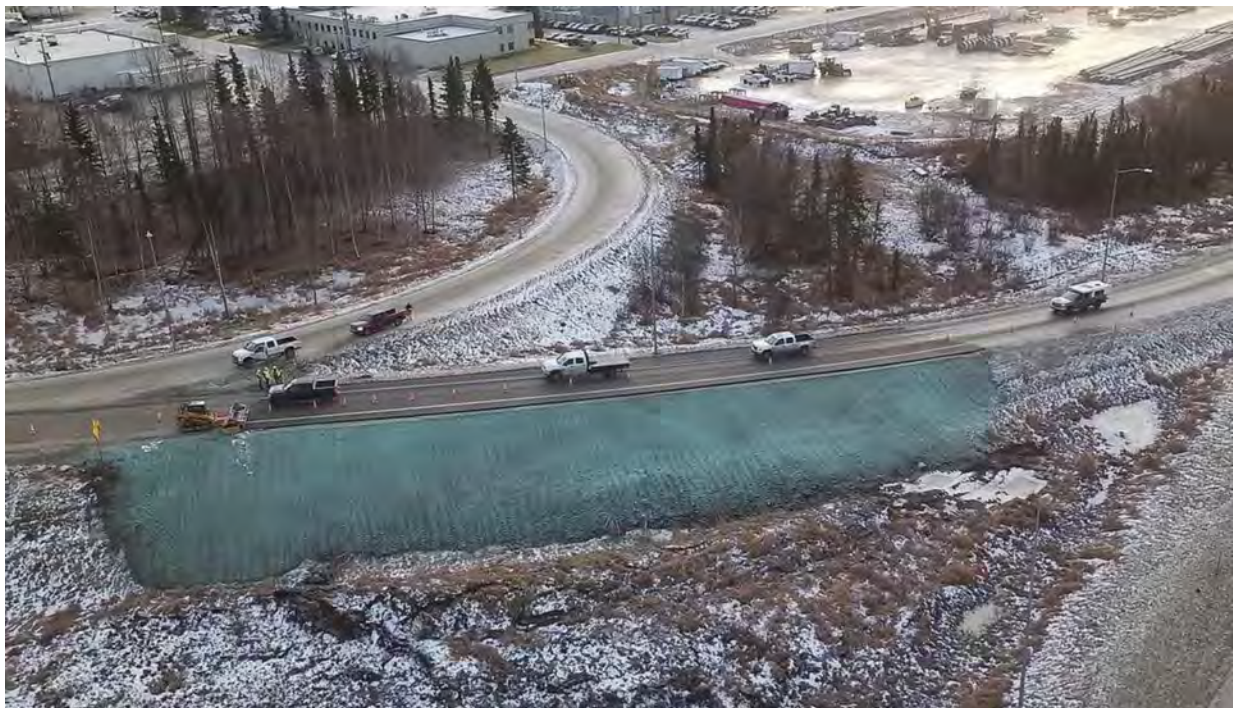
Some of the larger failures that were observed consisted of native foundation soils that failed below fill soils. Two examples of this, which received national and international attention in the days following the earthquake, include Vine Road in Wasilla and the Minnesota Drive northbound off-ramp at International Airport Road in Anchorage (Figures 8.20 and 8.21). Both sites included constructed road embankments over soft soils. While both sites are being studied to understand the failure mechanisms, it appears that in both cases, the foundation soils failed and caused rotational failures of the overlying embankments.

Figure 8.21. Northbound Minnesota at International Airport Road: (a) earthquake damage and (b) after repair. (source: Thornley, 2019).

The Minnesota Drive off-ramp is constructed in an area where groundwater is near the surface and peat soils overlie fine-grained sandy silt, which tends to be soft near the ground surface (Schmoll and Dobrovolsky, 1972). The initial failure mode is assumed to be global rotational slope failure due to low-shear-strength, saturated, sandy silt soils unable to resist the driving forces of the roadway embankment fill above.

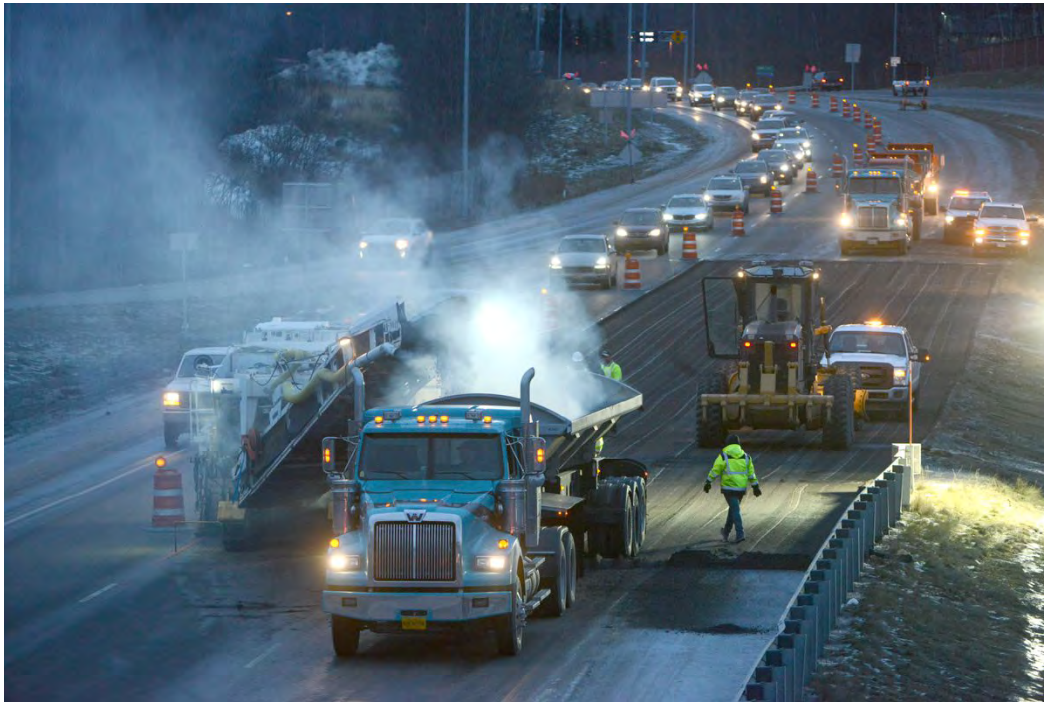
- New Seward Highway between Tudor Road and 36th Avenue had buckled pavement, shown in Figure 8.23, leading to closure of two lanes, with one lane remaining open. The road was reopened to three lanes northbound and two lanes southbound on December 4. All work was completed by December 6.

Figure 8.23. Repair of buckled pavement on Seward Highway between 36th Avenue and Tudor Road (photo: Anchorage Daily News).

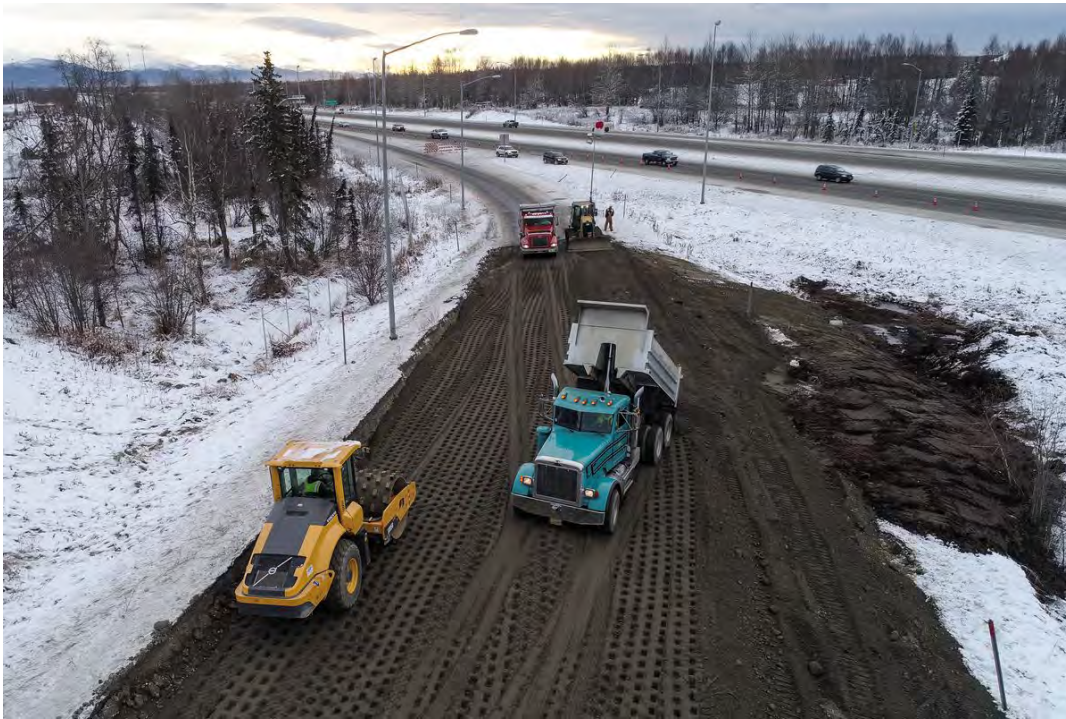
Figure 8.24. Repair of off-ramp from Minnesota Drive to International Airport Road (photo: Anchorage Daily News).

- Minnesota Drive northbound and southbound ramps to International Airport Road were closed and repaired, as shown in Figure 8.24. Both were reopened on December 4. The southbound ramp was temporarily closed on December 8 to allow barrier installation.

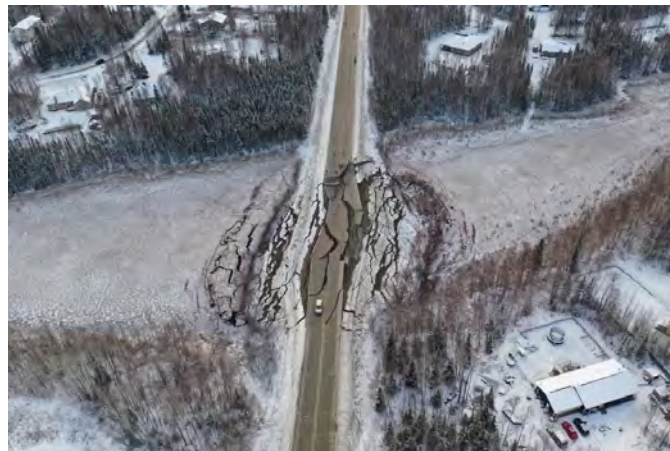
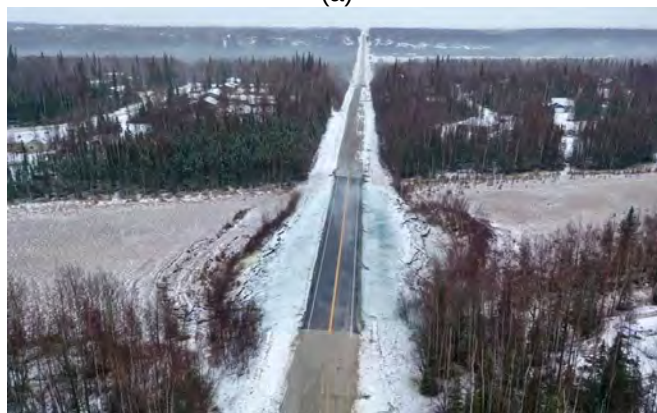
Because of the glacial terrain comprising ridges of glacial till consisting of silt, sand, and gravel and valleys with deep peat or muskeg found across Southcentral Alaska, road construction can be challenging. The muskeg is often found to be greater than 3 m deep, and surcharging is a common practice in lieu of overexcavation. Vine Road, at the location of the

failure, crosses deep muskeg. Observations suggest that the failure is again likely due to global rotational slope failure caused by saturated low-shear-strength peats supporting the road embankment. This site will be interesting for further study because there are numerous roads that were constructed in similar conditions that did not fail because of the Anchorage earthquake.

- Significant damage to Vine Road was caused by liquefaction of soil, as shown in Figure 8.25a. The damage to Vine Road was the most extensive of any road damage caused by the earthquake. Vine road was repaired and reopened on December 8, with a photo of the repaired road provided in Figure 8.25b.

Figure 8.25. (a) Earthquake damage to Vine Road and (b) repaired and reopened Vine Road (photos: KTVA)

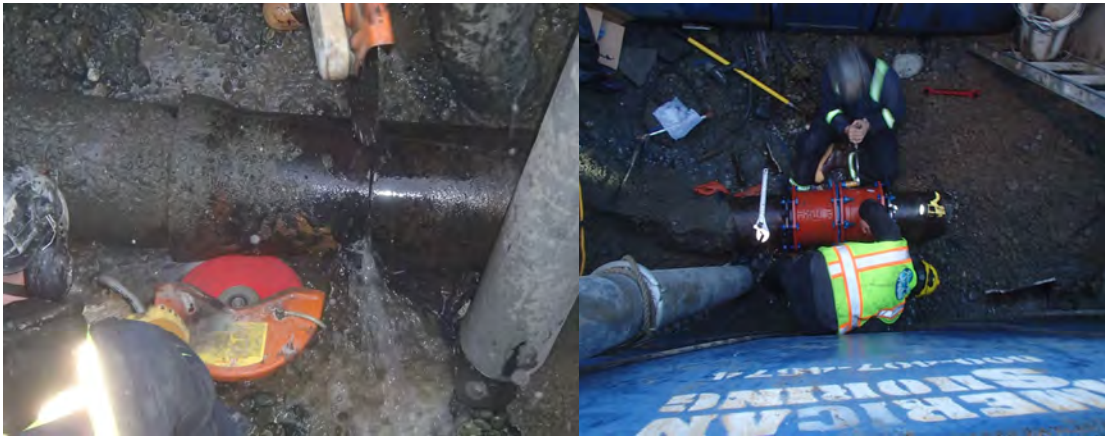
Figure 9.6. Emergency excavation to repair a damaged water main on Airport Drive (photos: AWWU).

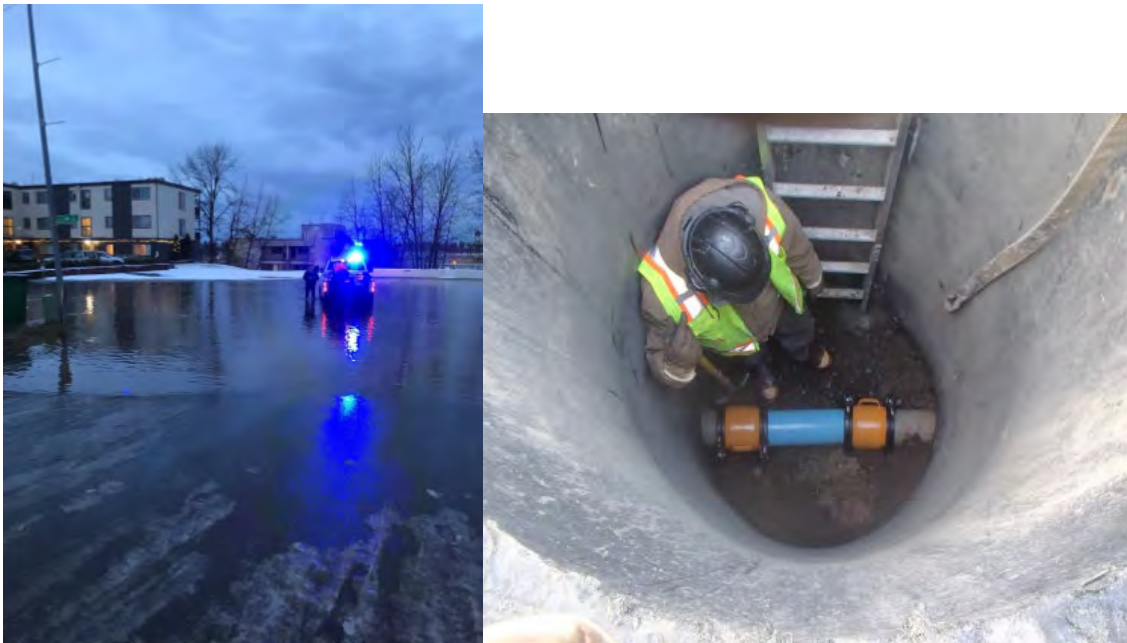
Figure 9.7. Emergency excavation to repair a damaged water main on Second Street, Cordova (photos: AWWU).

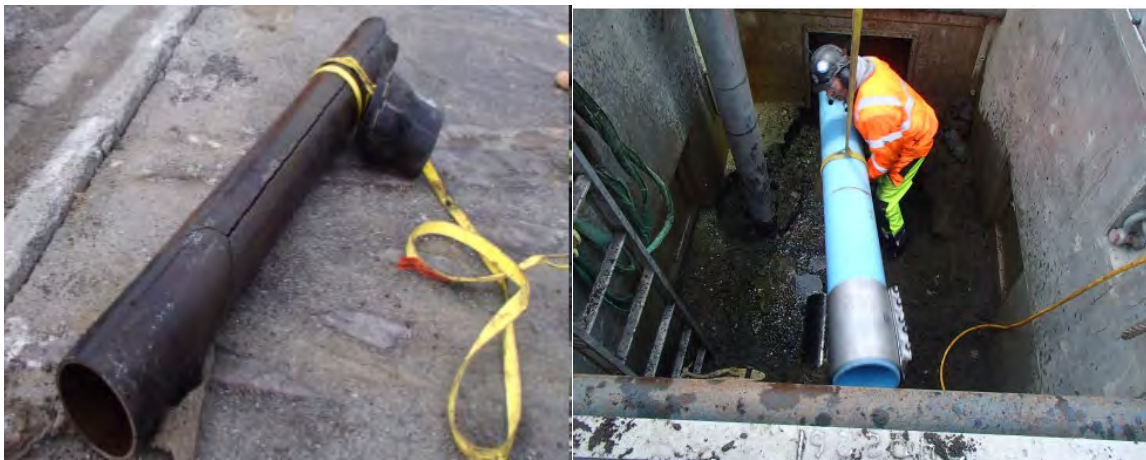
Figure 9.8. Emergency excavation to repair damaged pipe on First Avenue (photos: AWWU).

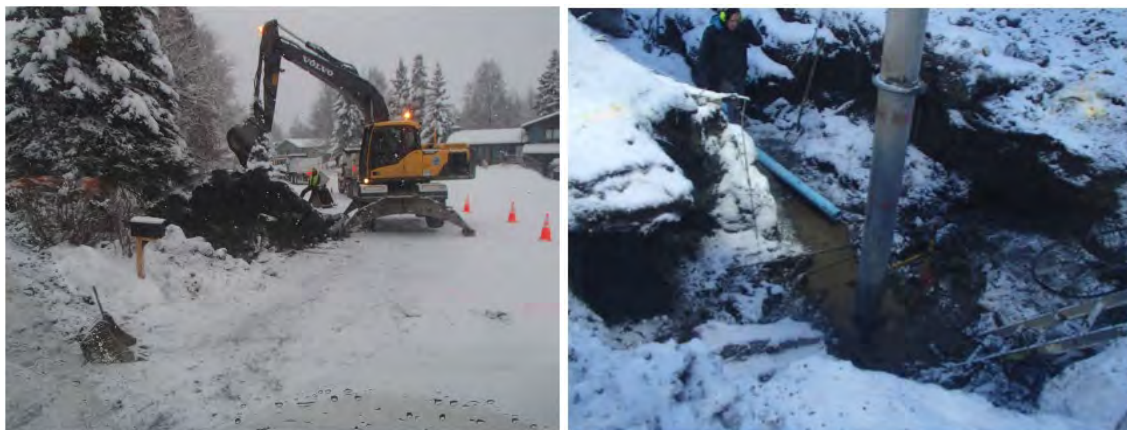
In addition to damage to the water distribution system, damage to sewer systems was observed. Damage to the sewer service at a house is shown in Figure 9.9. The damage was caused by settlement of the house because of the earthquake. The homeowner hired a contractor to repair their portion of the damaged sewer service, and AWWU coordinated with the homeowner and the contractor to repair their portion of the damaged sewer service.

*Figure 9.9. Emergency excavation to damaged sewer service (photos: AWWU).*

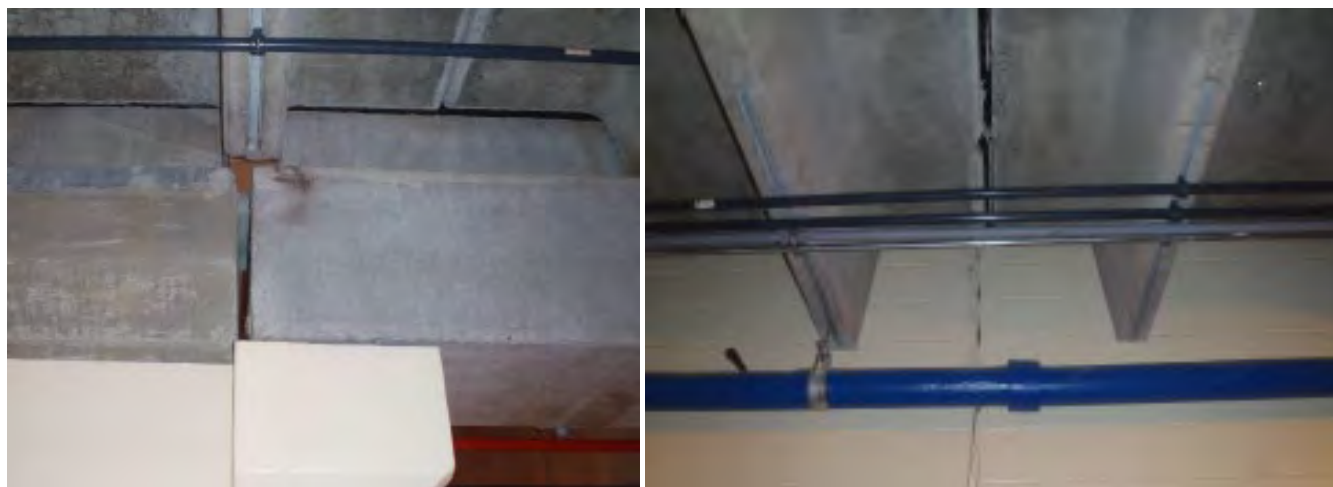
In addition to the damage to water distribution systems and wastewater systems, structural and nonstructural damage to building infrastructure was observed at water and wastewater treatment facilities. The Eklutna Water Treatment Plant was fully operational after the earthquake, although there was structural damage that included concrete cracking and spalling, as well as movement between concrete elements (e.g., girders), as shown in Figure 9.10. At the Hyland Crest Booster Station in Eagle River, there was damage to concrete masonry units (CMUs) at the corners of perpendicularly oriented walls, as well as shifting of the roof, as shown in Figure 9.11. Structural damage at the Girdwood Wastewater Treatment Facility included failure of an overhead crane beam, as shown in Figure 9.12, and damage to tensioning rods. Nonstructural damage at the Girdwood Wastewater Treatment Facility included damage to suspended ceilings and cracks in the drywall at corners and at seams. Failure of the cable seismic systems occurred in the wastewater treatment plant in Eagle River.

*Figure 9.10. Structural damage at Eklutna Water Treatment Plant (photos: AWWU).*

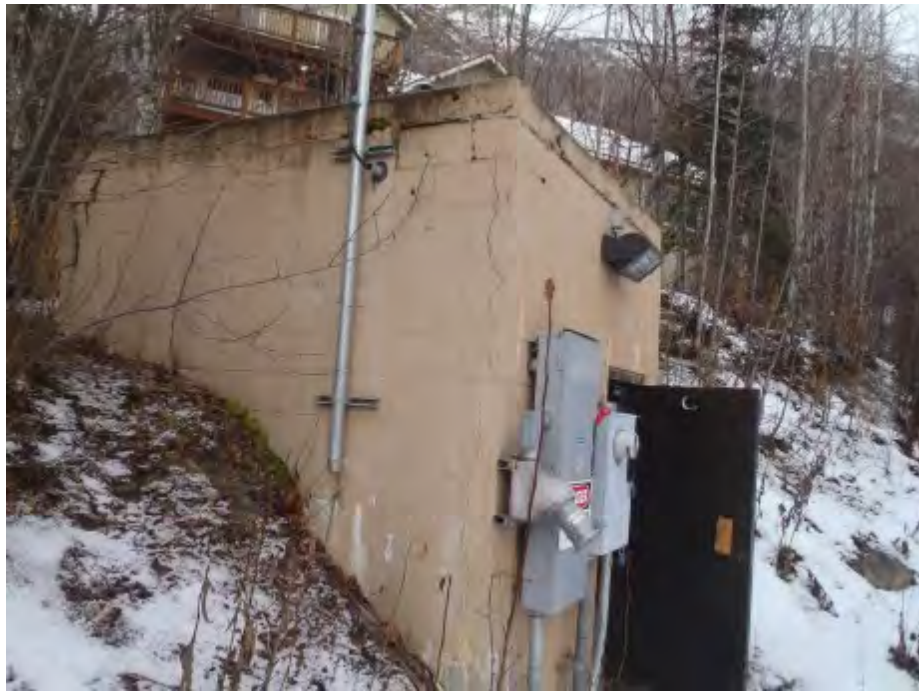
Figure 9.11. CMU damage at the Hyland Crest Booster Station in Eagle River (photo: AWWU).

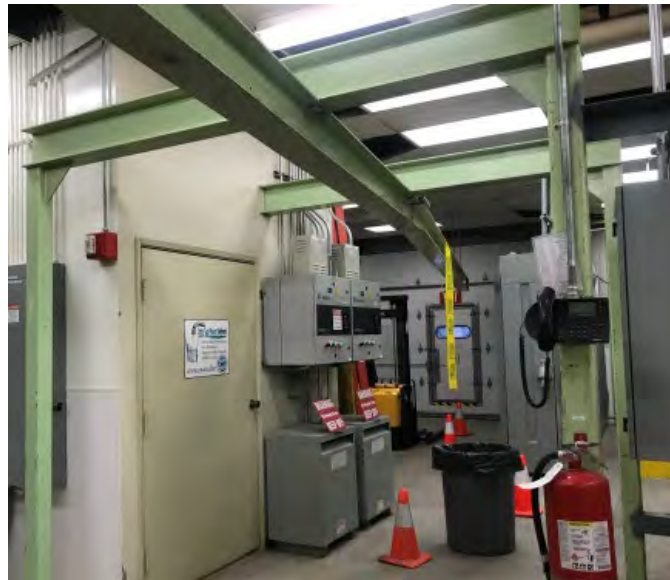
Figure 9.12. Failure in overhead crane beam at Girdwood Wastewater Treatment Facility (photo: AWWU).

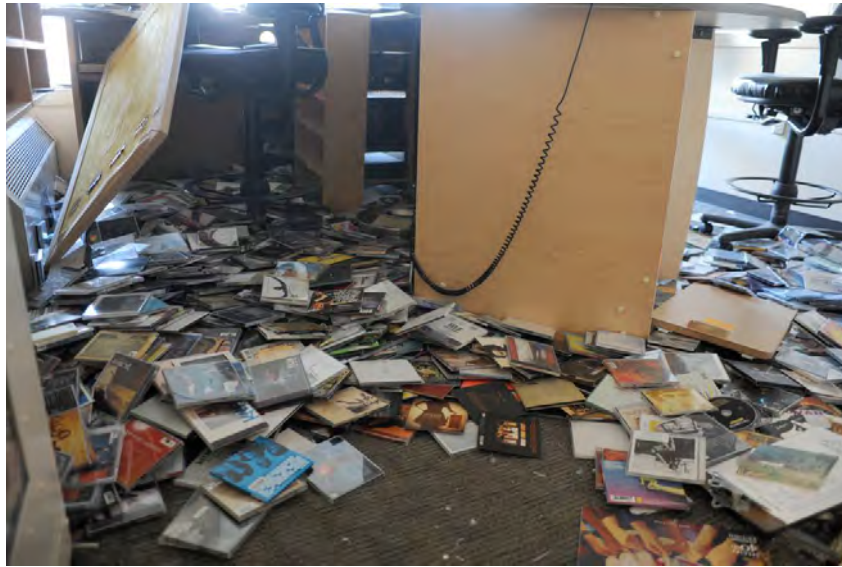
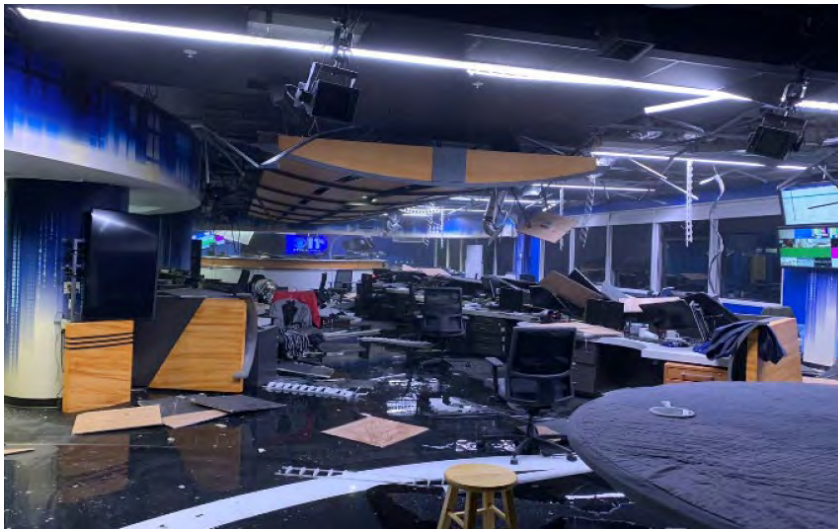
Figure 9.13. (a) KNBA studios damage (photo: ADN) and (b) KTVA office damage (photo: CNN).
