# EERI Earthquake Reconnaissance Report: M7.1 Anchorage Earthquake on November 30, 2018

Wael M. Hassan, John Thornley, Janise Rodgers, and Christopher Motter

July 2021

*A product of the EERI Learning from Earthquakes Program*

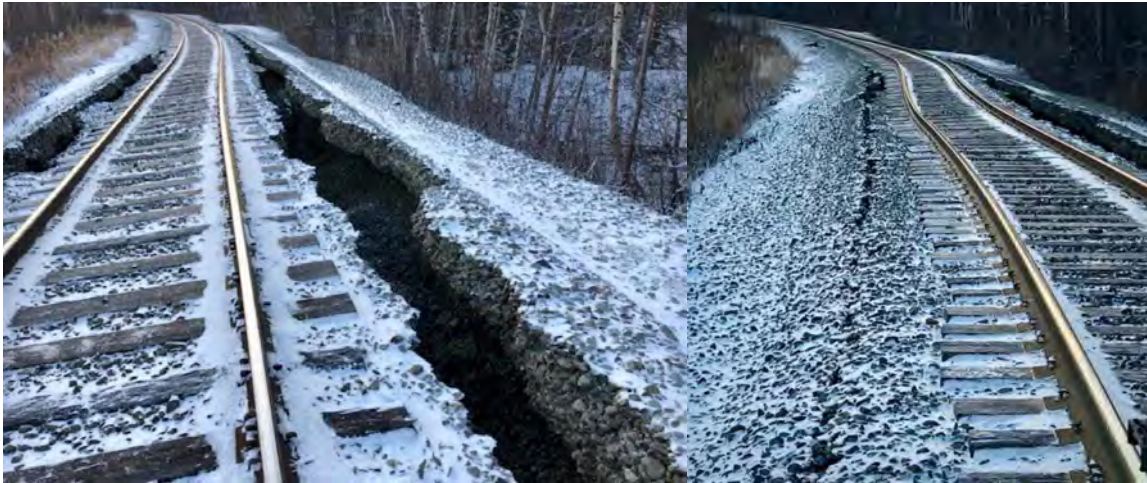
Three areas north of Anchorage were identified as impassible (for more than 1 mile), preventing trains from traveling between Anchorage and Fairbanks. Examples of damage are provided in Figure 9.14. Lateral spreading and liquefaction were observed at several segments. One of the sites was near Nancy Lake, about 45 miles north of Anchorage, where

ground cracks up to 4 feet wide, 3 feet deep, and 150 feet long were observed on either side of the tracks (Associated Press, 2018).<sup>11</sup> As of December 3, service between Anchorage and Fairbanks was resumed on the Alaska Railroad (ADOT&PF, 2018). Regularly scheduled freight and passenger service on the Alaska Railroad was resumed on December 4. Passage through portions of the track south of Eklutna Lake and south of the Cheri Lake Road were restored following earthquake damage (Boots, 2018<sup>12</sup>; *Anchorage Daily News*, 2018).<sup>13</sup> In addition to the damage to the railway, there was water damage to the Alaska Railroad operation center in Anchorage (Associated Press, 2018). In addition to the delays in freight train service, there were delays to passenger train service. The first passenger train ran on December 6. Holiday trains resumed service on the second weekend after the earthquake (i.e., 8 days after the earthquake).

Figure 9.14. Damage to Alaska Railroad (photo: Associated Press, 2018).

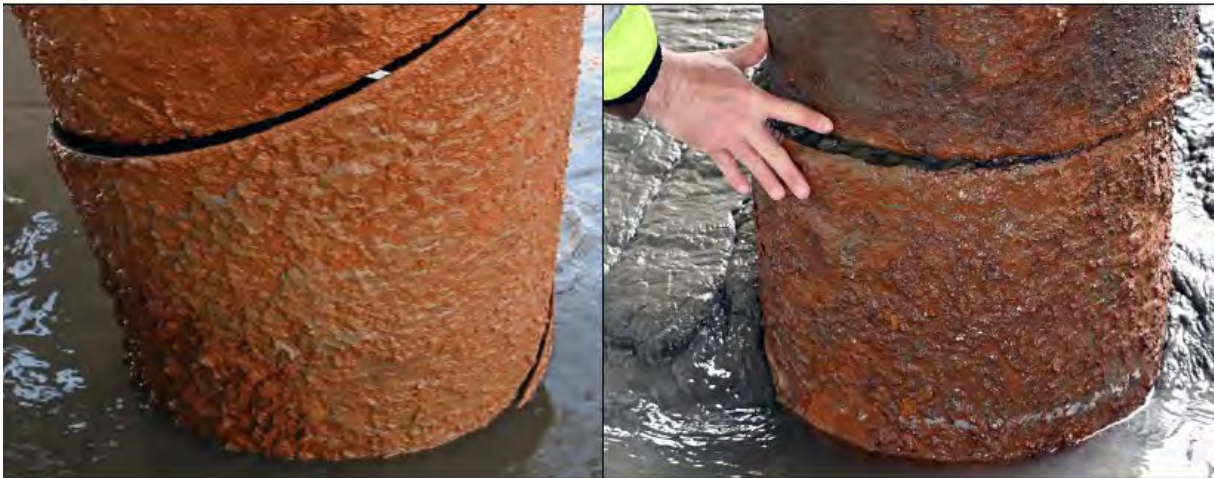
An aerial view of the Port of Alaska is provided in Figure 9.15. Damage at the Port of Alaska resulting from the earthquake included substantial dock and shore infrastructure failures, as well as damage to seismic/expansion joints. Failures at the seams of pile welds were particularly prevalent, and in many instances, these failures were only possible to detect in the spring of 2019, after snow melted. The port has 1,400 piles, many of which were in service beyond their intended design life and were in a deteriorated condition prior to the earthquake because of the harsh environmental conditions. In addition to visual inspections of piles that were conducted at low tide, ultrasound imaging was used to assess structural damage because of accessibility issues at many locations. It was determined that weld failures had occurred in piles at spiral seams, butt welds, and vertical seams. Weld failures on spiral seams, shown in Figure 9.16, were particularly prevalent under Petroleum, Oil, and Lubricants Terminal (POL) 2, where it was reported that approximately 20% of the deck piles were compromised. Failures of butt welds were particularly prevalent under POL 1 and Terminal 1. Weld failures on

Figure 9.16. Weld failure in spiral seam of wharf pile (photo: Port of Alaska).

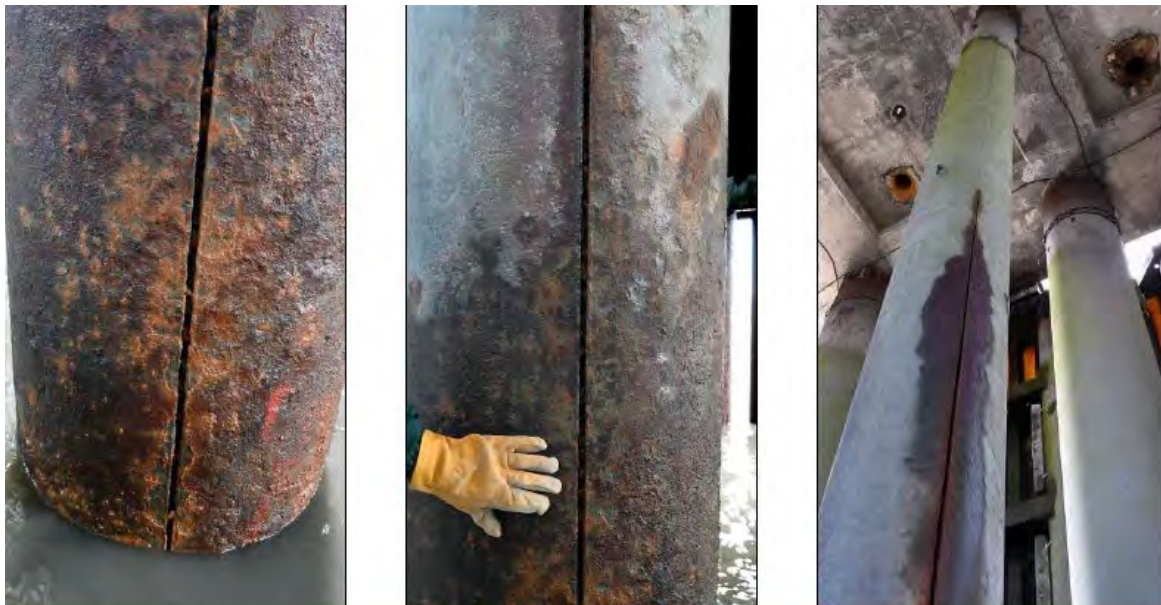
vertical seams, shown in Figure 9.17, were limited, with most occurring under Terminal 2. Damage at the welded seams of pile jackets was attributed to the welding steel used in the 1960s and 1970s, which differed from modern-day welding steel. Specifically, the older steel was more galvanically reactive than the main pile steel, such that the cathodic behavior of the welding steel caused more rapid corrosion relative to the main pile steel. Following the earthquake damage to pile jackets, repairs were made. Fender pile failures and storm drain failures, shown in Figure 9.18, were also observed.

Figure 9.17. Weld failure in vertical seam of wharf pile at Terminal 2 (photos: Port of Alaska).

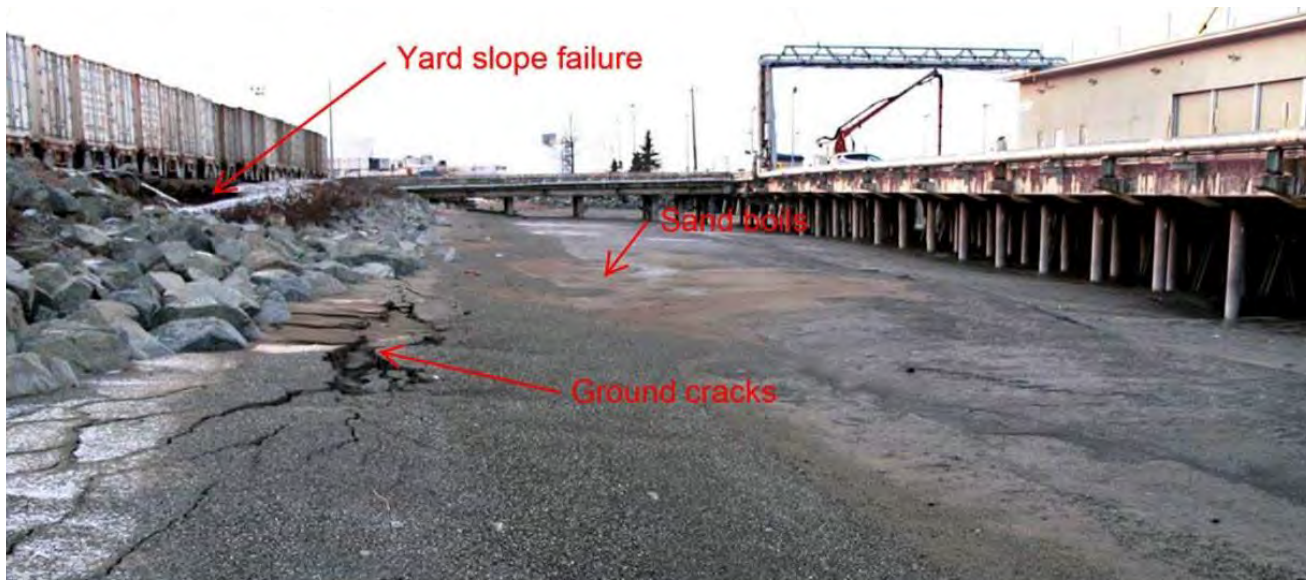
In addition to the structural and nonstructural damage, geotechnical damage was observed at the Port of Alaska as a result of the earthquake. Failure of the shoreline was observed adjacent to Terminal 1, as shown in Figure 9.20. Slope failures and liquefaction, shown in Figure 9.21, caused movement of the shore. Additionally, slope failures were observed along the full length of container docks, as shown in Figure 9.22. Although slope failures occurred near the dry barge berth, a tugboat and barge that were dry-docked remained on their blocks, as shown in Figure 9.23. Repairs that are underway are shown in Figure 9.24.

Figure 9.21. Yard slope failure and liquefaction moved shore (photo: Port of Alaska).

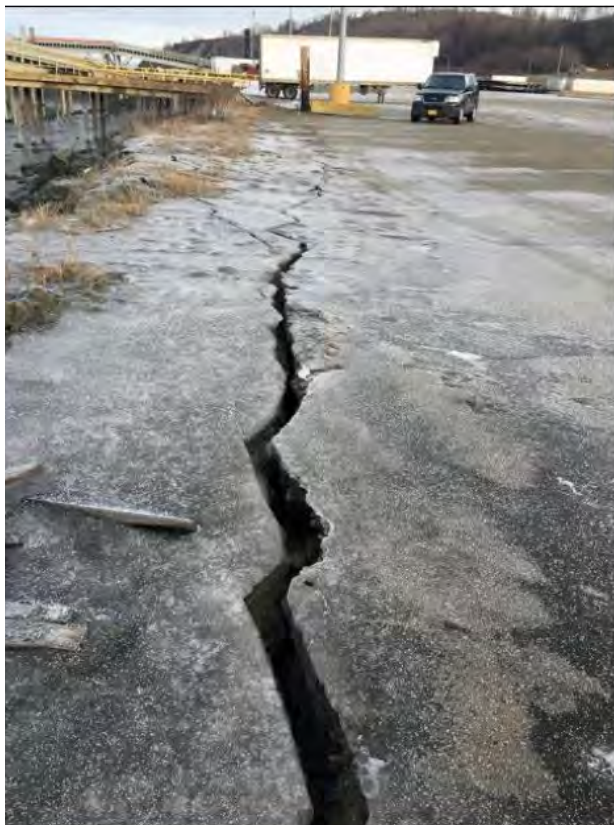
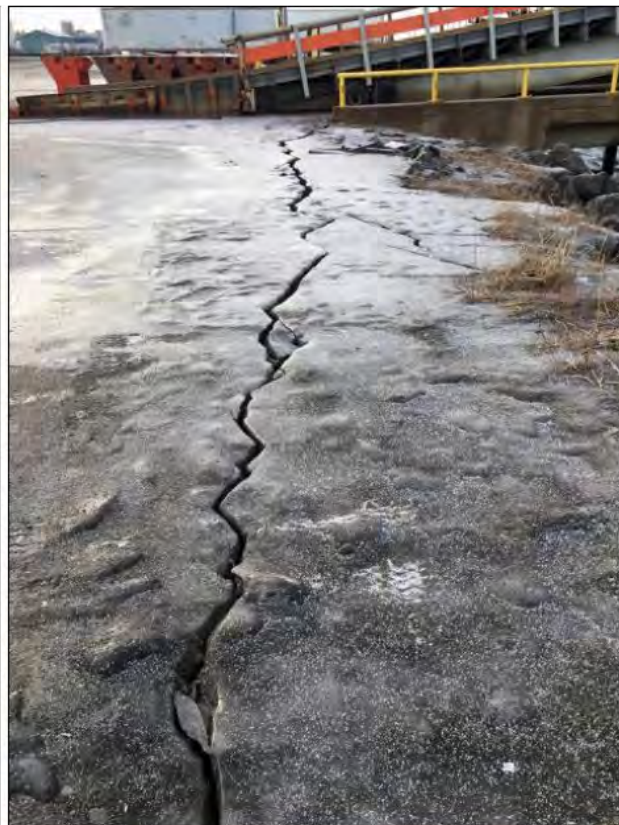
*Figure 9.22. Slope failures along the length of container docks (photos: Port of Alaska).*
