**FINAL**  
**FAILURE INVESTIGATION**  
**WESTCHESTER NORTH LAGOON BRIDGE**  
**Anchorage, Alaska**

August 2014

*Prepared for:*  
Municipality of Anchorage  
Project Management and Engineering  
P.O. Box 196650  
Anchorage, Alaska 99519-6650

*Prepared by:*  
*USKH Inc. now Stantec*  
2515 A Street  
Anchorage, Alaska 99503  
Phone (907) 276-4245  
Fax (907) 258-4653

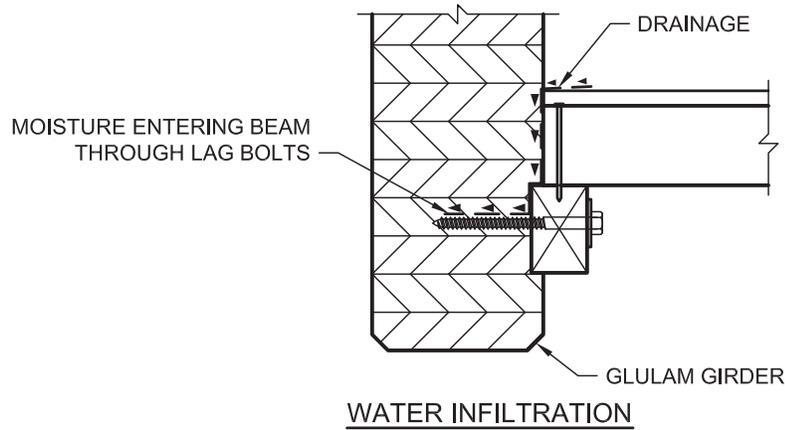
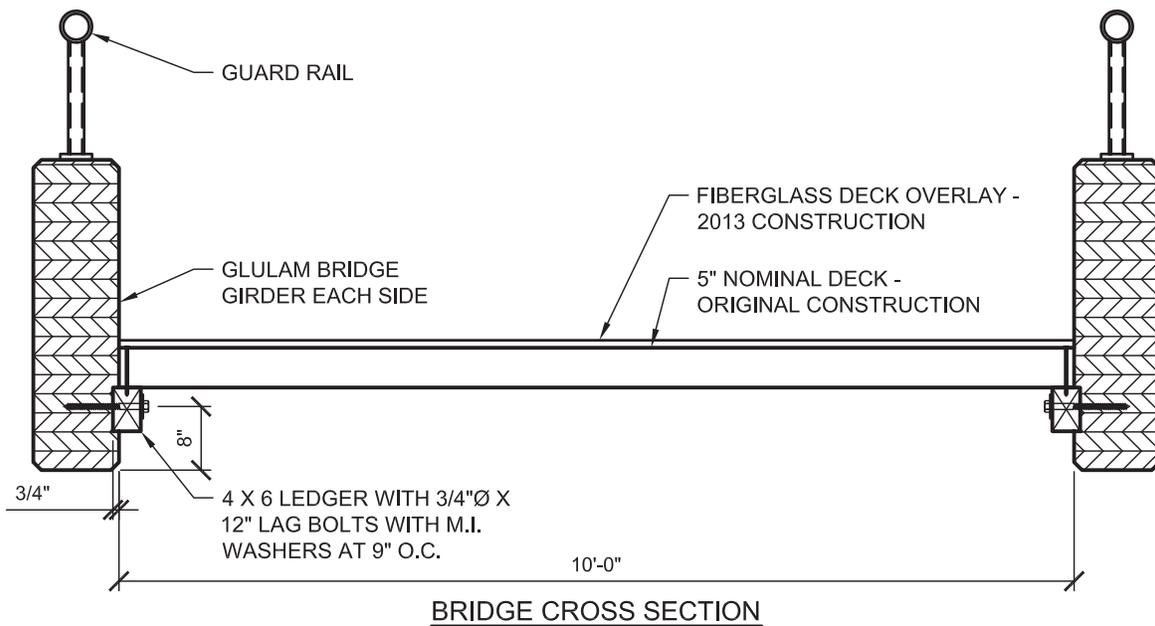
The failure mode, confirmed by analysis and site observations, appears to be cross-grain tension in the glulam beam. The ledger is set inboard of the glulam from 3/4- to 1-inch near the bottom of the glulam beams. The location means the bottom of the beam is loaded inducing cross-grain tension in the glulam. The NDS does not recognize this type of loading since wood is extremely weak in cross-grain tension, so designing connections that rely on cross-grain tension is not a recommended practice. The NDS gives recommendations for radial tension in curved glulam beams, which is basically the same as cross-grain tension. Using the allowable radial tension stress limitations given in NDS, and an assumption for length influenced by the tire loading, gives a Demand-Capacity Ratio of about 1.4. This means under the assumptions listed, the stress caused by the tire exceeds the allowable stress by about 40%. The code has a typical average factor of safety of 2, so in practice the vehicle loading did not cause failure until the plane was weakened when moisture infiltration and decay reduced the strength.

A review of the as-built drawings and site investigation shows how this plane of weakness developed. Water drains off the deck onto the ledger below and eventually migrates down to the lag bolts drilled into the glulams. While in the glulams, the moisture collects in the wood and although some moisture will dissipate through the wood and back to the surface, most will stay. This results in this location of the glulam remaining in a saturated condition over time causing decay. The black/brown stains and the moistness of the beams at this area confirm this decay zone. The ledger detail relies on cross-grain tension developed in the bottom of the beam to transfer the load. This load transfer detail is not recommended as wood is weakest in this loading condition. A calculation using some assumptions showed that this was the weak link of the design. The connection held until strength reduction from wood decay reduced this capacity gradually over time.

**WEAKENED CONNECTION**

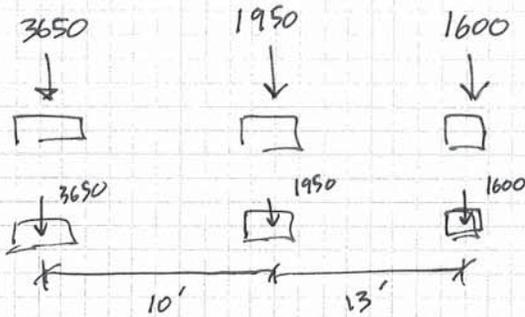
if tires placed on one side, 1 ft from edge, 1.2 multiplier for one side

$$V_{u \max} = 6.3 (1.2) (1.75) = 13.2 \text{ k}$$
