# **2014 Dry Weather Screening Report**

## **APDES Permit No. AKS-052558**

**MUNICIPALITY OF ANCHORAGE**  
**WATERSHED MANAGEMENT SERVICES**

November 2014

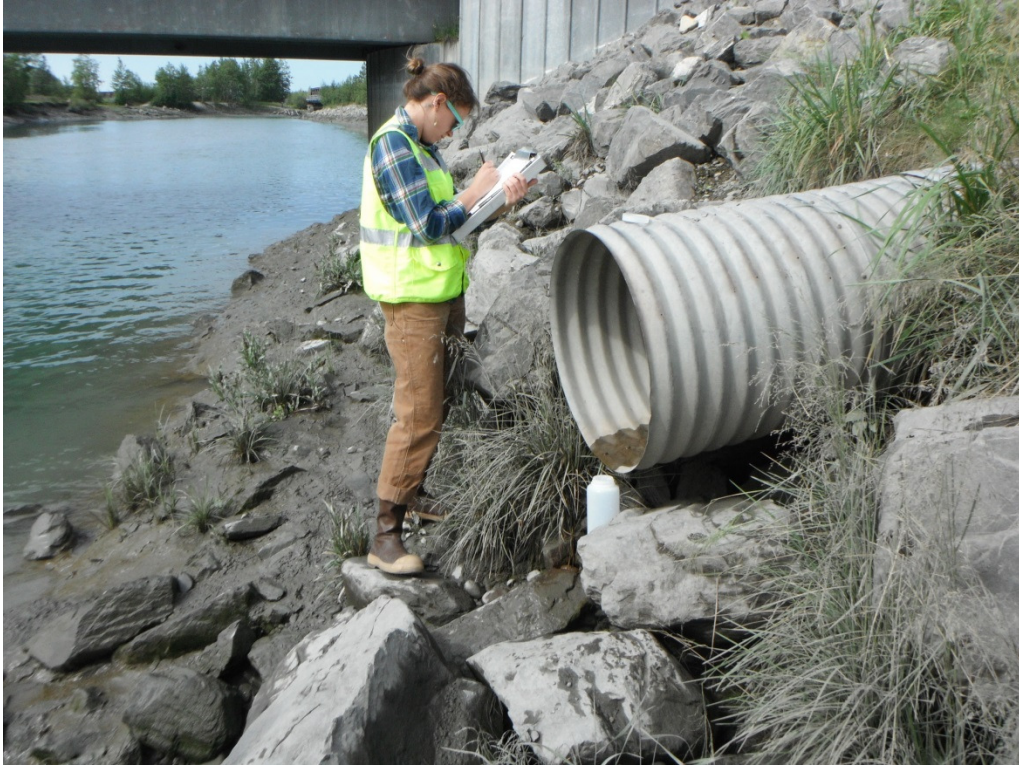
Ship Creek **436-1**: North bank of Ship Creek, east of C St bridge.

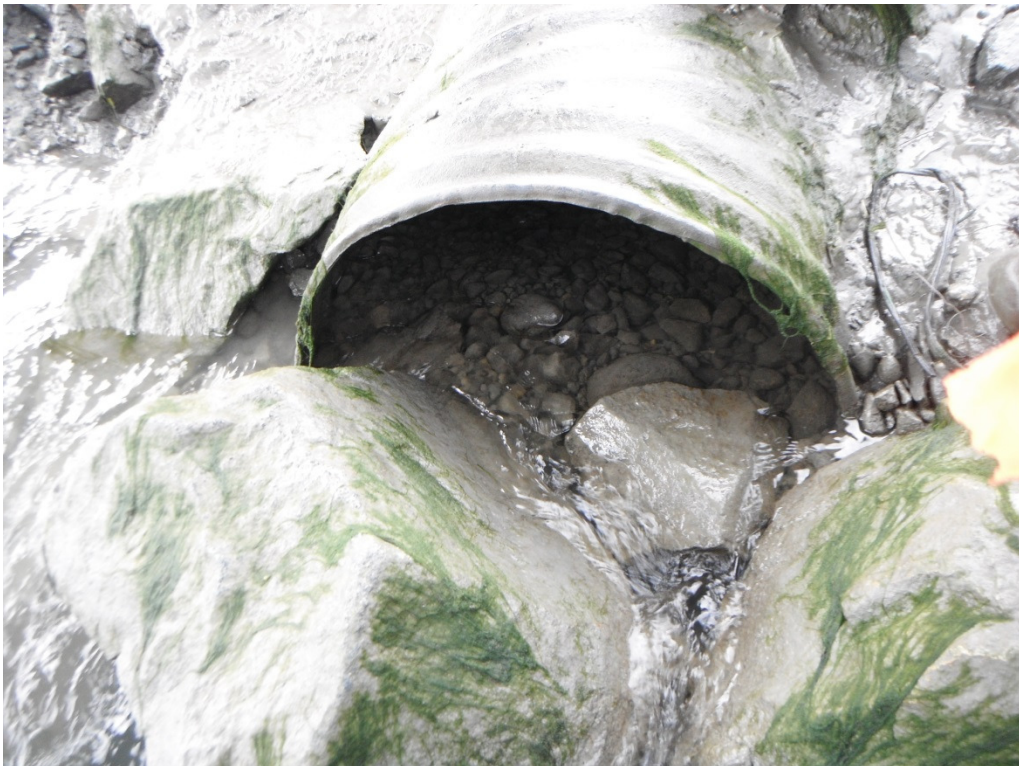
Ship Creek **550-2**: South bank of Ship Creek just east of the Bridge Restaurant.

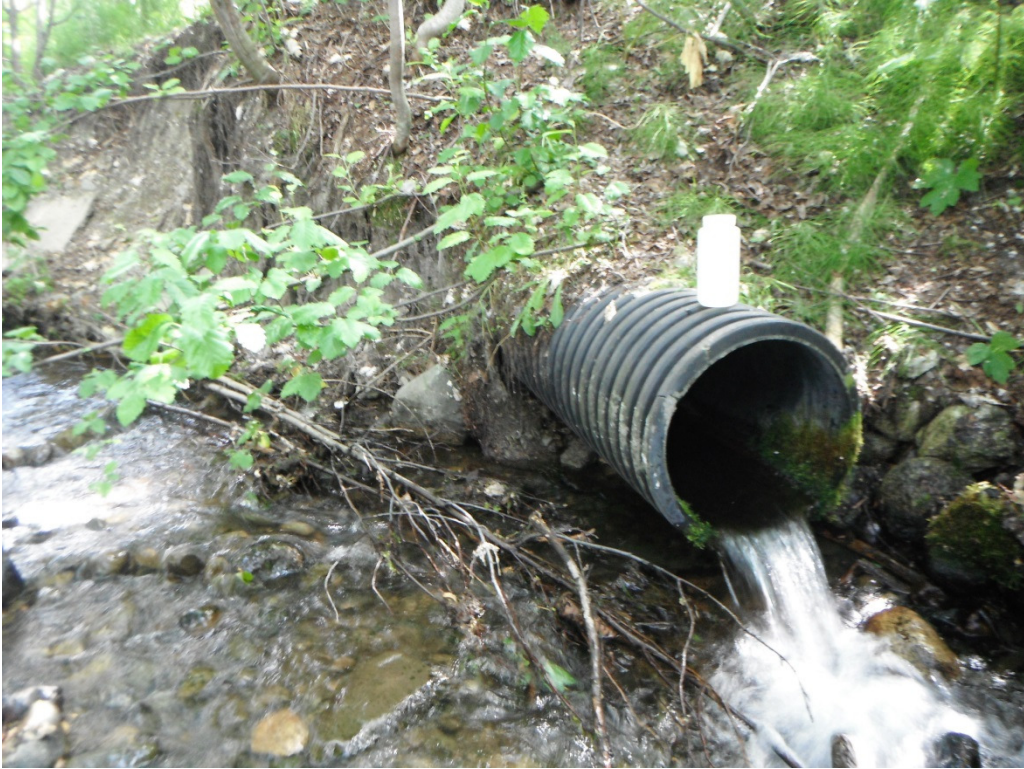
Eagle River **646-71**: South bank; Chain of Rock Street and Teklanika Drive.

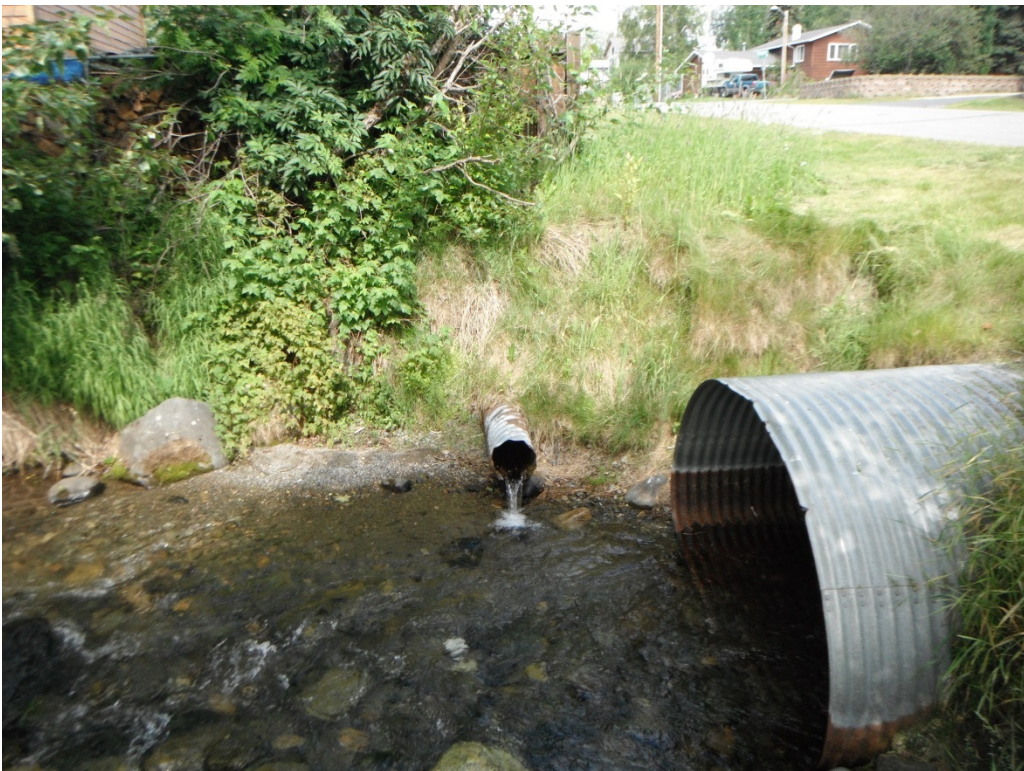
Eagle River **1375-99**: North bank; Chain of Rock Street and Teklanika Drive

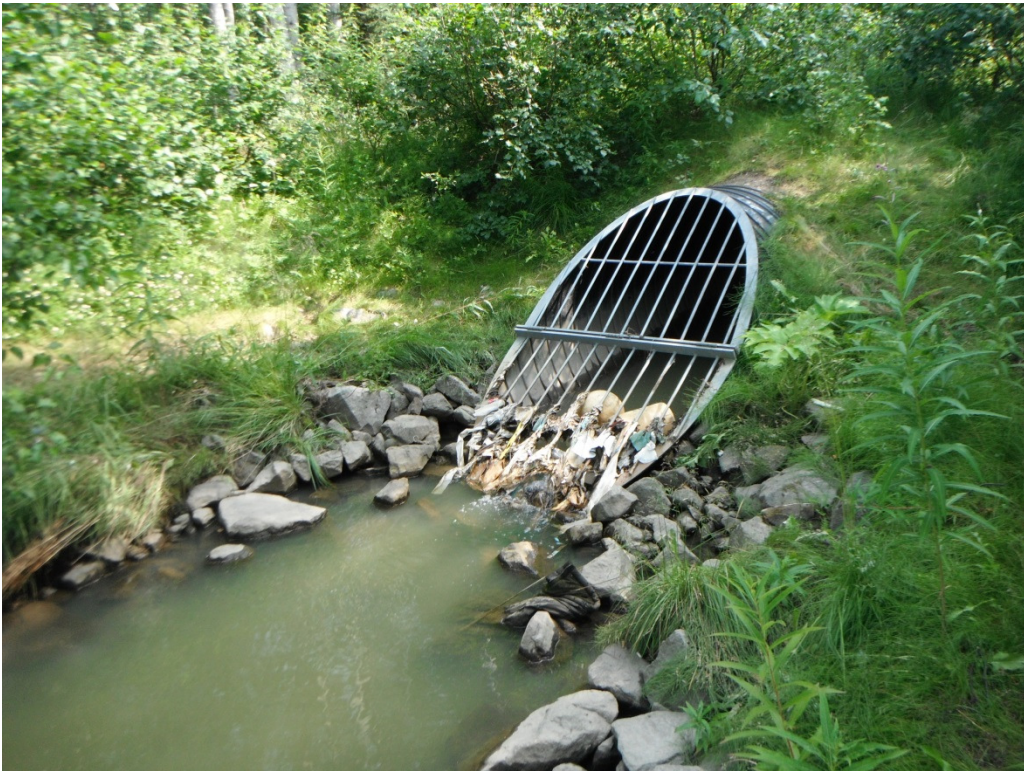
Campbell Creek **1488-1**: Behind Las Margaritas property on Dimond Blvd and C St.

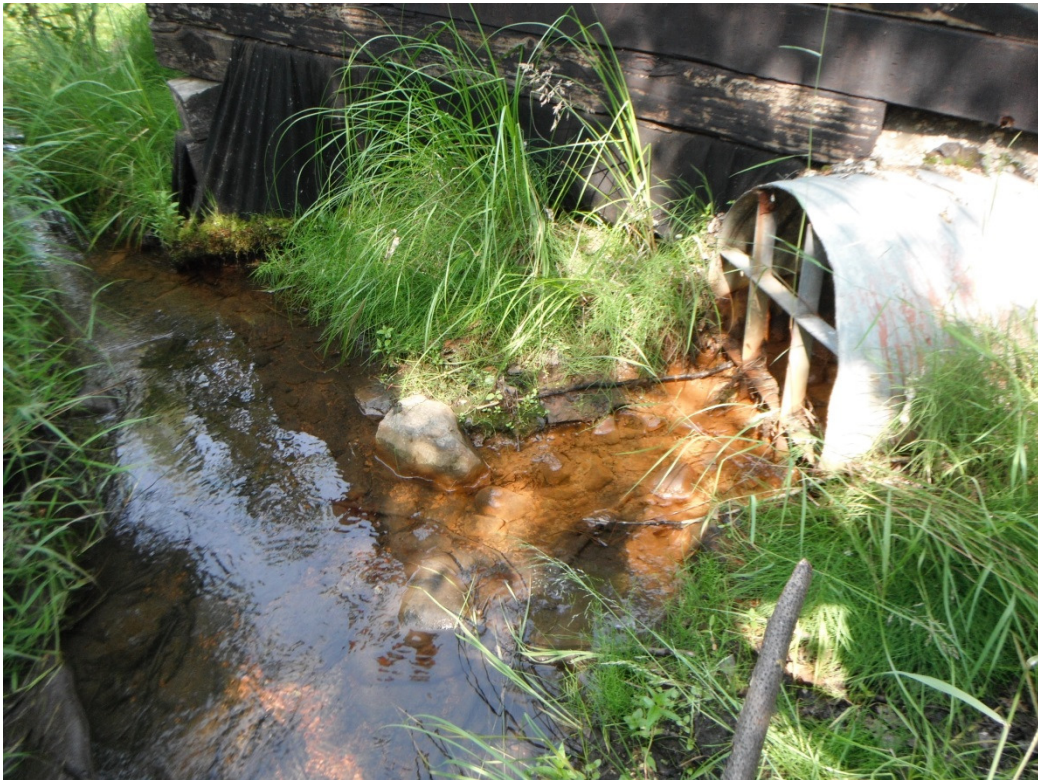
Campbell Creek **1056-117**: Southwest corner of Carriage Drive.

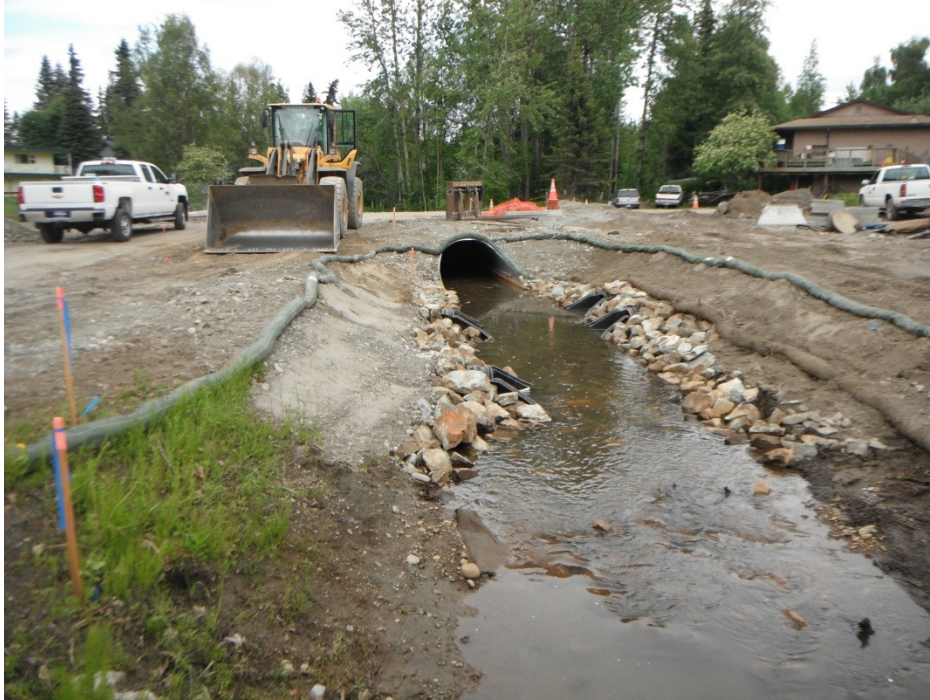
Fish Creek **1310-201**: New construction and new outfalls

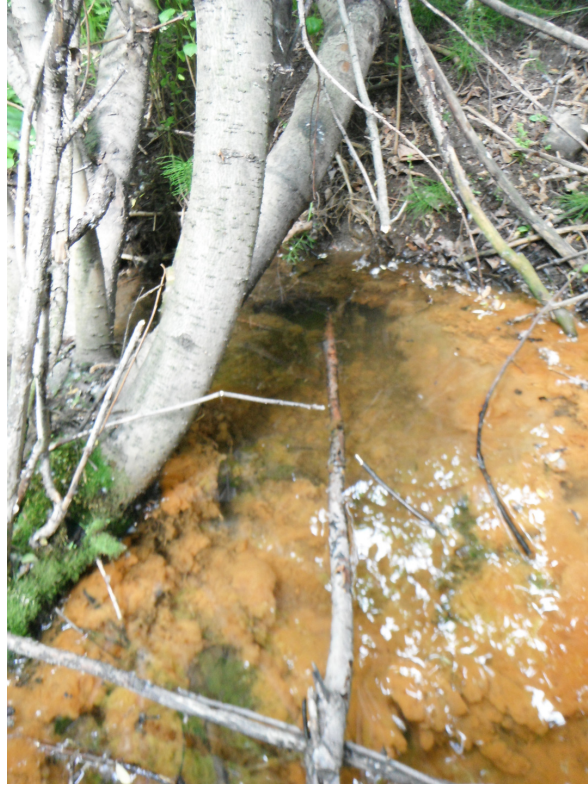
Campbell Creek **551-1**: Completely submerged
