# MOA and ADOT&PF 2015 Low Impact Development Project Performance Monitoring Report

The Municipality of Anchorage

*January 2016*

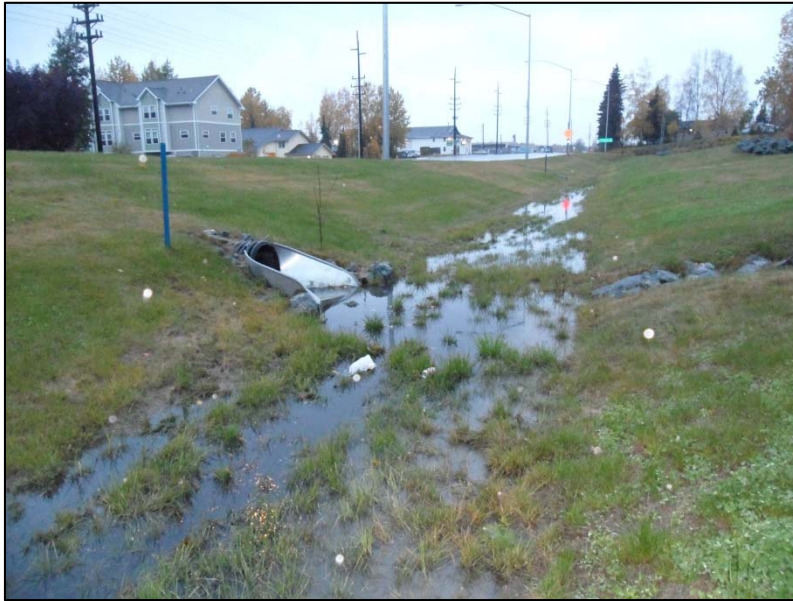
Figure 6: Bioswale Overview on 9/29/15

During the site observations on September 29, the swale was observed to be holding significantly more water than previous site visits. The water was flowing more rapidly, though still fairly slowly, toward the outlet. The water was observed to be more sediment-laden than in previous site visits, as evident by the water color. The swale outlet was flowing steadily. Downstream of the outlet, water was flowing into Campbell Creek, though it was bypassing the intended flow route and entering the creek by flowing under the embankment riprap. This is not expected to be problematic and did not appear to be causing erosion issues.

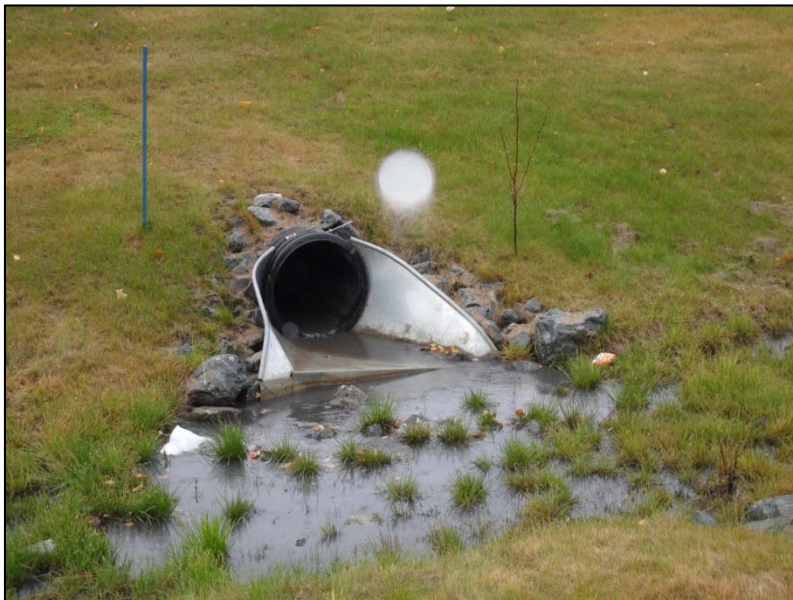
Figure 7: Outfall Discharging to Bioswale

During the observations on September 12 and September 28, water was slowly and steadily entering the bioswale from four of the five storm drain outfalls that discharge to the swale. Water was ponding on the swale bottom and slowing trickling toward the swale outlet. Figures 5 through 8 provide an overview of the swale and photos of the outfalls. The slow movement of water through the existing vegetation allows sediment to fall out of the water. It was noted that most of the grassy vegetation is being mowed and kept very short. One outfall was observed to be partially blocked by vegetation, but did not appear to be causing any problems. Water downstream of the bioswale was observed to be ponding on the surface instead of flowing into Campbell Creek, allowing for additional treatment potential.

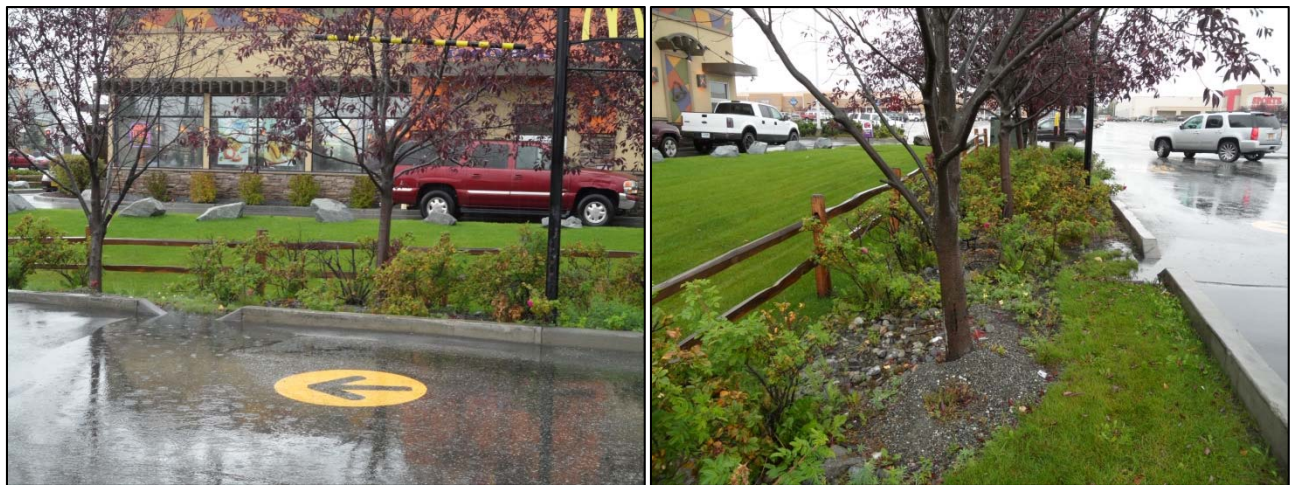
**Figure 34: Curb Cuts Draining to Landscaping**

During each site visit, water from the parking lots and walkways was observed to be flowing via overland flow to the parking lot perimeter and into the landscaping and grassy swales via curb cuts and perforated drains. (See Figures 34 and 35.) Generally, the curb cuts appeared to be much more effective, as the drains were partially clogged and flowing slowly. The number of curb cuts significantly exceeds the drains, and it is expected that drains were used only in locations that curb cuts were determined to be not feasible for traffic reasons.

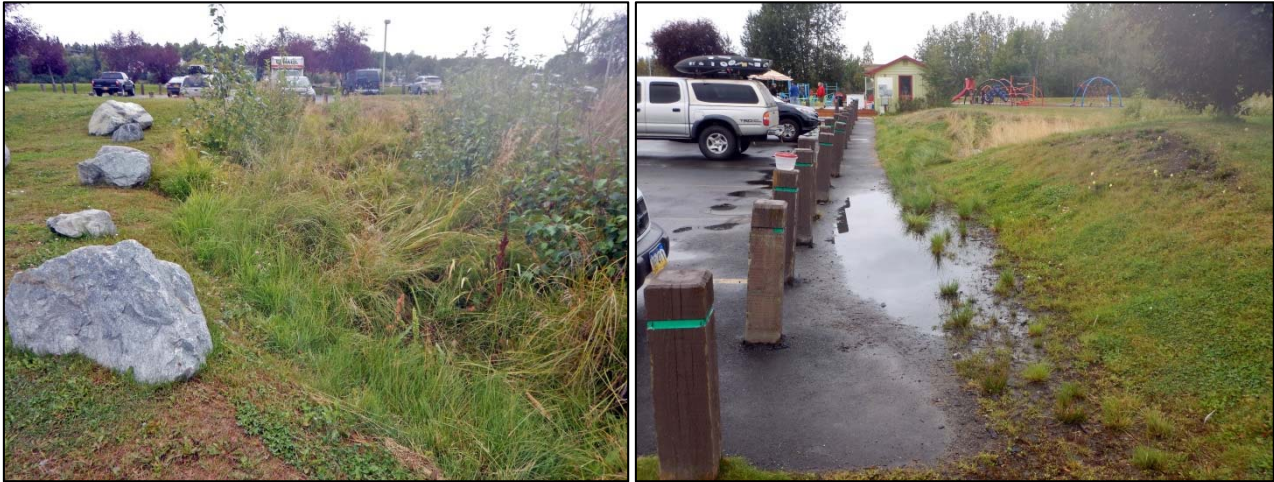
Figure 40: Westchester Lagoon Rain Garden and Parking Lot

- ~ The rain garden and drainage swale from the parking lot are in need of maintenance. In areas where grades are particularly flat, ongoing maintenance is required to ensure that GI facilities continue to function as needed to maintain positive drainage. These observations were made following during a light rain event. During a heavier rain event with more runoff generated, it is not known if water would be able to overcome the sediment build up and flow into the rain garden.
- ~ Vegetation maintenance is important to facility longevity. Species like cottonwoods can be damaging to rain gardens by harming other plants and causing root interference with subdrains or liners.

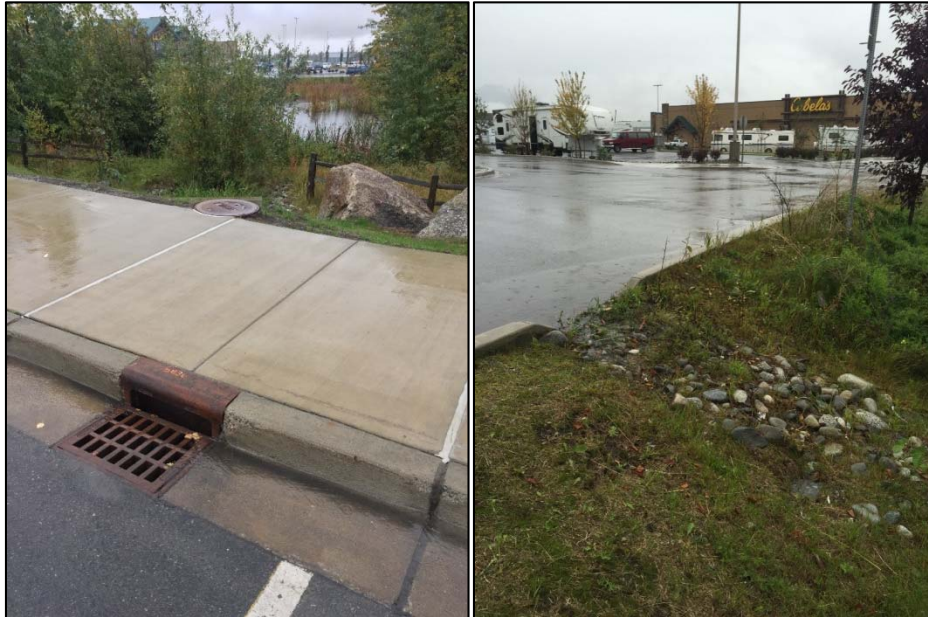
Figure 43: Inlets to Target Stormwater Pond

It was noted during the site visit that the facility appears to be functioning well, and water fowl were observed to be using pond. Substantial flow was entering the pond via multiple pond inlets, and the pond did not appear to be at or beyond its design capacity. Erosion protection measures were in place in locations where curb cuts and outfalls discharge to the pond, and these seemed to be working well. No erosion was observed. Pond inlets are shown in Figure 43.

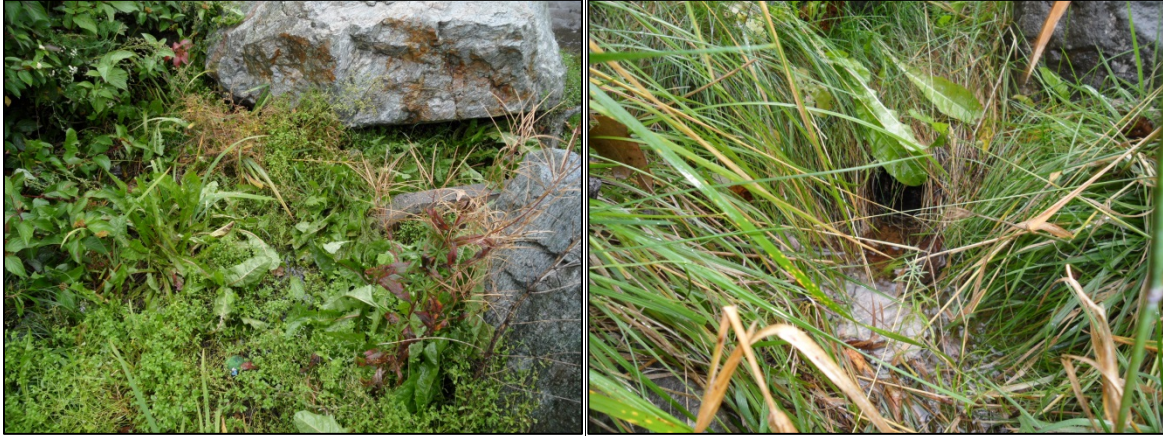
*Left: Vegetation inside the rain garden. Right: Underdrain outfall*

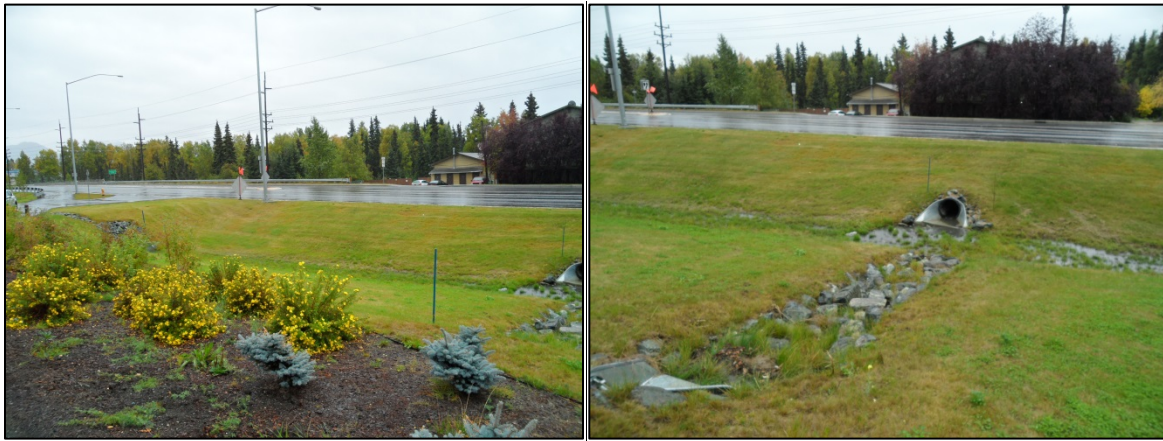
Observations: Water was steadily flowing into the bioswale from 4 of the 5 storm drains that outfall to the swale. At the far west storm drain outfall, vegetation was partially blocking the outfall, causing ponding and back of water in the storm drain pipe. Did not appear to be a problem at this flow rate. There was standing water in the swale that was trickling slowly toward the swale outlet on the east side. Water was flowing slowly into the bioswale outlet pipe. The bioswale vegetation looks good. Overall the system is looks to be performing very well. Inflowing water is slowed down, ponding occurs, and water moves slowly through the vegetation to the outlet.

*Overview and storm drain outfall to bioswale.*

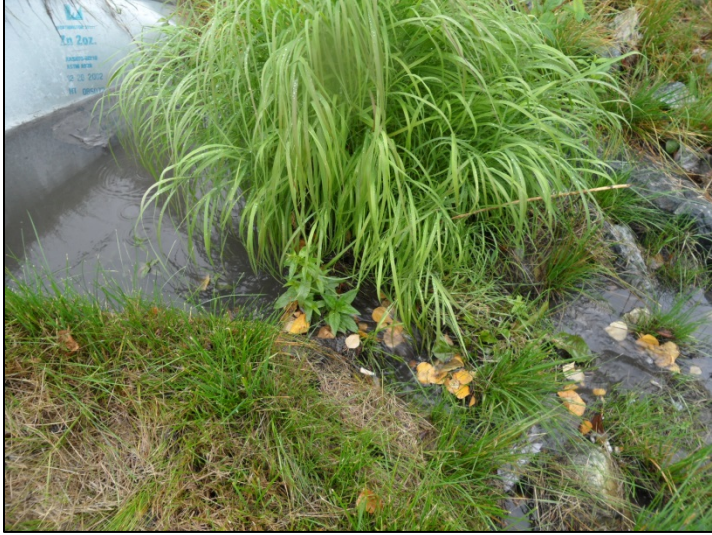
*Inflow partially blocked by vegetation.*

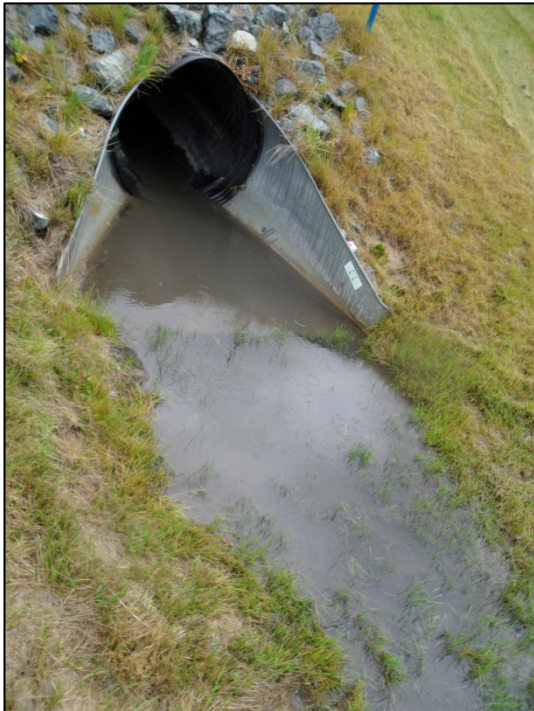
*Bioswale outfall – flowing slowly.*

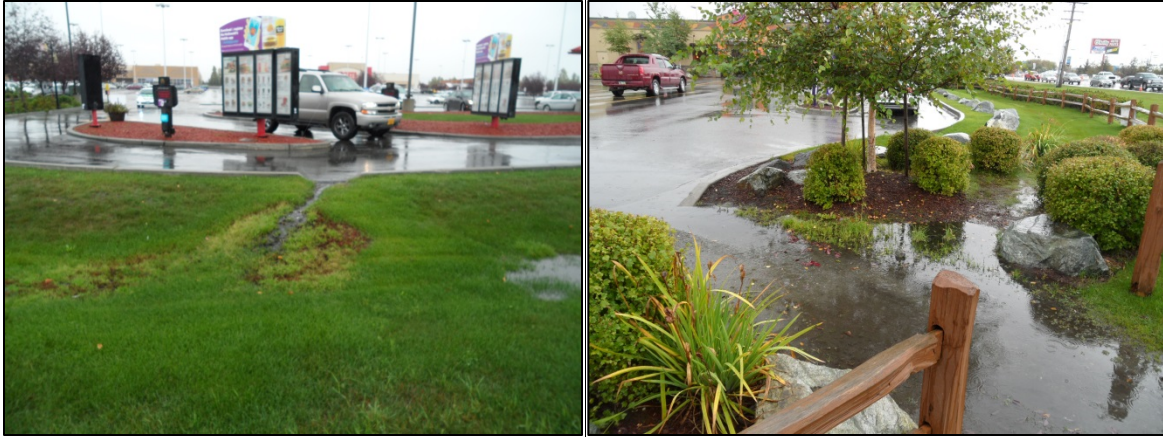
*Left: Water entering swale from drive-through. Right: Water entering vegetation from parking lot.*

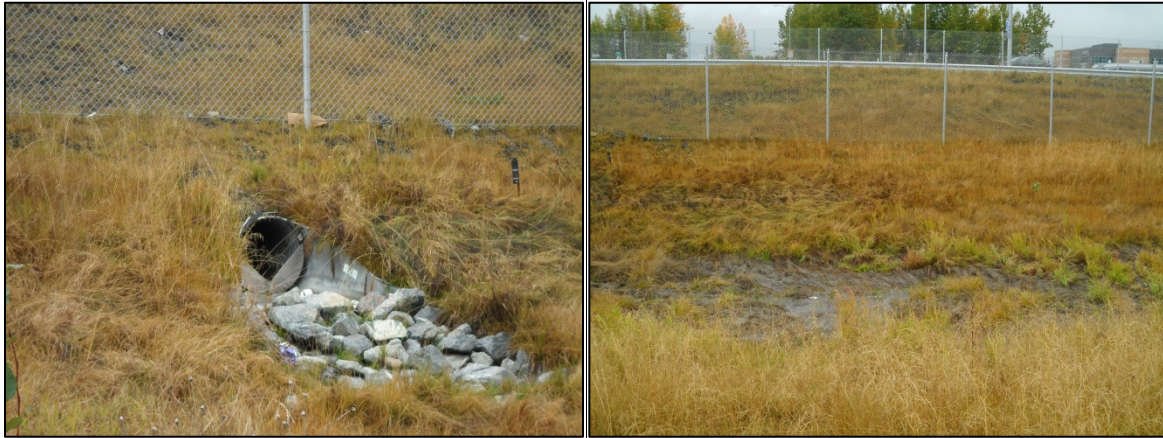
Water was observed to be flowing into the facility from the inflow culvert, and some ponded water in the floor of the basin was visible. No outflow was observed. Instrumentation tools for 2014 monitoring were still in place.

*Left: Inlet Right: Ponding in the facility*

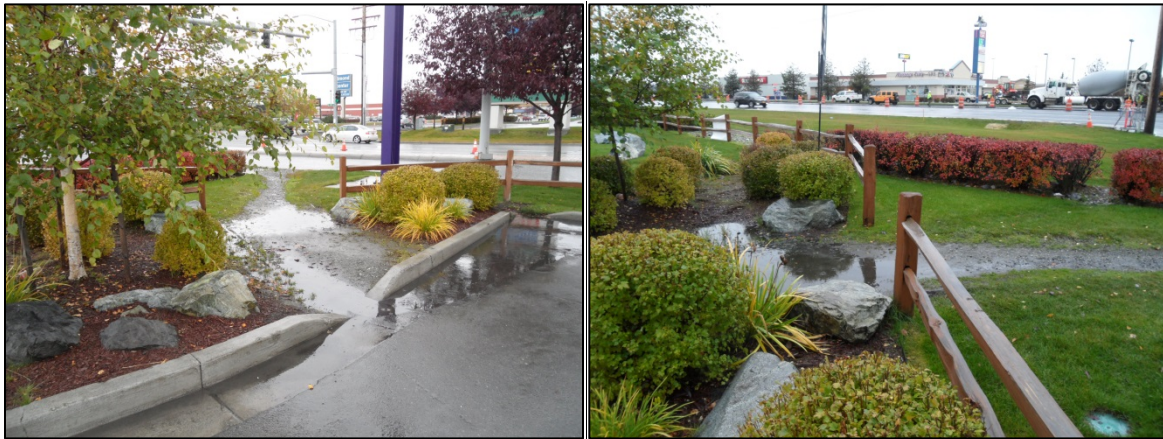
The vegetated swale and associated landscaping appeared to be working quite well. The footpath near the north end of the Taco Bell parking lot was not flowing, but looked as though it had been recently. Water was not flowing through the lowest beehive inlet in the swale. Grass was observed to be growing through the beehive. It is believed that either 1) there isn't an actual inlet in this location or 2) the inlet has been blocked by a sediment trap, such as a witch's hat, that has been in place for quite some time.

*Taco Bell Parking Lot – North Side. Foot path not overflowing.*

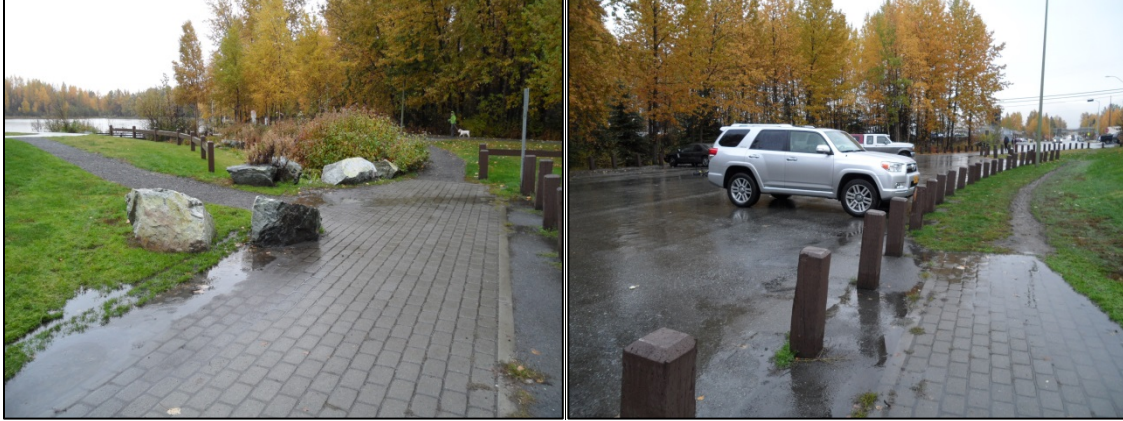
*Left and right: Water flow toward the rain garden inlet.*

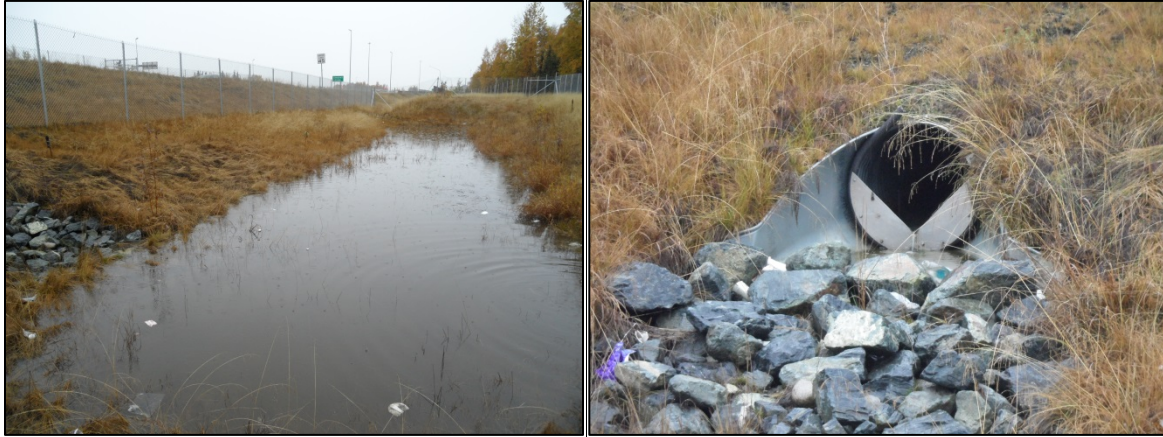
Water was observed to be flowing into the facility from the inflow culvert, and some water in the floor of the basin was visible. No flow over the outfall weir was observed. Standing water was 13 to 15 inches deep.

*Left: Ponding in the facility. Right: Inlet actively flowing.*

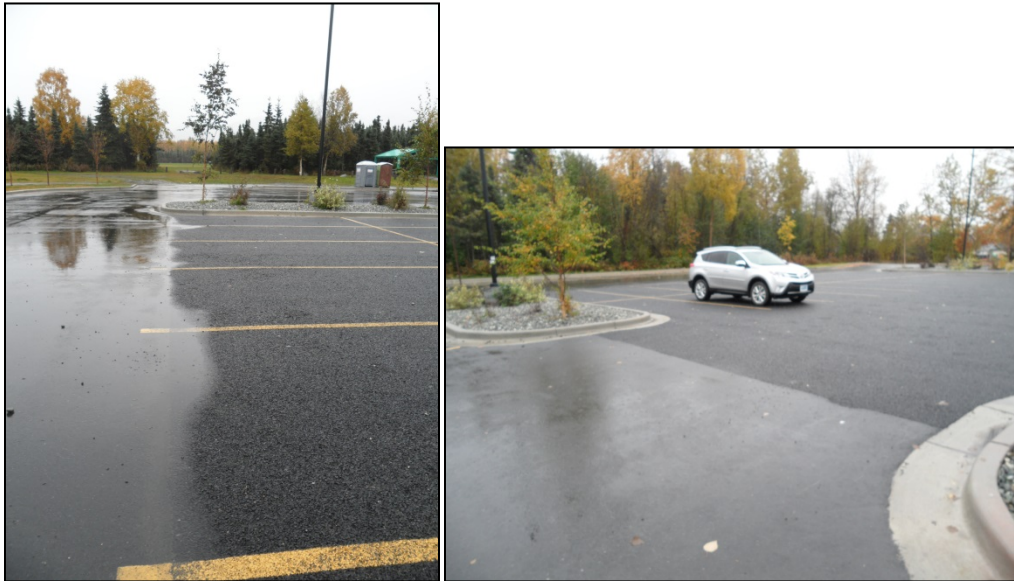
- The raveling porous asphalt unraveling was still visible. Rocks from the asphalt surface were scattered around the parking lot, and the parking needed to be swept. Driving on these small rocks is anticipated to further worsen the raveling, thus creating a “snowball” effect. The loose rocks are also flowing to the curb inlets leading to the infiltration gallery.
- The north interface between porous asphalt and traditional asphalt was ponding water.
- A barricade to prevent vehicles from driving on the east side was not visible.
- The cap on the easternmost observation port of the infiltration gallery was broken off.

*Left: North asphalt interface. Right: West asphalt interface*

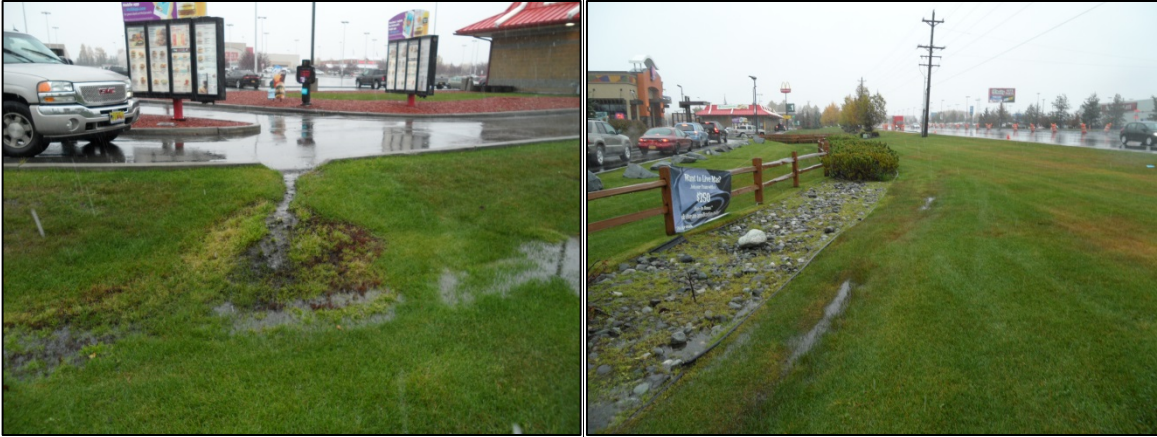
*Left: Flow from the parking lot to the vegetated swale via curb cuts. Right: water ponded in the vegetated swale.*

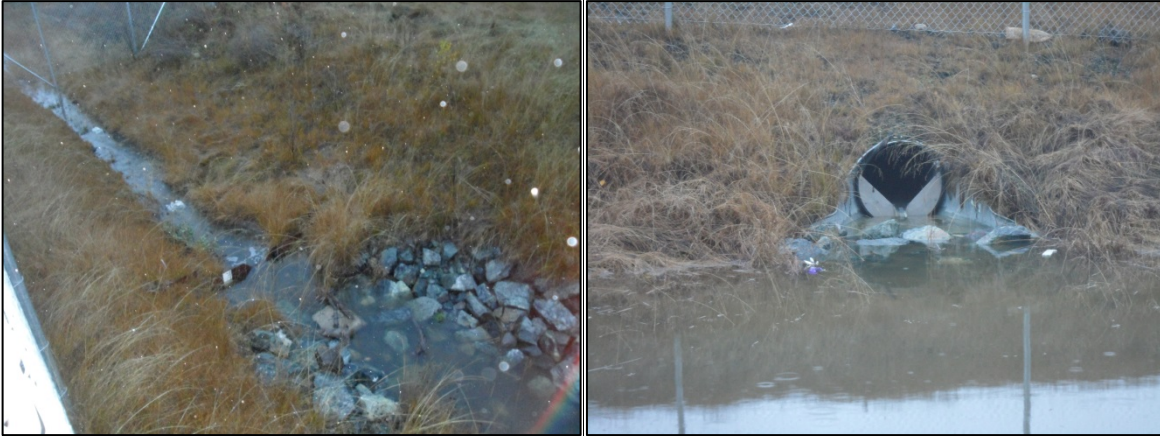
- Water was flowing over the inflow and outflow weirs. The water height on the outflow weir was estimated to be about 3 inches.

*Left: Facility outlet. Right: Facility inlet*

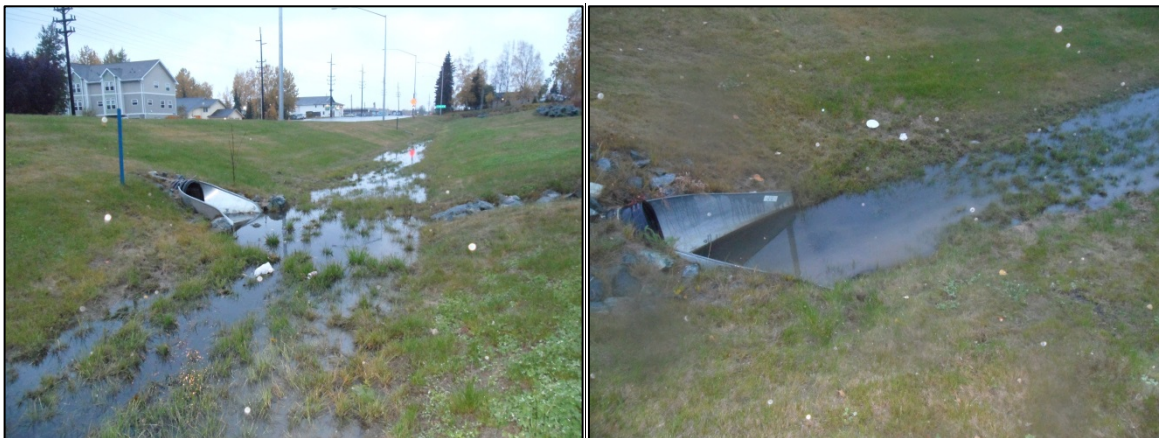
- More water in the swale than was present the previous day. Water was visibly dirty-looking and brown, particularly water that was flowing into the swale from the further east inlet on the north side.
- All inlets into the swale were flowing except the second one from the outlet on the north side.
- Downstream of the swale outlet, water was trickling into Campbell Creek from between the rocks on the shoreline. There is an armored pathway that appears to be intended to direct water from the swale into the creek. However, water does not enter the creek via that pathway. Instead, it turns to the south and flows under the rip rap on the shore of the creek and eventually flows into the creek near at the bridge.

*Left: Overview of bioswale. Right: Bioswale outlet.*

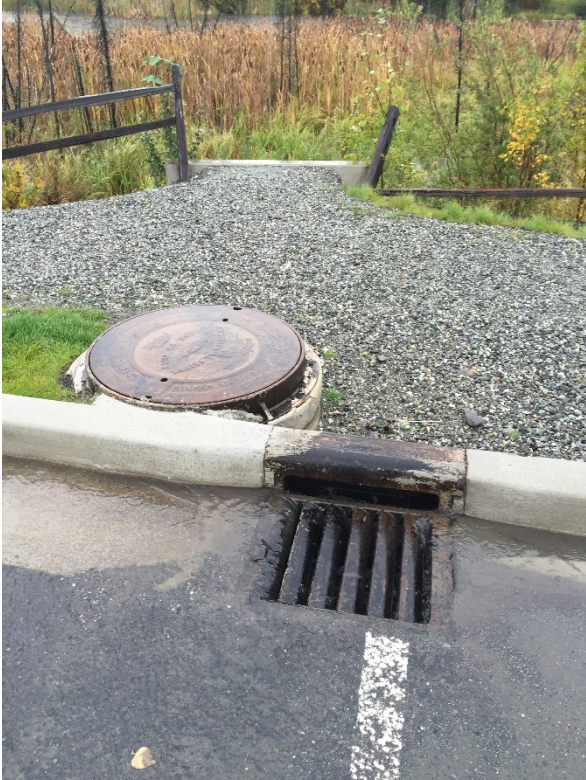
Catch basin on south side of pond (from Cabelas lot).

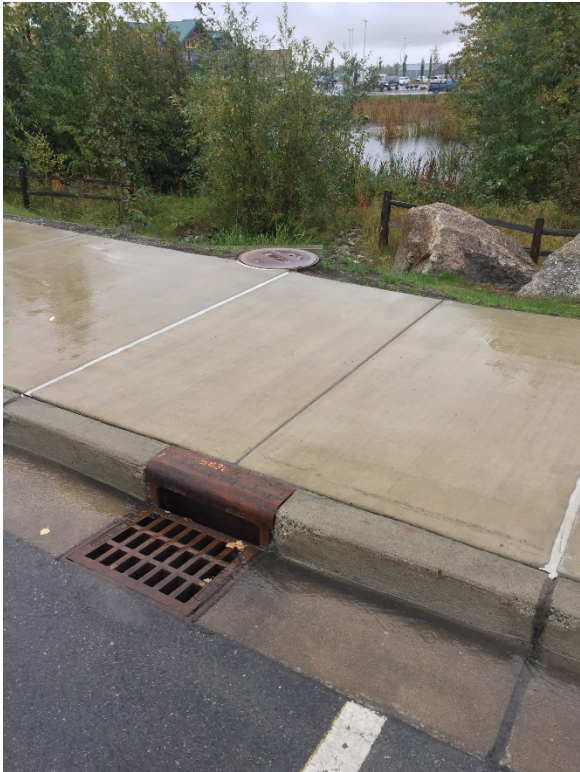
Catch basin on north side of pond, leading to culvert and discharge into pond.

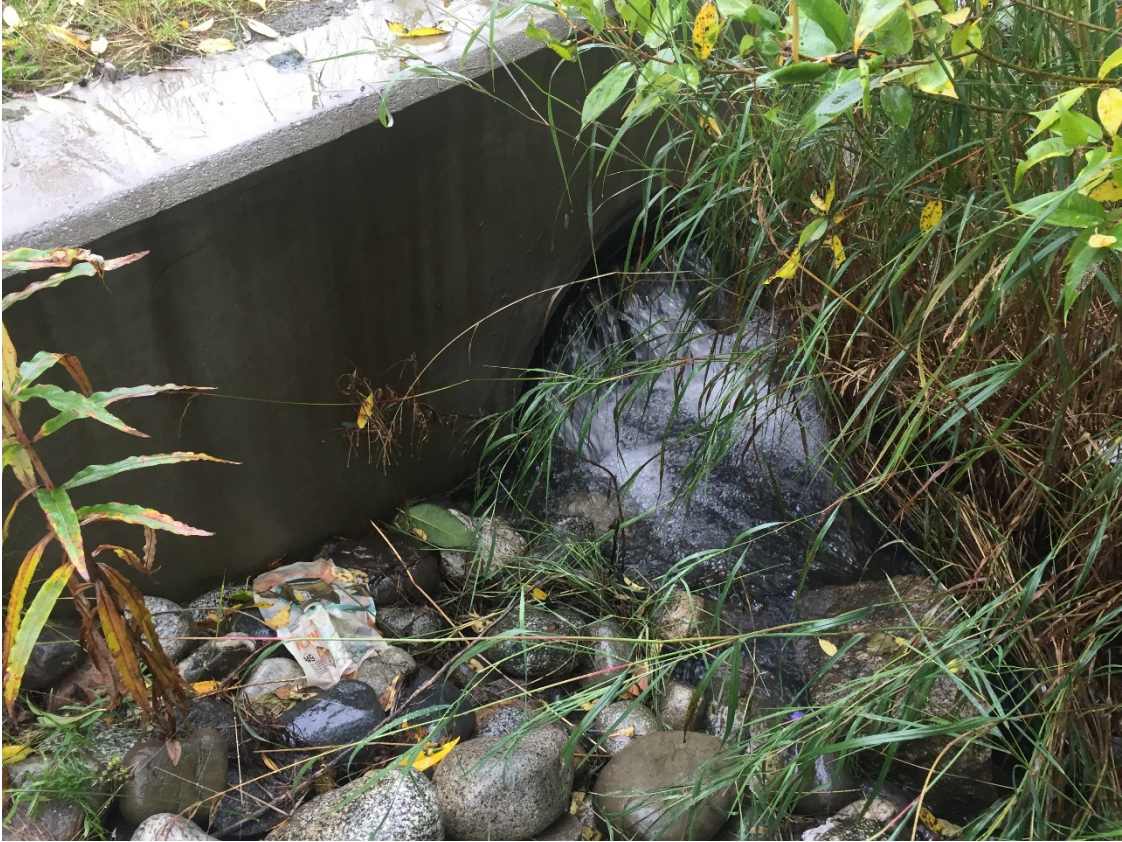
Flow from culvert connected to catch basin at north side of pond (Target parking lot).

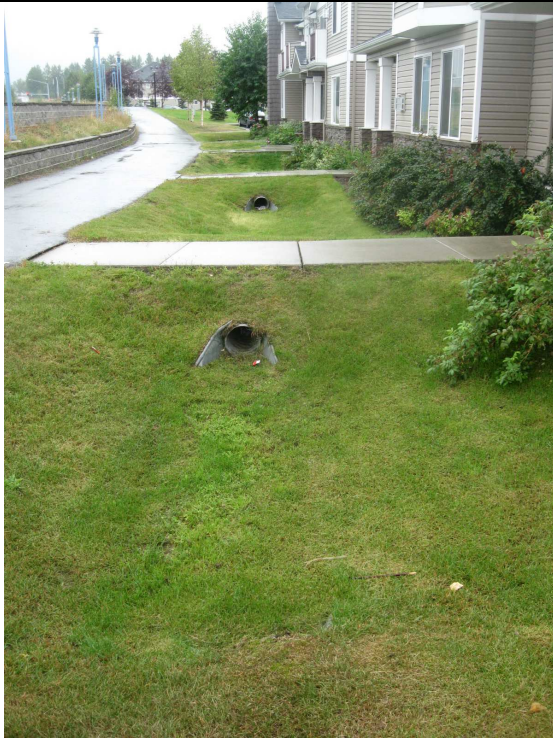
3 East portion of north east-west swale  
< some standing water in second cell from front >

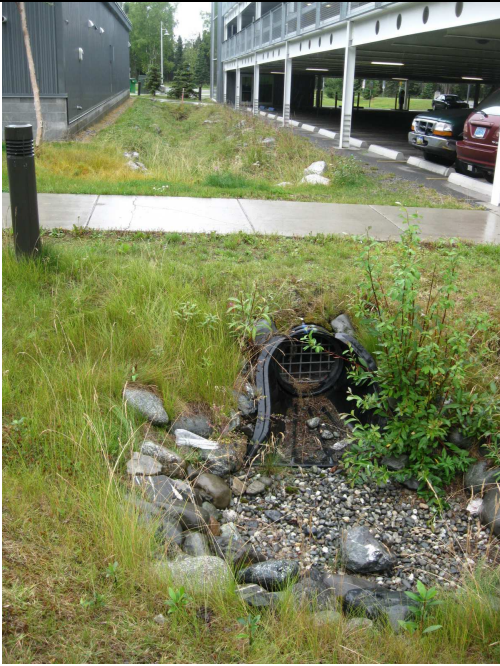
1 looking west along bioswale btwn parking garage on right and ANSEP bldg. on left (north side of ANSEP bldg.) Area #3 on site plan

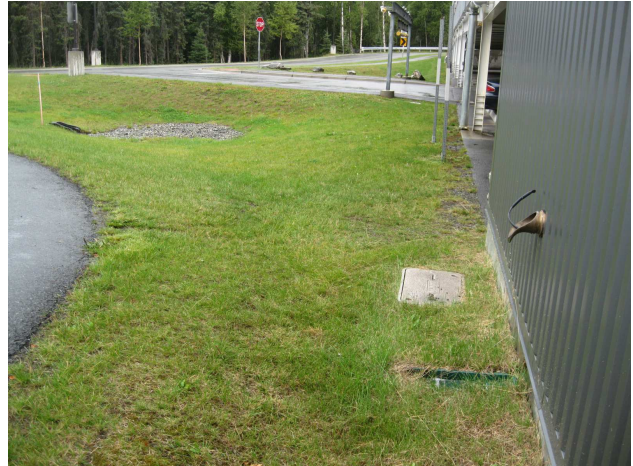
2 scupper on west side of ANSEP bldg. between Areas #2 and #3 on site plan

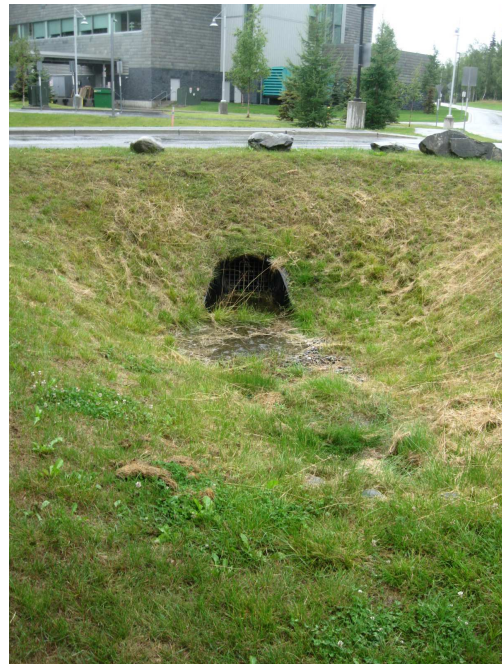
Outlet from Area #1
