MOA and DOT&PF 2018 Green Infrastructure and Low Impact Development Project Performance Monitoring Report

The Municipality of Anchorage

February 2019

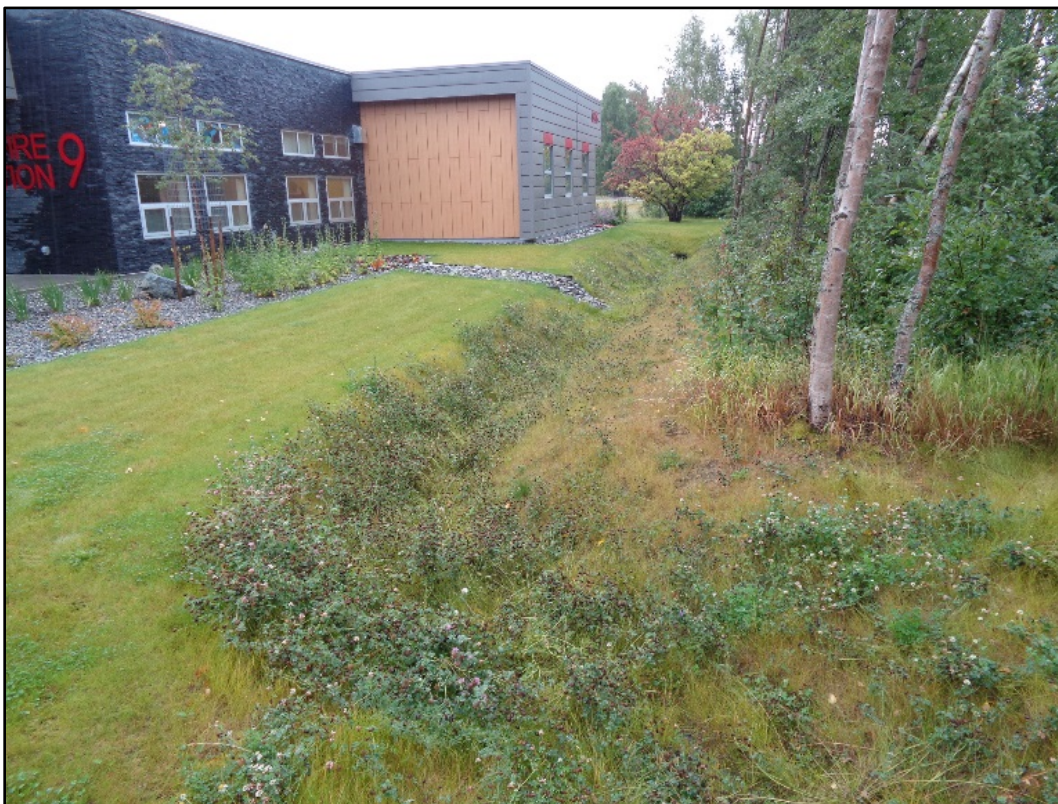
Figure 3: Vegetated Swale

The vegetated swale is approximately 140 feet long and is roughly 2 to 3 feet deep. The swale is generally triangular in shape with 2:1 side slopes. The surface vegetation is dense grass, as shown in Figure 3.

Vegetated Swale and Landscaped Detention Area. During the August 21 site visit, it was actively raining. Water was flowing from the fire station roof structure and from the rear parking lot into the vegetated swale. Only a small amount of water was observed in the vegetated swale, indicating that some of the inflow was successfully infiltrating. The vegetation in the swale was mature and healthy, and was keeping water movement through the swale at a slow velocity to provide opportunity for infiltration and evapotranspiration.

- The vegetation in the vegetated swale is both functional and aesthetic, and is expected to be relatively low maintenance. Use of these types of plants is recommended in similar locations, where appropriate.

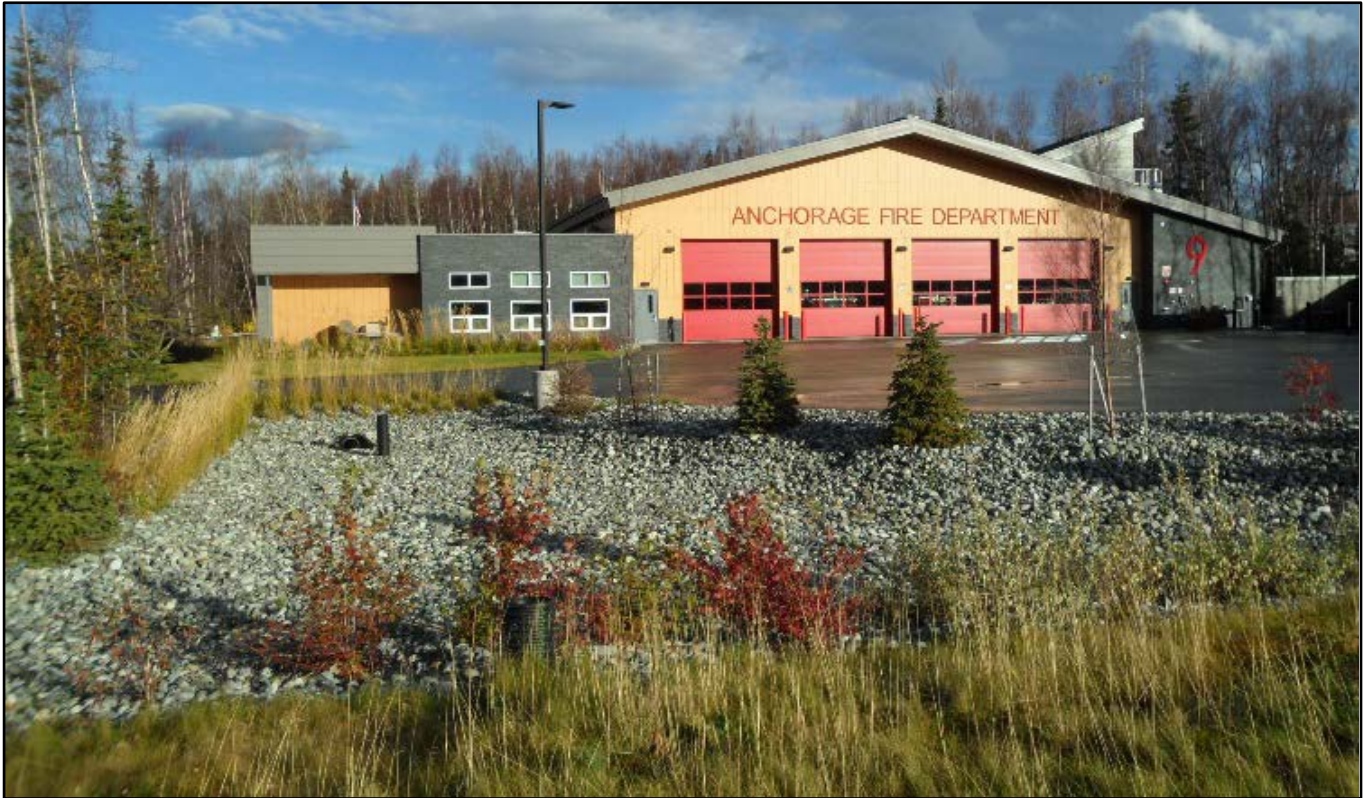
Figure 4: Landscaped Detention Area

is designed to allow for approximately 2 feet of ponding. Higher flows are released into the storm drain system through a surface overflow. The surface is landscape rocks with some shrubs, bushes, small trees, and plants around the edges. The landscaped detention area and associated design diagram from the project plans are shown in Figures 4 and 5.

Water that was conveyed through the swale was entering the landscaped detention area via a connecting culvert. A small amount of vegetation and organic debris were partially blocking the inlet and outlet of this culvert but did not appear to be impacting performance. Water was also entering the landscaped detention area via direct runoff from the adjacent parking lot. Water was percolating through the treatment layers to the underlying subdrain. Surface ponding (which would indicate a subsurface blockage or slowing of percolation through the treatment media) was not observed in the landscaped detention area, which indicates that the facility is performing very well. Flow in the subdrain could be heard through one of the cleanout risers.

The October 16 site visit occurred after the peak of that rainfall event, and it was not actively raining during the site visit. Facility conditions were similar to the August site visit, except that no standing or moving water was observed in the vegetated swale. The swale and the detention area were in good condition and no issues from the recent rainfall were noted. The Fire Station Chief noted that both the vegetated swale and the landscaped detention area were performing well and that he had never seen standing water in the landscaped detention area.

- The Fire Station chief reported some maintenance issues with keeping grass out of the landscaped detention area, and noted that he pulls grass out of the rocks regularly. Low maintenance vegetation could be considered for this type of facility instead of a rock surface. Vegetation would also enhance the filtration and evapotranspiration potential for this area.

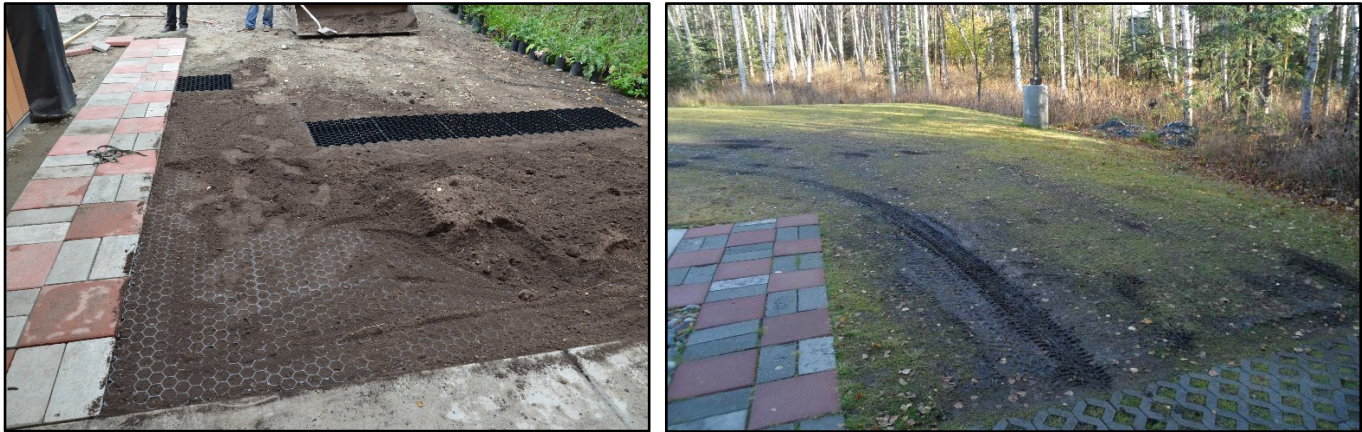
Figure 6: Permeable Pavement Turf Grid

installed over 24 inches of Type II structural fill compacted to 95%. Topsoil infill was placed roughly to the top of the turf grid prior to seeding. Figure 6 shows the turf grid during installation and after approximately two years of use.

October 2018 Site Visit

Permeable Pavement Turf Grid. During both site visits, several performance issues were noted with the turf grid area. The surface of the turf was primarily muddy, as the vegetation was not mature and healthy. In some locations there was ponding on the surface instead of percolating into the subgrade. The grid structure itself was loose and moving under foot traffic. When walked on, water would splash out of the grid surface and subgrade. Vehicle ruts were visible on the surface, and in many areas, no grass was growing. Discussion with the Fire Station Chief indicated that the turf grid area was regularly used by the fire fighters to load and unload their gear and supplies at the beginning and end of their shifts. He also explained that crew members use this area to wash vehicles. The Fire Station Chief also discussed that he had tried to add seeding and fertilizer to the turf grid, but it had not improved the condition of the vegetation.

Permeable Pavement Turf Grid. The performance issues observed with the turf grid area is expected to primarily have been caused by site use that is inconsistent with designer expectations and improper preparation of the soil subgrade.

In addition to the site use change, the constructed subgrade does not appear to have been compatible with the turf grid installation. The turf grid was placed over traditional Type II fill material, compacted to 95% of maximum density. NDS generally recommends that this turf grid product be constructed over an open-graded backfill layer such as AASHTO #57, which is generally one-inch minus rock. Some manufacturer literature does discuss using road base as backfill in cases of heavy surface loading, which was expected to the basis of this design. Compacted Type II fill is not expected to percolate water very well, which may have contributed to the soggy conditions at the ground surface. The area was also generally flat, so surface water was not able to shed to adjacent areas.

Other factors that MOA representatives, the Fire Station Chief, and/or the project design team have discussed that could have contributed to the turf grid failure but have not been confirmed include the following: poor quality of the topsoil, lack of sunlight on the north side of the building where the turf grid was located, insufficient depth of topsoil or topsoil that was too compacted, and/or accidental damage from human activity (e.g. snow plowing, salting, soaps, etc.).

- Limit turf grid applications to locations where frequent or heavy traffic loading is not expected, and ensure that the base material is a porous, open-graded rock that is appropriate for the design loading. The open graded rock will provide void space to hold water and allow it to eventually percolate into the natural subgrade. If infiltration is not desired or practical, consider installing a perforated subdrain in the rock layer to collect excess water and direct it to an outlet or to a receiving system.

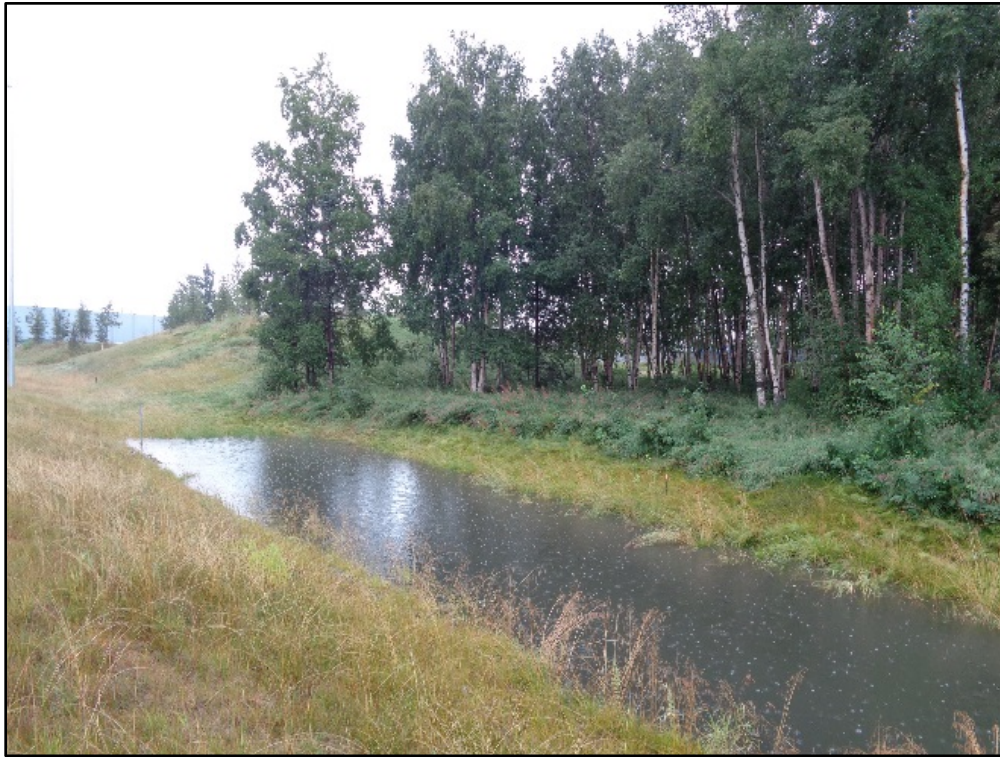
Figure 13: Infiltration Pond #1

Infiltration pond details used in this analysis are based on information from the project design documents (provided by DOT&PF) and from visual observations. Infiltration Pond #1 collects stormwater from approximately 4.8 acres, 2.1 acres of which is impervious surface from the new roadway and pathway and from the business park to the northeast. The infiltration pond is vegetated with grasses and is approximately 90 to 100 feet long by 25 feet wide, with 4:1 side slopes. Approximately one-half acre of forested area lies east of the pond. Riprap is present near the inlet, and the pond has no outlet. Infiltration Pond #1 is shown in Figure 13.

The infiltration ponds were visually inspected during Event 1 and Event 2, and other than a few inches of difference in pond water level, observations were similar for both events. Overall, the three ponds were performing well.

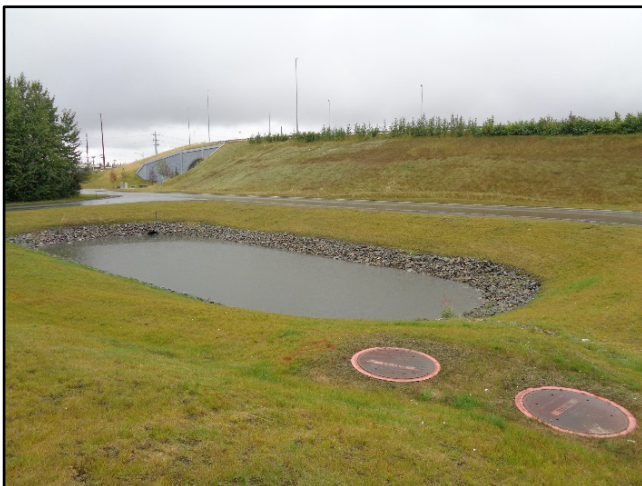
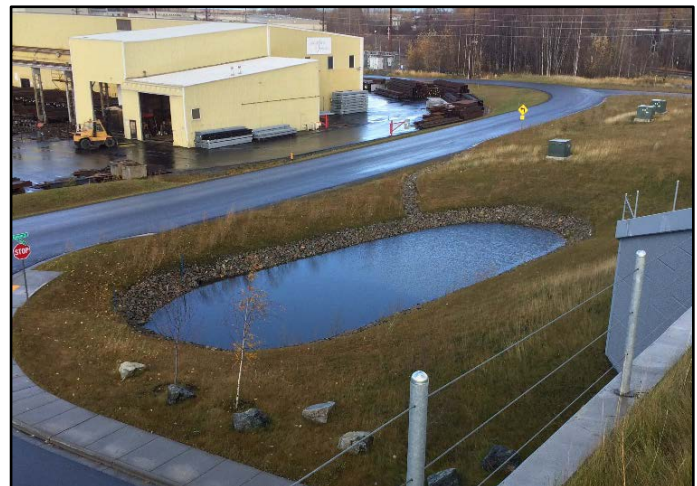
Figure 14: Infiltration Ponds #4 (left) and #5 (right)

Infiltration Ponds #4 and #5 collect stormwater from approximately 6.2 acres. Of this area, Electron Drive, West Dowling Road, and the pathway contribute 1.7 acres of impervious surface. Pond #4 is located west of the southern end of Electron Drive and Pond #5 is located northeast of the intersection of Electron Drive and Howard Holton Court. Ponds #4 and #5 are connected hydraulically via a pipe with a 0% slope. The water surface elevations are designed to be the same in both ponds. Pond #4 is approximately 115 feet long by 50 feet wide, and Pond #5 is approximately 125 feet by 40 feet. As shown in Figure 14, Infiltration Ponds #4 and #5 both have riprap around the pond edges, with vegetated grasses above the riprap. Both ponds have no outlet.

It was observed during both site visits that vegetation surrounding Infiltration Ponds #1 and #5 had grown into tall grasses, but the grass around Pond #4 was fairly short. Figure 18 and Figure 19 show inlet culverts for each of the three ponds.

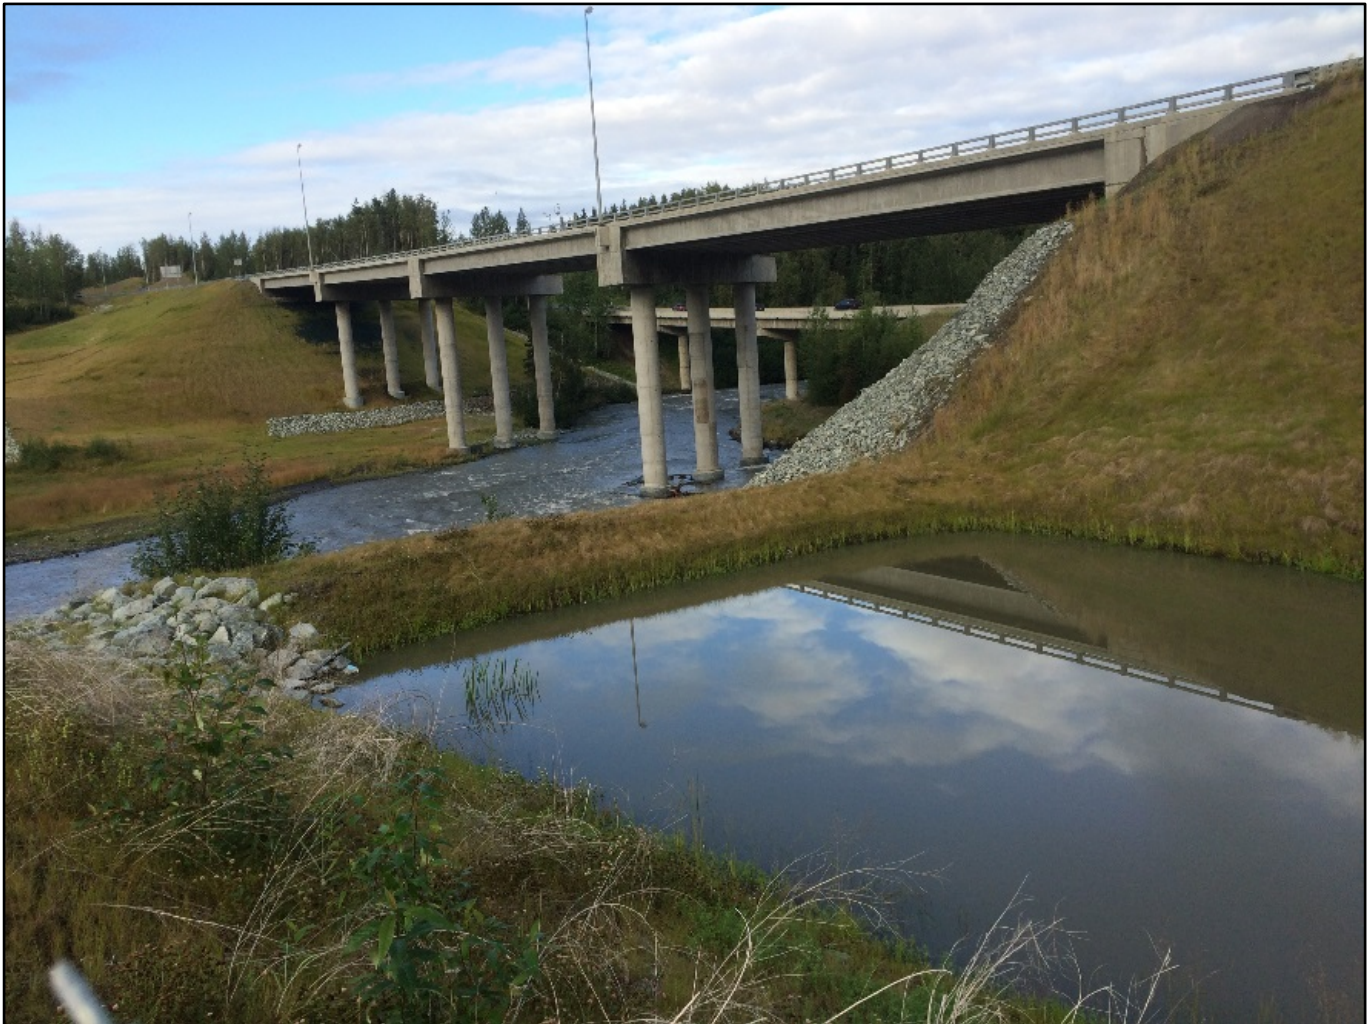
Figure 27: North Detention Pond Berm and Outfall

3.7 acres of which is impervious surface from the northbound Glenn Highway and VFW Road. The detention pond is vegetated with grasses and is approximately 120 feet long by 50 feet wide. Side slopes vary. The pond inlet is a storm drain pipe that collects water from the northwest side of the northbound Glenn Highway. The south edge of the pond is an earthen berm six feet above the pond bottom with a riprap-lined, trapezoidal spillway that outfalls to Eagle River. The pond and the top of the spillway are shown in Figure 27.

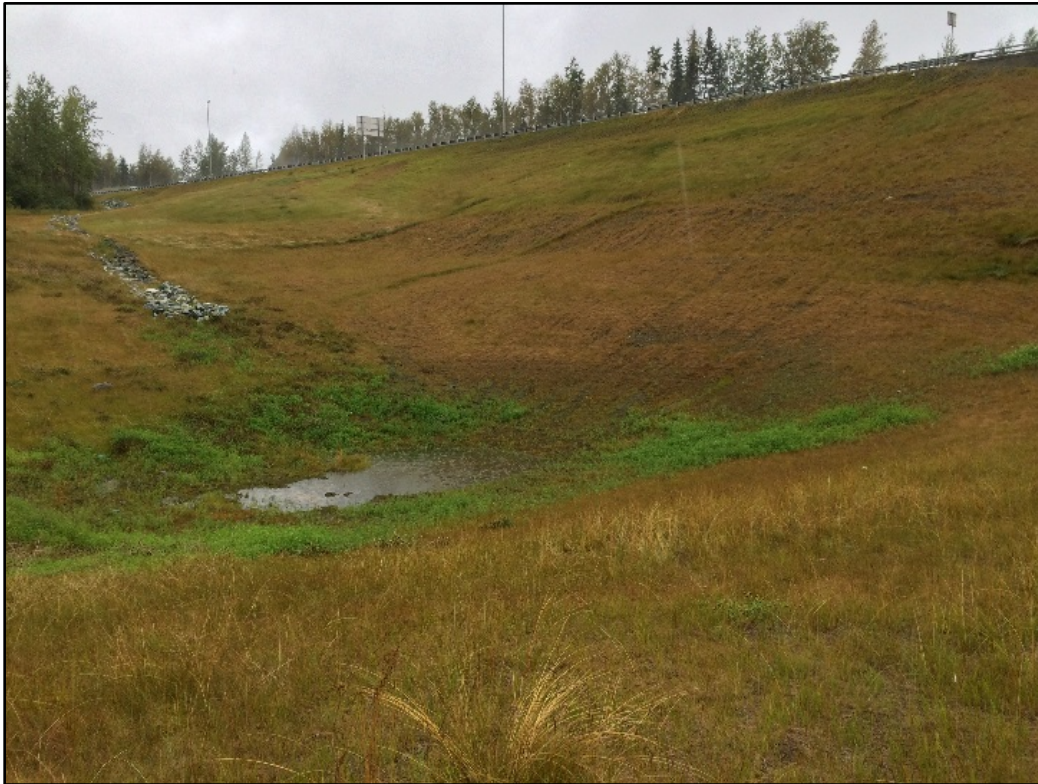
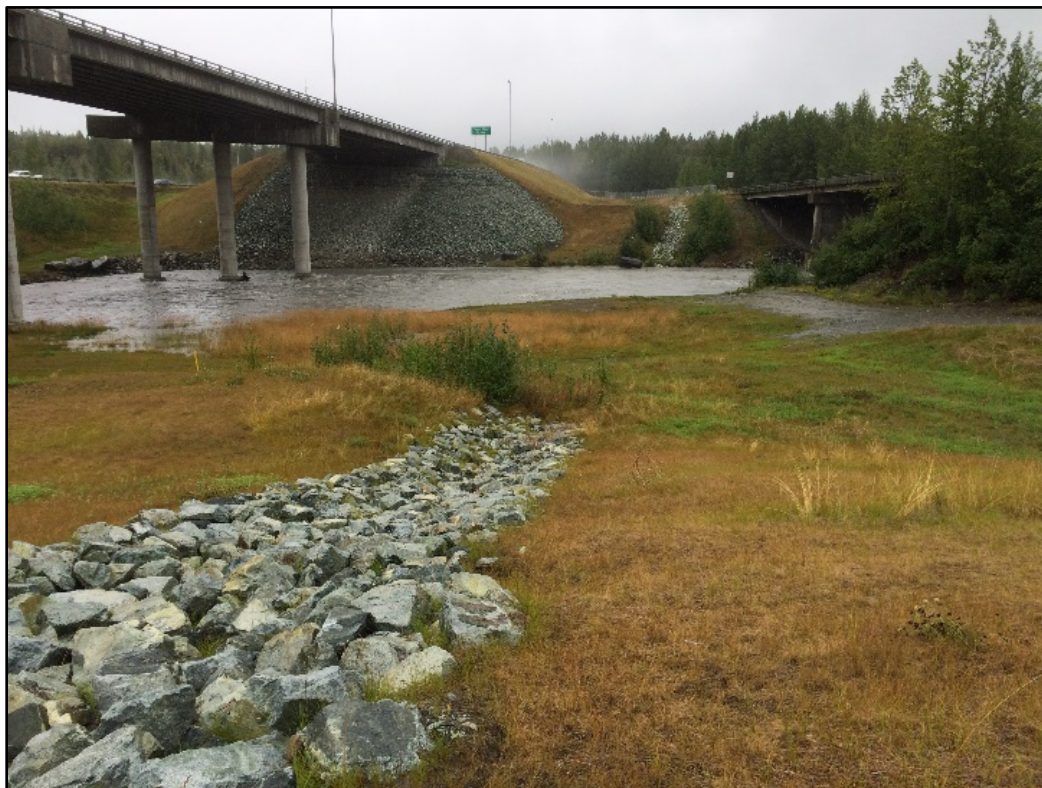
Figure 28: South Detention Pond Inlet Ditch (top) and Outfall (bottom)

The south detention pond is located between the northbound Glenn Highway and VFW Road, south of Eagle River. The pond collects stormwater from approximately 29.7 acres, 5.7 acres of which is impervious surface from the northbound Glenn Highway. The detention pond is vegetated with grasses. The pond is approximately 220 feet long by 70 feet wide at the top and has 4H:1V side slopes. Stormwater enters the pond via a riprap-lined inlet ditch on the pond's south side. An 8.3-acre forested area lies south of the pond. The pond's north edge is an earthen berm 13 feet above the pond bottom with a riprap-lined, trapezoidal spillway that outfalls to Eagle River. The pond and spillway are shown in Figure 28.

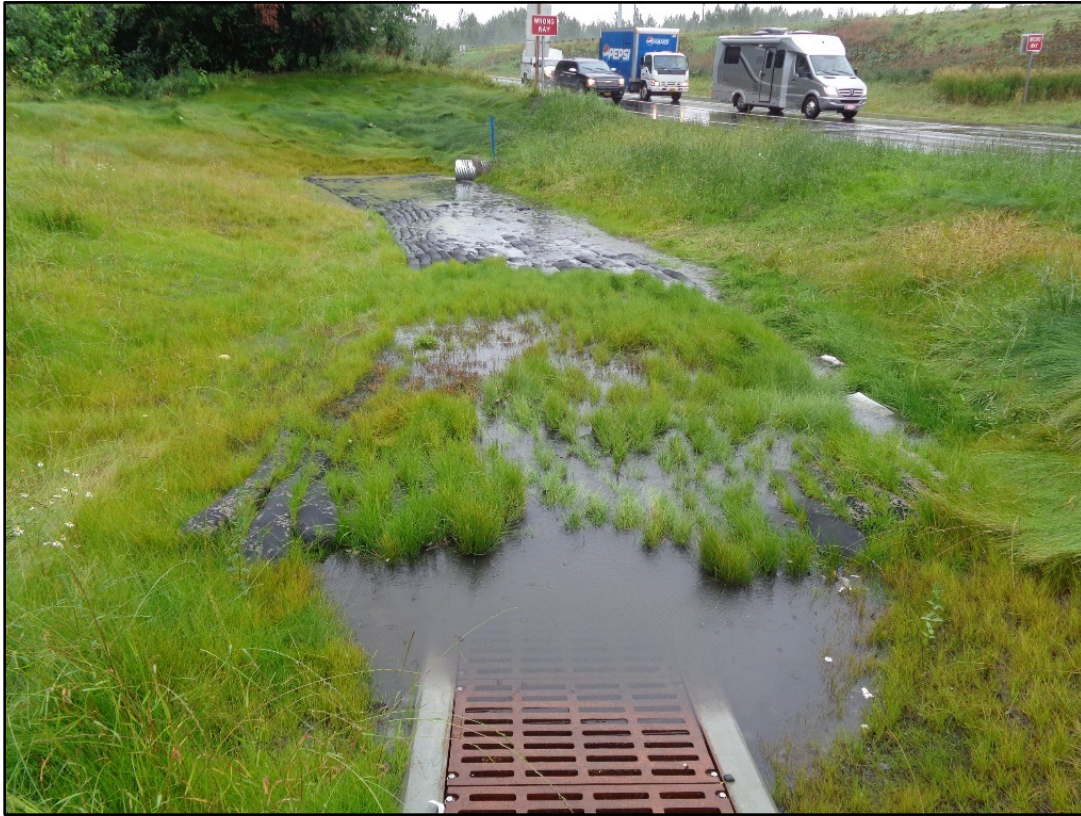
Figure 40: O'Malley Road Bioswale

culvert at the southern end of the bioswale. Figure 40 shows the inlet in the foreground and compost socks and the culvert outlet in the background.

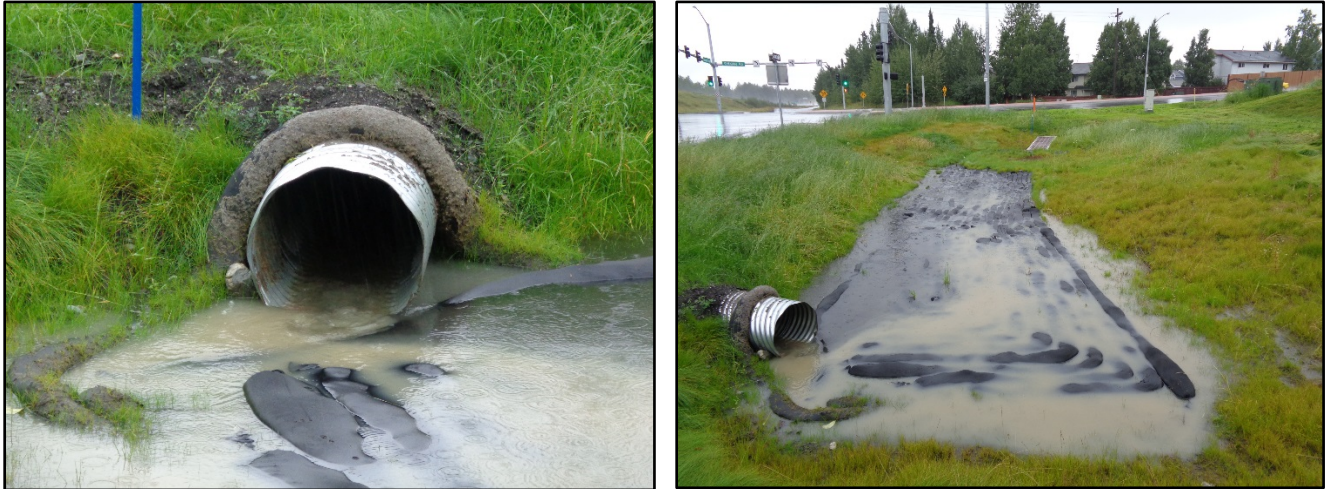
Figure 41: Bioswale Outlet and Bottom, August 21, 2018

There was limited vegetation in the swale, though surrounding grasses were long and were observed to be in good condition. Some grasses were growing near the inlet. It is expected that bottom vegetation of the swale may not be fully established yet at the time of this performance monitoring. Establishment of bottom vegetation would notably improve the treatment properties of the swale. Slight ponding was also observed in a grassy area east of the bioswale. Figure 41 shows the swale's outlet and the facility bottom.

Although the bioswale was not providing notable stormwater benefits at the time of this report, performance is expected to be substantially enhanced if/when bioswale vegetation or non-mowed grasses are grown to maturity along the bioswale floor/flow area. To maximize performance, vegetation should be taller than the expected flow depth of the swale. This would slow the incoming flow, allowing an opportunity for infiltration and filtration by the vegetation. Vegetation roots also provide a pathway for infiltration and help prevent the facility floor from becoming compacted over time.

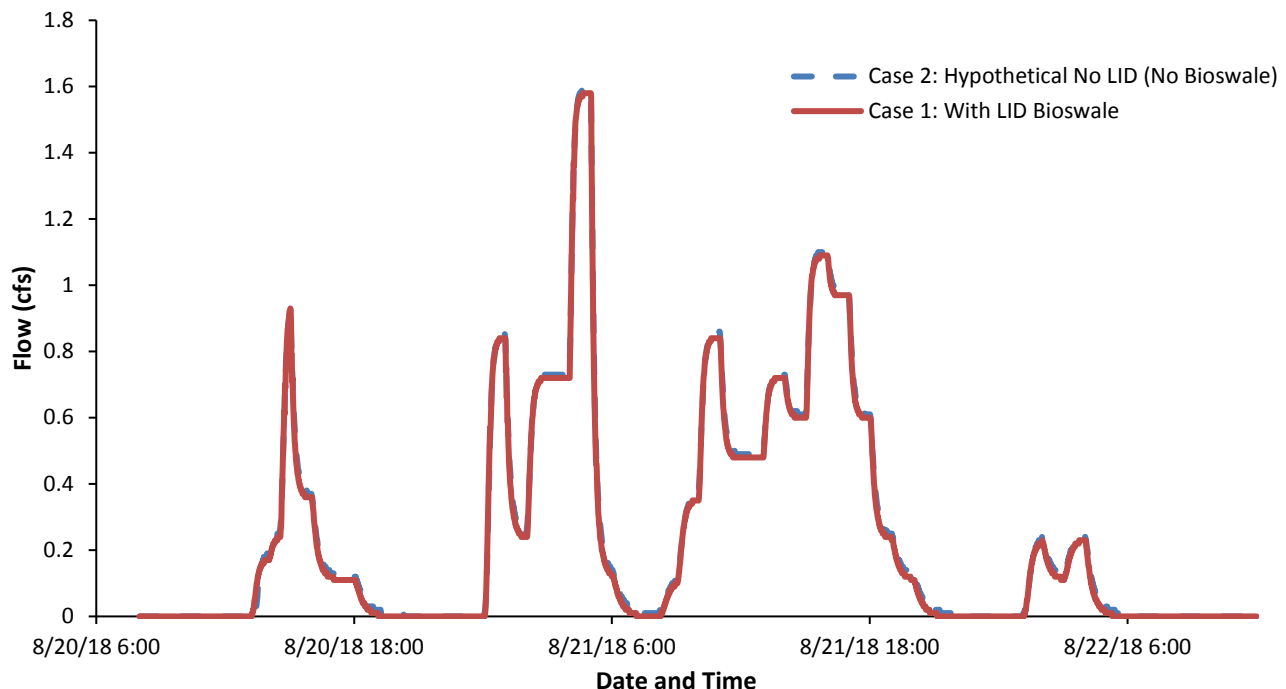
Figure 43: Event 1 August 20-22, 2018 Discharge Hydrograph – O'Malley Road

Hydrographs representing the discharge to the outlet culvert for the two rainfall events are shown in Figure 43 and Figure 44, and Table 9 shows the peak flow and total volume of runoff for each case. Results show that the bioswale is not notably reducing peak flow or peak runoff volumes during the two events analyzed.

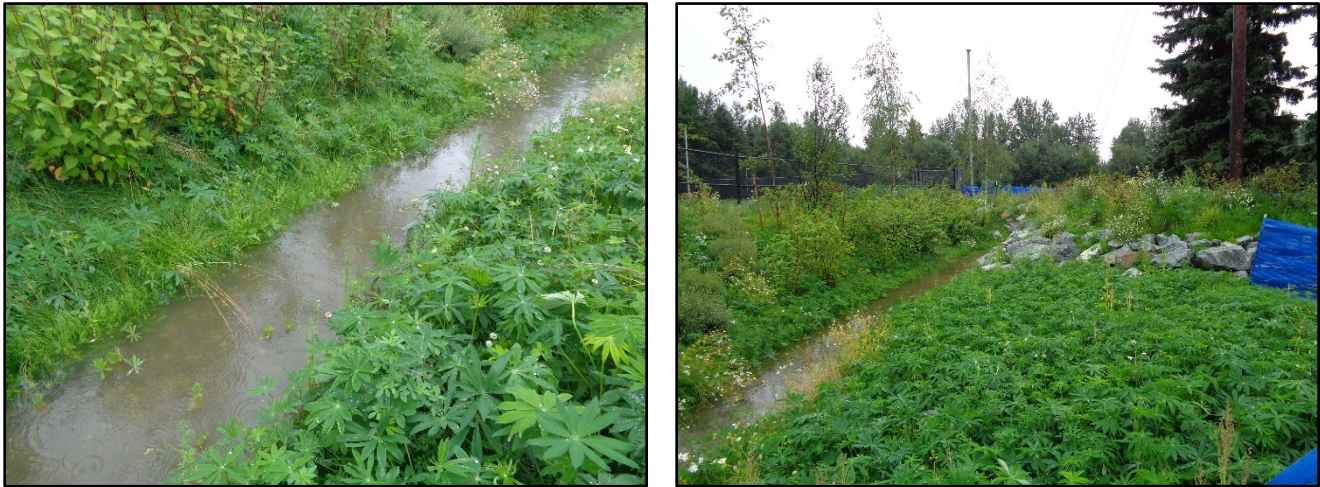
Figure 47: Standing Water in the Rain Garden (left) and Near the Dog Park (right), August 21, 2018

The project was observed on August 21, 2018. It was actively raining at the time of the site visit, and approximately six to eight inches of standing water was observed in the rain garden. A 30-foot by 75-foot area of the parking lot was draining to the rain garden. The remaining portion of the parking lot was flowing to the grassy, depressed areas

on the southwest side of the parking lot. The dog park appeared to be draining to the rain garden. The pathway areas to the north of the rain garden adjacent to the road were draining into the rain garden. Figure 47 shows the rain garden at the time of the site visit. Figure 48 shows the surrounding areas.

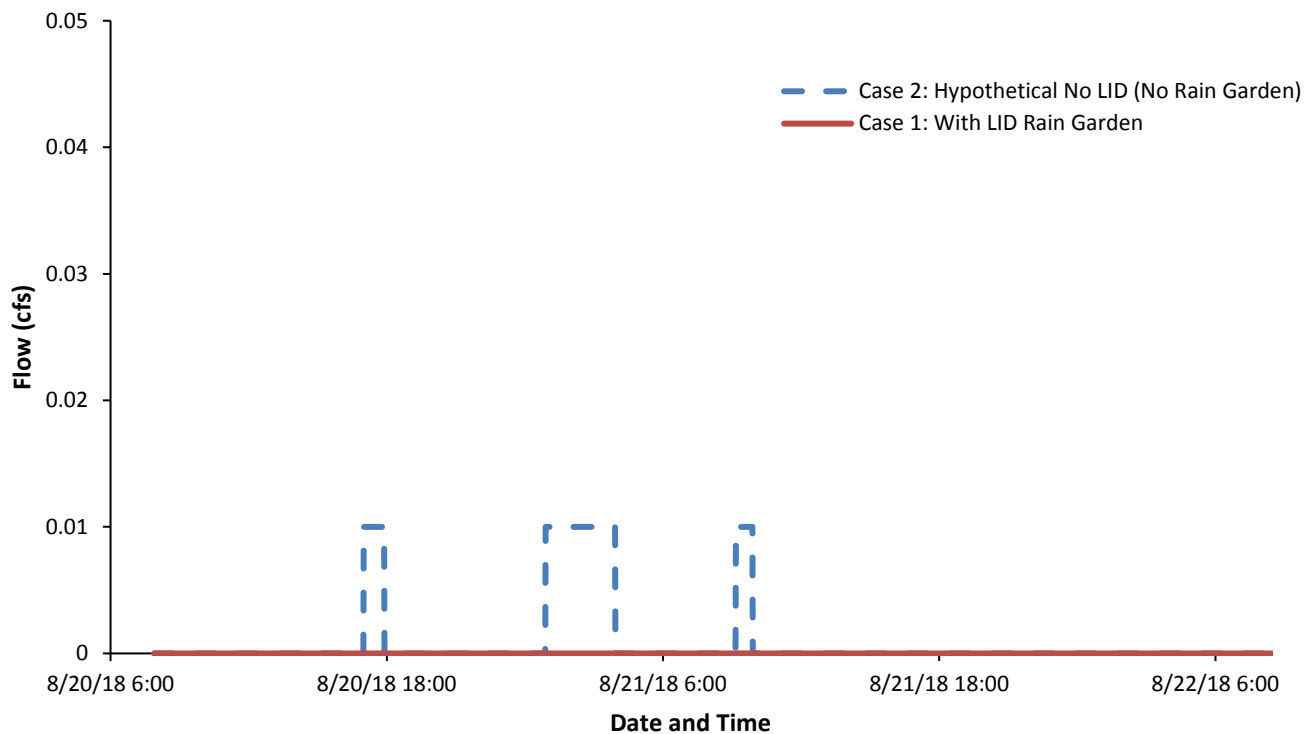
Figure 49: Event 1 August 20-22, 2018 Discharge Hydrographs – Valley of the Moon

Figures 49 and 50 provide discharge hydrographs for Case 1 and Case 2 for each rainfall event. Table 10 provides a summary of peak flows and runoff volumes for both cases for the two rainfall events. The SWMM modeling results show that the rain garden held all stormwater runoff for the two events analyzed.

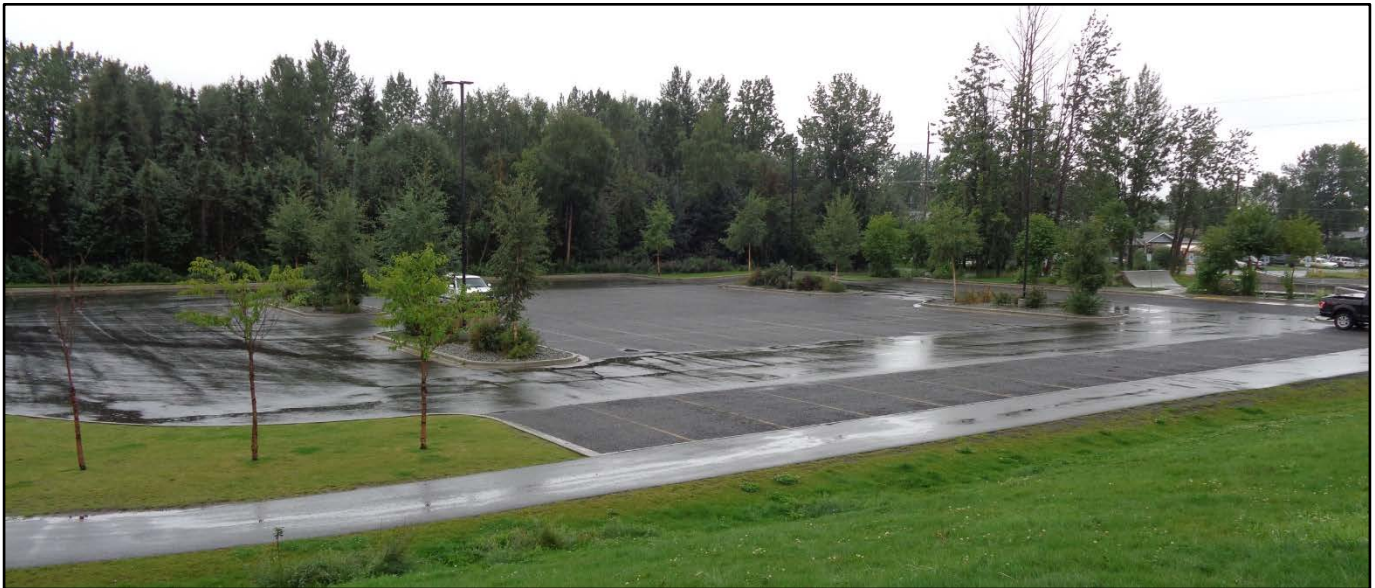
Figure 54: RJSP Parking Lot August 21 Site Visit

RJSP was visited on August 21 and on October 16 of 2018. Previous monitoring reports (2013 through 2016) have noted good drainage performance of this parking lot despite ongoing maintenance and site use concerns associated with the porous asphalt. The 2018 observations continue this general trend. An overview of the parking lot from the August site visit is provided in Figure 54 below.

The August 21 site visit occurred about 5:30 pm. It was actively raining at this time, and the site visit occurred near the end of a storm event that generated 0.72 inches of rain in a 24-hour period and over an inch of rain in a 48-hour period. (This event is described in Section 4.2 of this report.) All three sections of porous asphalt were observed to be draining well. Surface ponding was only noted at the edges of the porous asphalt, where runoff from the traditional asphalt was flowing onto the porous asphalt.

Previous monitoring reports have noted surface raveling of the porous asphalt. This continues to be a concern, but did not appear to be notably worse than previous observations. There did not appear to be signs of new asphalt wear or damage, such as rutting or depressions. Damage mentioned in previous reports, such as rutting on the parking lot's west side, was still present but did not appear to be worsened. Light debris and small rocks from the surface raveling were observed on the asphalt surface.

Despite the noted surface raveling and ongoing concerns with maintenance, the porous asphalt is still draining well and performing as intended. The surface raveling remains a concern. The small rocks that are loosened from the asphalt surface cause additional surface abrasion as they are driven on, which further compounds the raveling. Frequent sweeping of the parking lot may help reduce this issue, but resources for frequent sweeping are generally not available. The approved maintenance plan for this parking lot calls for two sweeps each year.

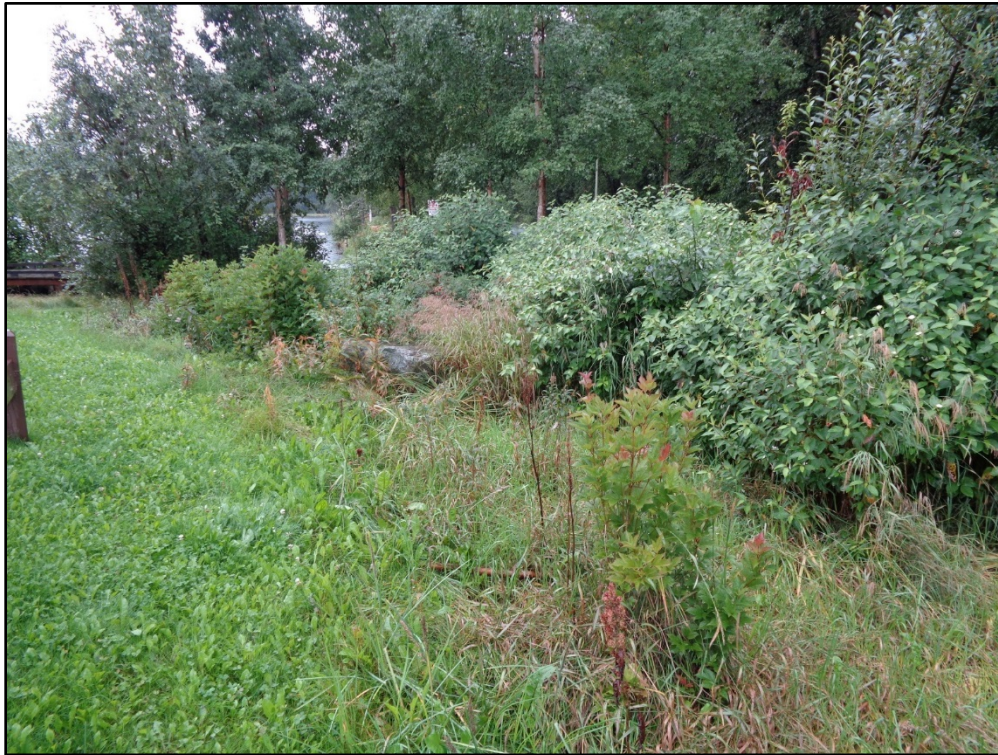
Figure 58: Taku Lake Rain Garden – August 21 Site Visit

Surface runoff from the contributing parking lot and additional impervious areas was flowing into the rain garden near the edge of the parking lot. Vegetation in the rain garden was thick and mature, and there was a large alder growing near the rain garden's main inlet area. There was no standing water observed in the rain garden. The rain garden's perforated subdrain was flowing about half full and discharging water to adjacent Taku Lake.

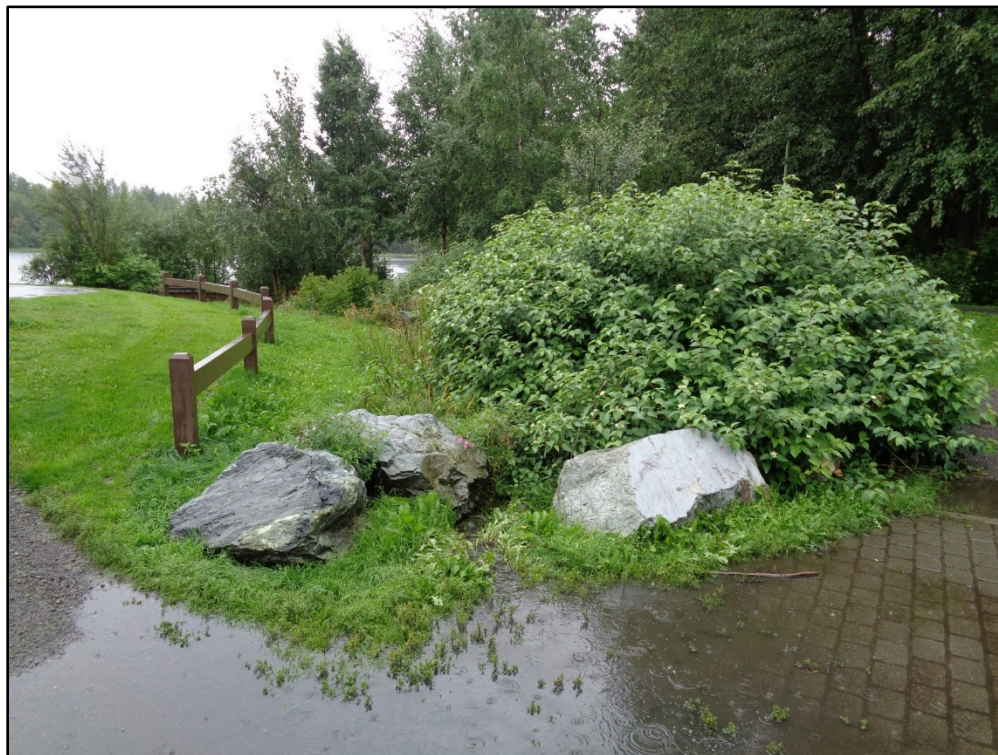
Figure 59: Parking Lot Flow to Rain Garden – August 21 Site Visit

The Taku Lake rain garden has been successfully treating, infiltrating, and detaining stormwater runoff for over 11 years. It is an excellent example of how successful bioretention can be, and it is a low-maintenance facility. Vegetation in this rain garden does not appear to be controlled, as the facility has become dominated by alders. While this is not expected to be negatively influencing the facility performance, the alders may be hindering the growth of other plant species.

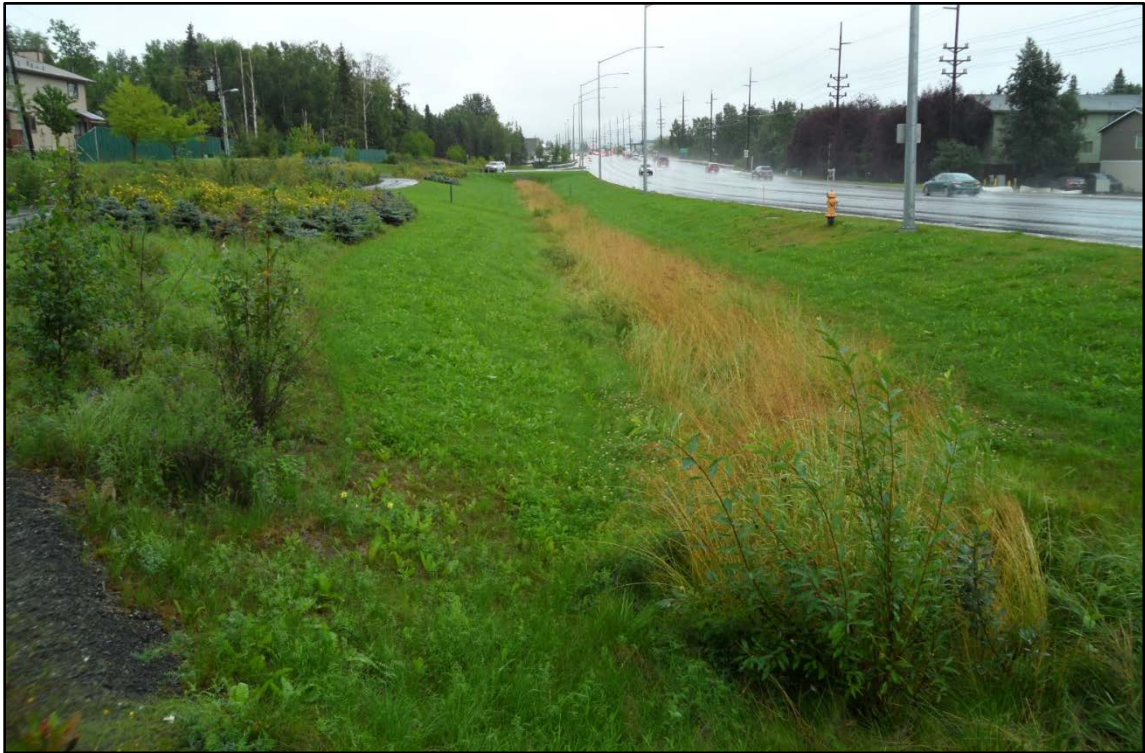
Figure 61: West Dowling Bioswale West End – August 21 Site Visit

Water was flowing into the swale from all but one of the 5 storm drain pipes that discharge water into the swale. Water in the swale was moving slowly to the east, toward the swale's outlet into Campbell Creek. The grasses on the swale side slopes had been mowed, but the vegetation in the facility bottom was un-mowed and tall, which helped slow water as it moved through the facility. In previous site visits, vegetation in the facility was primarily noted as grasses, but cattails were also observed at this site visit. Water from the swale was discharging into Campbell Creek via a rock-lined outlet channel at the far east end.

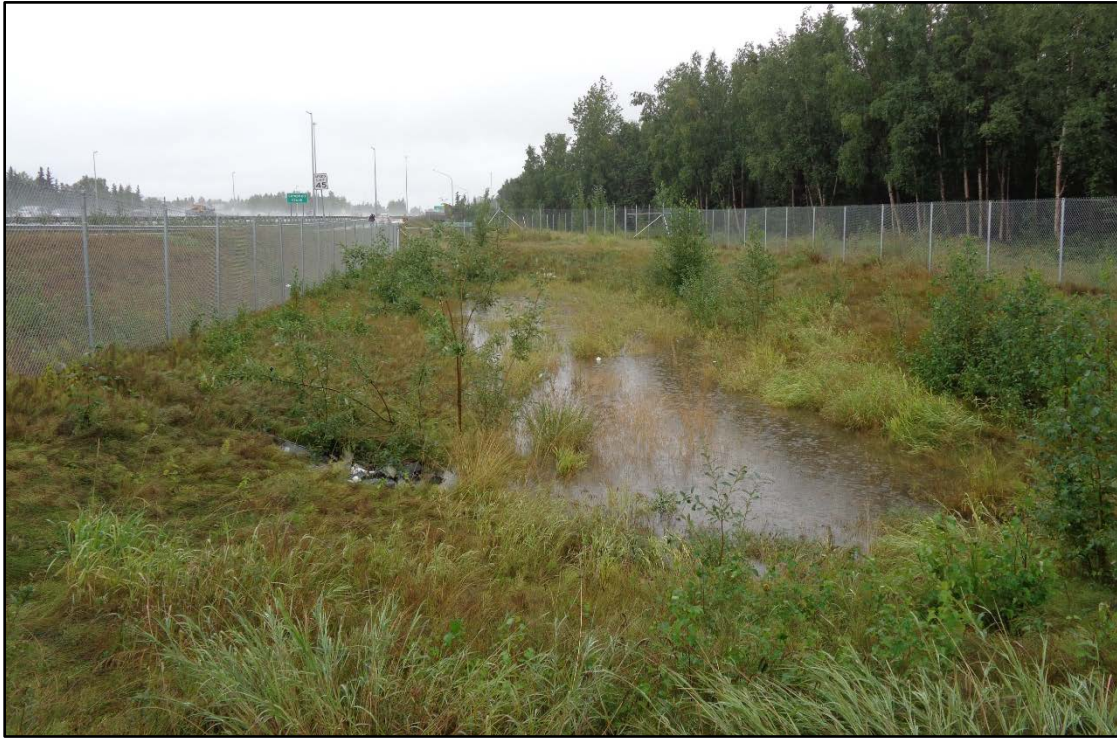
Figure 64: NSH Infiltration Basin – August 21 Site Visit

There was noticeably more mature vegetation around the pond than had been observed in previous years. Alders and tall grasses lined the pond's perimeter. Photos from the August site visit are provided in Figures 64 and 65.

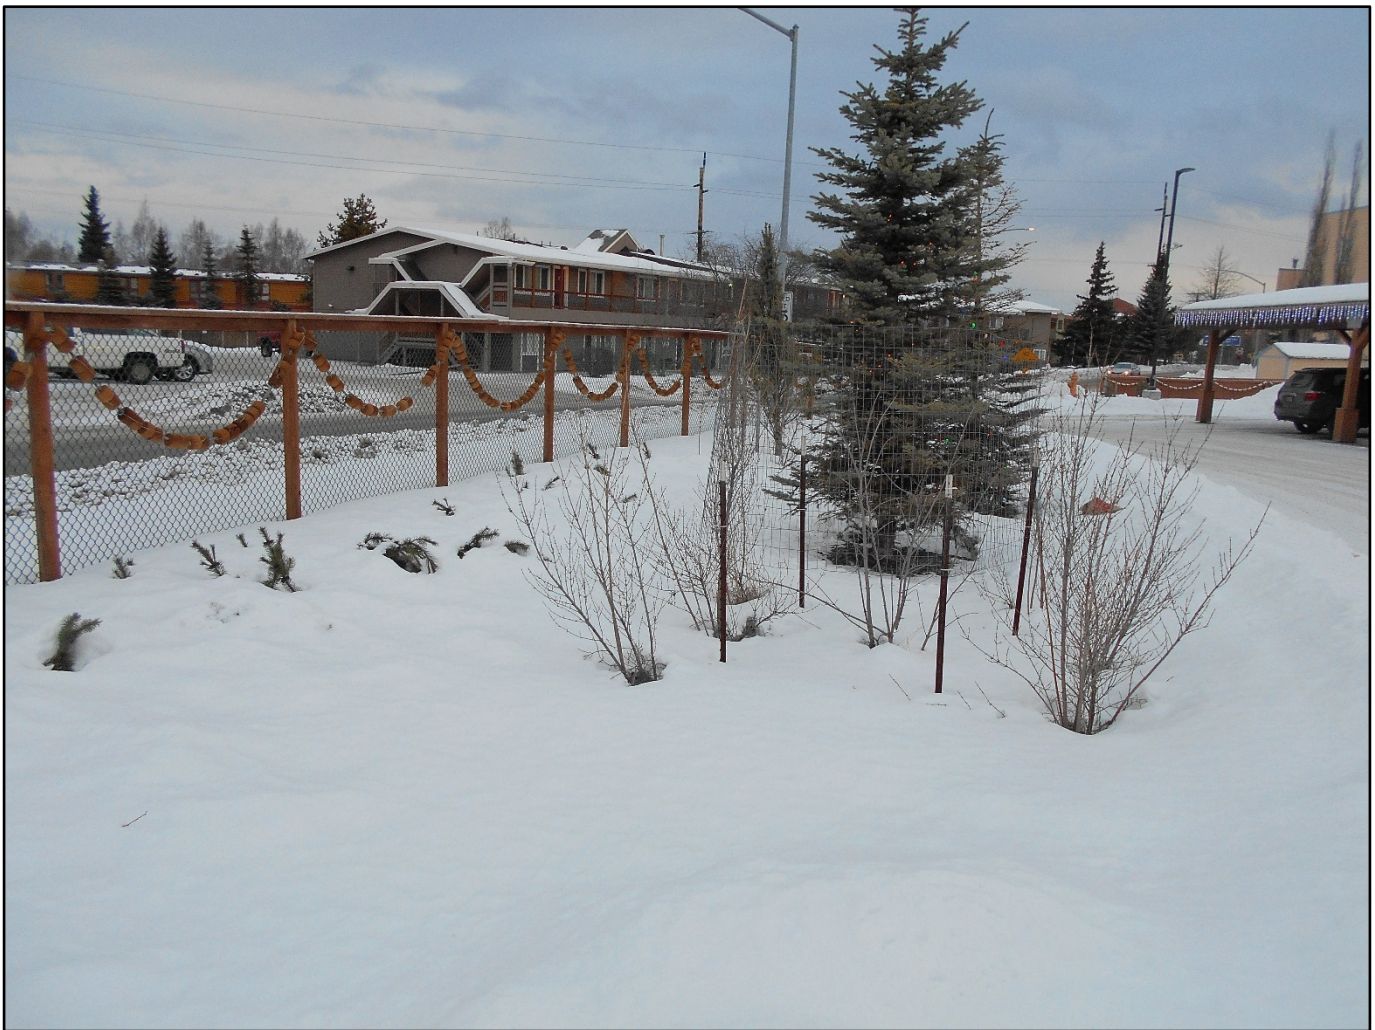
Figure 68: CFAB Rain Garden – January 2019 Site Visit

A winter inspection of the CFAB rain garden was completed to determine how the rain garden space was being used in the winter months and if the facility was used to store snow. The site visit was completed on January 24, 2019 at about 10:30 am. It was overcast with no precipitation and temperatures were in the mid-20s. The facility was covered in approximately two feet of snow. The snow on the rain garden surface was from natural accumulation and did not appear to be from plowing adjacent parking areas. Taller trees and shrubs were visible above the snow. The facility's beehive inlet was covered with snow, but was located and uncovered for reference.

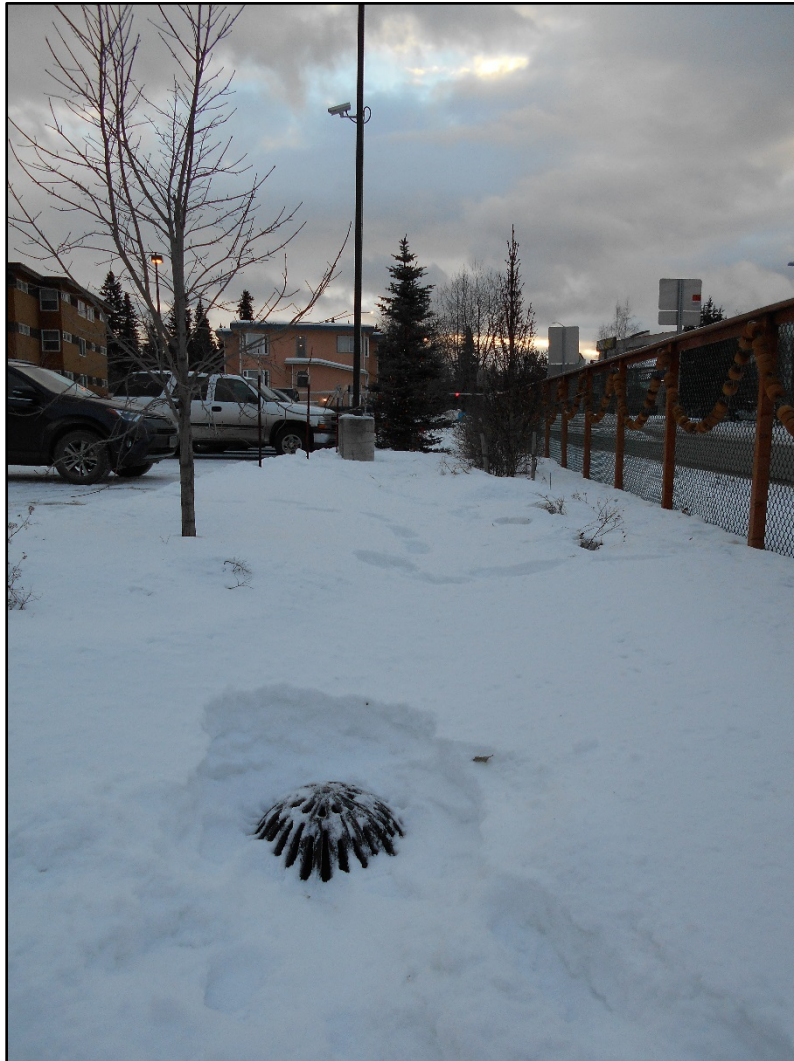
Figure 69: CFAB Rain Garden and Beehive Overflow – January 2019 Site Visit

The CFAB rain garden is not being used for snow storage or snow melt runoff treatment. This approach is likely helping to keep heavy sediment loading out of the rain garden, as it not known if the facility was designed for snowmelt loading. Snow that falls on the rain garden surface will be treated by the rain garden as it melts, or, if the underlying soil layers are frozen when the snow melts, snow melt will be directed to the beehive in the center of the rain garden.
