**Final Report**

# **State Farm Intersection Safety Studies**

*Date Prepared: July 2003*

*Authors: Gerry Forbes, President  
Geoffrey Ho, Senior Safety Specialist*

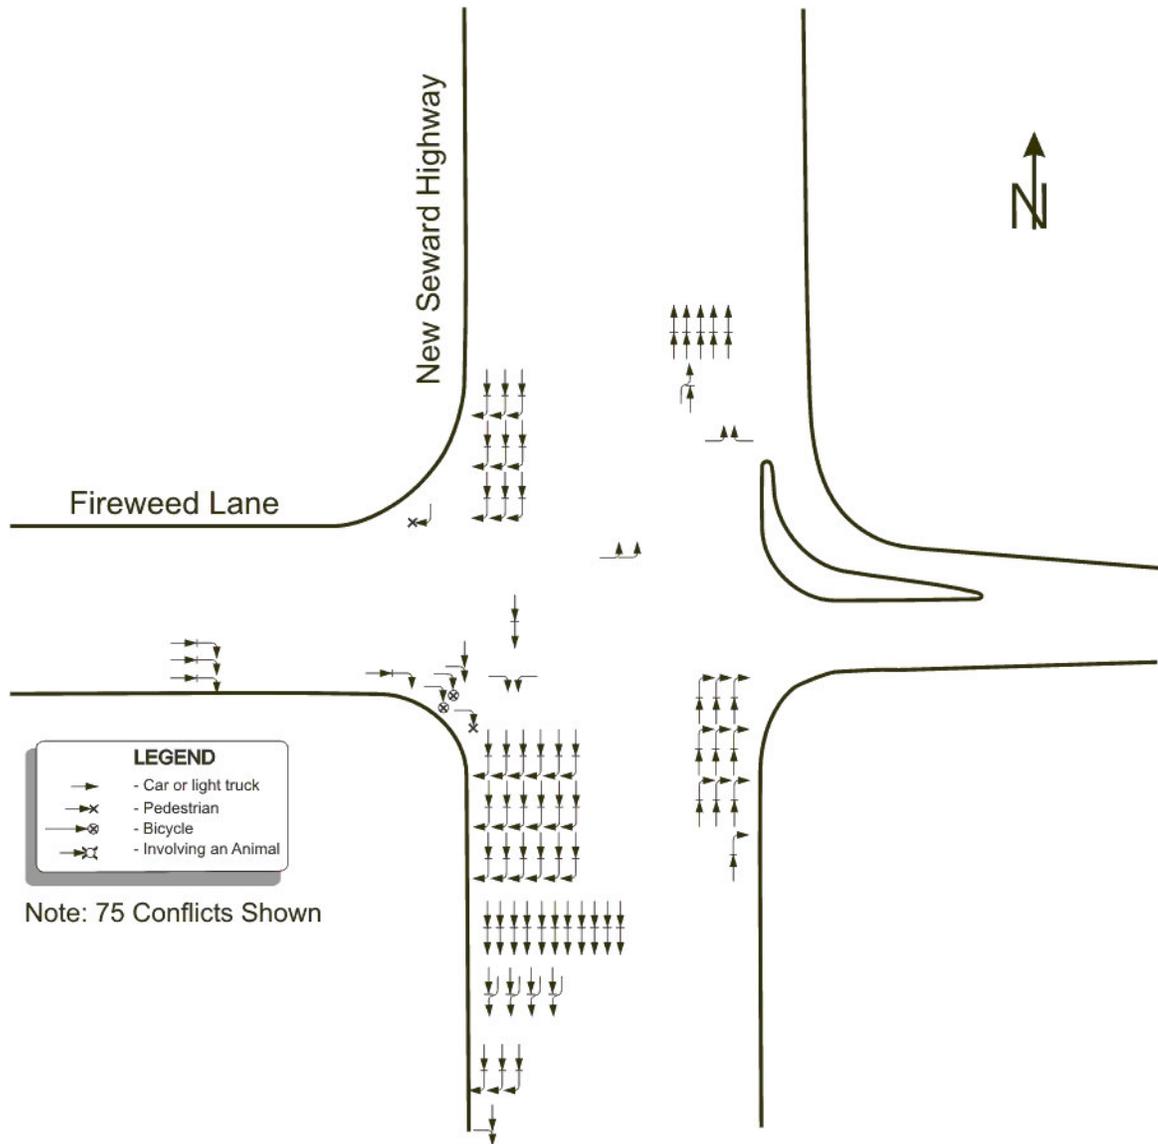
FIGURE 3.3: Traffic Conflict Diagram for NSH at Fireweed Lane

The spatial distribution of traffic conflicts is summarized in FIGURE 3.3. The results indicated that rear-end conflicts accounted for 81% of all observed conflicts. The majority of the rear-end conflicts were observed at the southbound approach and the exit leg, and were associated with the right-turn movements.

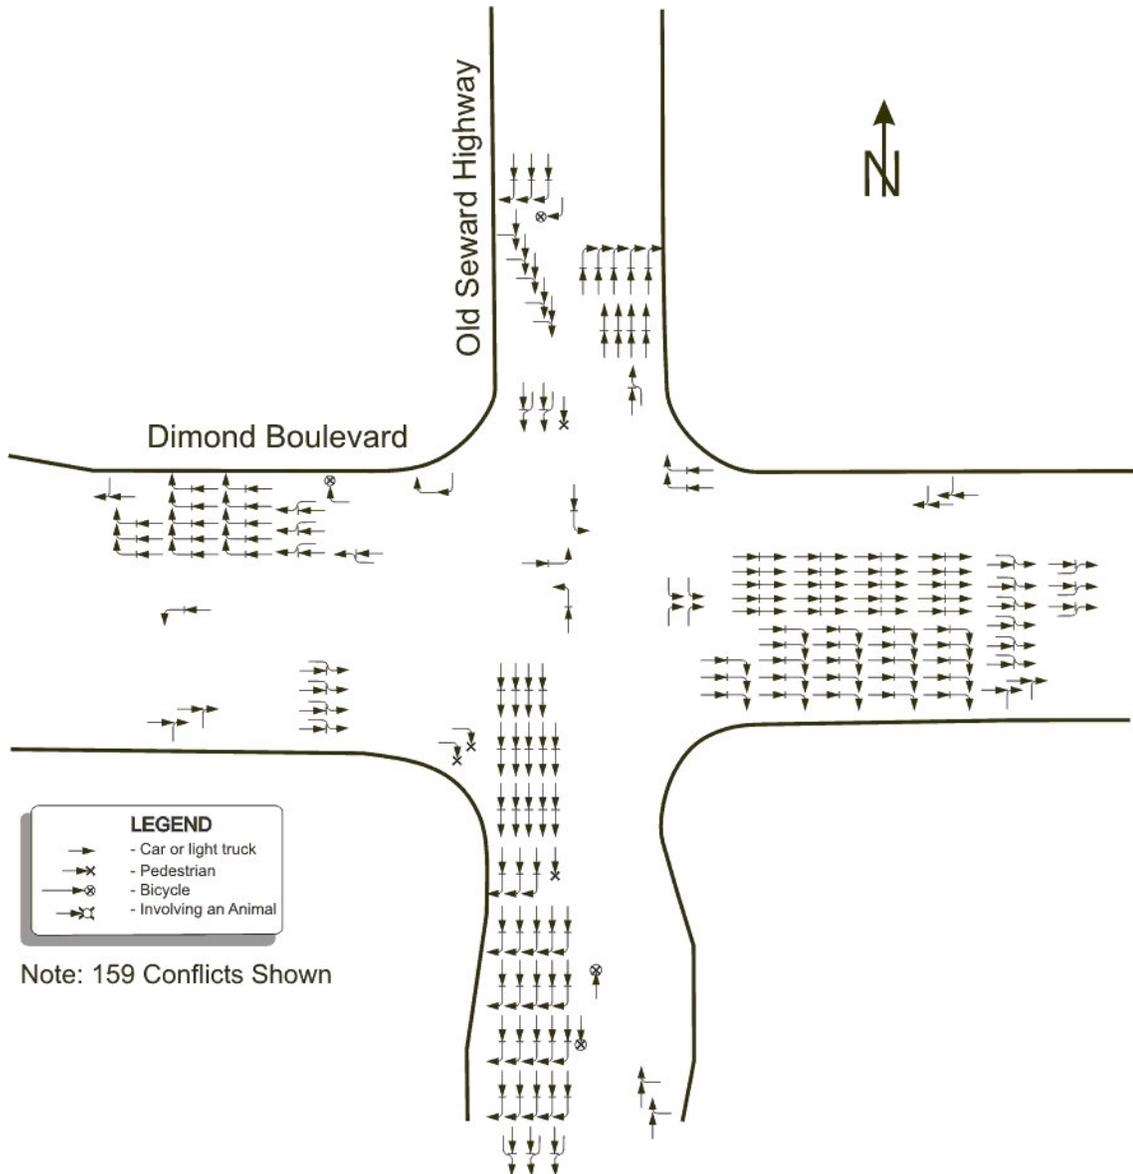
FIGURE 4.2: Traffic Conflict Diagram for OSH at Dimond Boulevard

The spatial distribution of traffic conflicts is summarized in FIGURE 4.2. The results indicated that rear-end conflicts accounted for 75% of all observed conflicts. The majority of the rear-end conflicts were observed at the southbound and eastbound exit legs, and were associated with the right-turn movements.

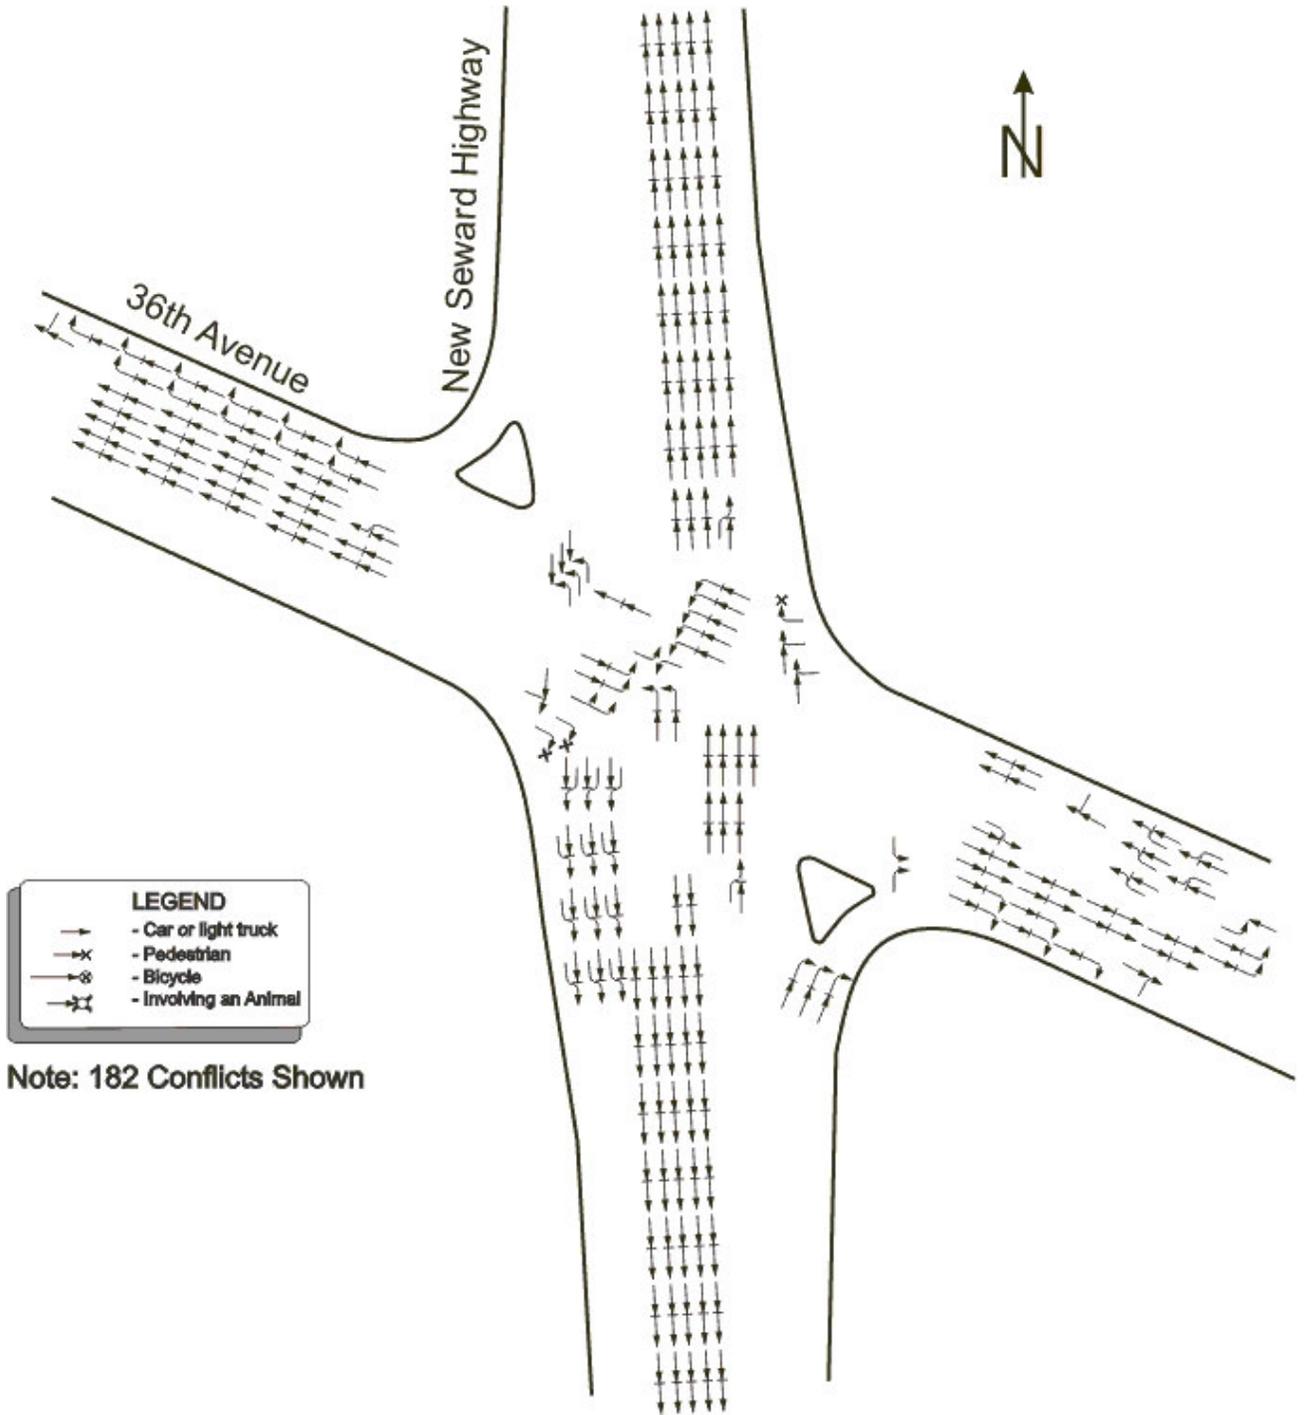
FIGURE 5.3: Traffic Conflict Diagram for NSH at 36<sup>th</sup> Avenue

The spatial distribution of traffic conflicts is summarized in FIGURE 5.3. The results indicated that rear-end conflicts accounted for 81% of all observed conflicts. The majority of the rear-end conflicts were observed at the northbound and southbound exit legs, and were associated lane changing or drivers following too close.
