**NAVIGATION CENTER & SHELTER FACILITIES
LOCATION STUDY**

**Volume 3
Recommended Renovations**

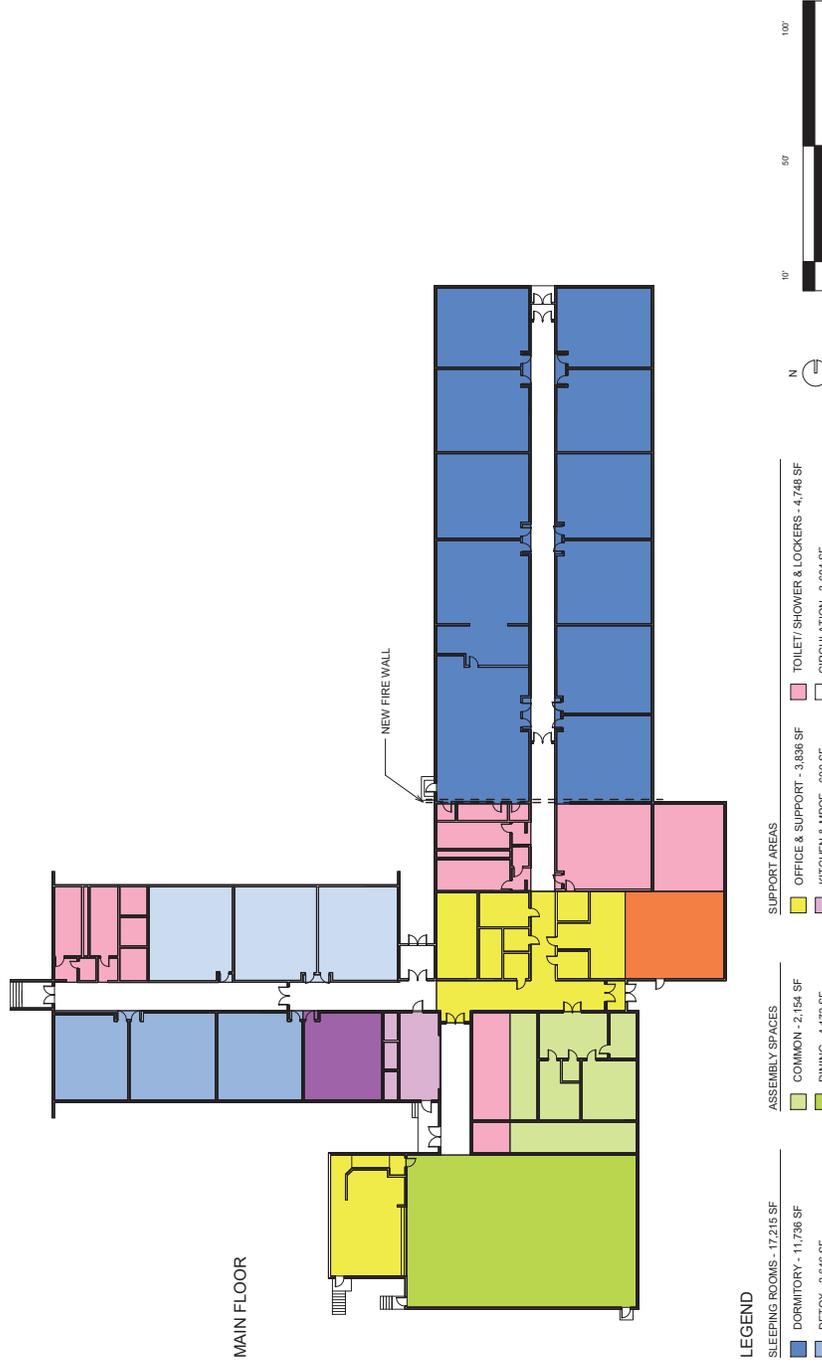
MAIN FLOOR

550 BRAGAW STREET PRELIMINARY CAPACITY ANALYSIS DIAGRAM

SCOPE: RENOVATION OF THE EXISTING SCHOOL BUILDING INTO A MASS SHELTER
 CAPACITY: TOTAL 38,213 SF (344 BEDS)

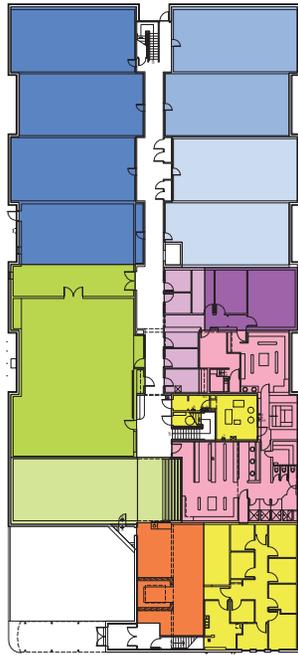
MAIN FLOOR

SCOPE: RENOVATION OF THE EXISTING GYMNASIUM BUILDING INTO A MASS SHELTER
CAPACITY: TOTAL 28,088 SF (249 BEDS)
