Municipality of Anchorage Geotechnical Advisory Commission Work Session

SEPTEMBER 13, 2022

2018 M_w 7.1 Anchorage Earthquake

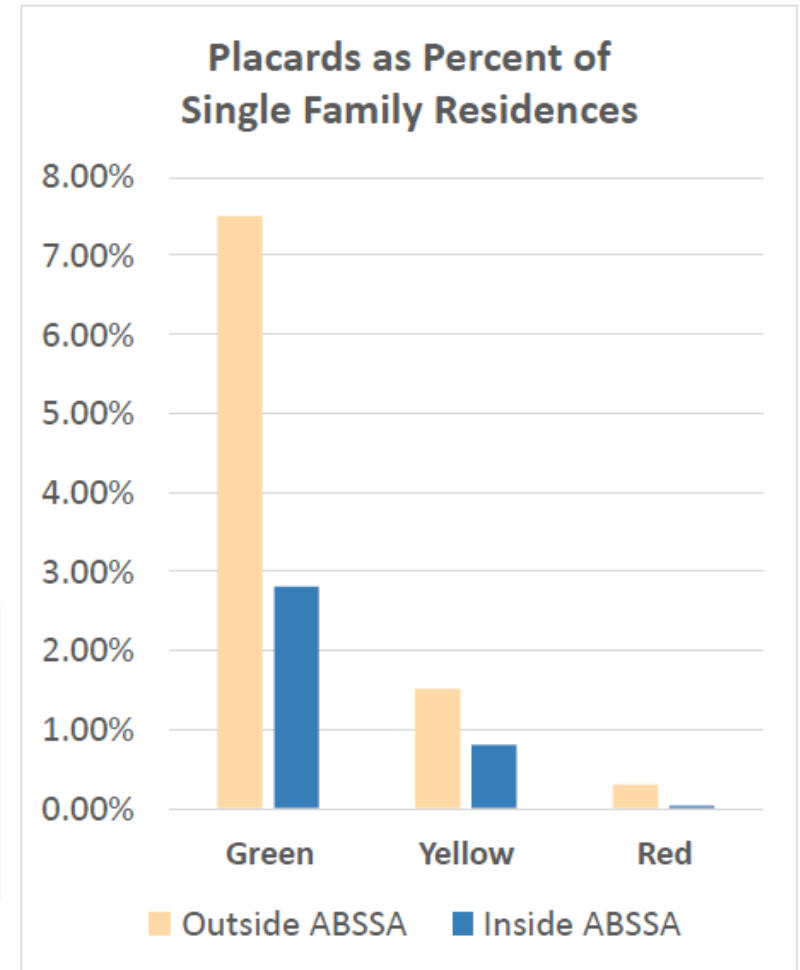
TOTALS	None	Green	Yellow	Red	Inspections	Total
Inside ABSSA	43506	1272	367	8	1647	45153
Outside ABSSA	9721	804	163	34	1001	10722
PERCENTAGES	None	Green	Yellow	Red	Inspections	
Inside ABSSA	96.35%	2.82%	0.81%	0.02%	3.65%	
Outside ABSSA	90.66%	7.50%	1.52%	0.32%	9.34%	
Ratio out/in:	0.94	2.66	1.87	17.90	2.56

The bottom row shows the ratio of the rates outside the ABSSA to the rates inside. At all 3 placard colors, the areas outside the ABSSA sustained much higher rates of damage.
