**MUNICIPALITY OF ANCHORAGE
GEOTECHNICAL HAZARDS ASSESSMENT
TECTONIC HAZARDS AND MAXIMUM EXPECTABLE
EARTHQUAKE INTENSITIES - ANCHORAGE**

MUNICIPALITY OF ANCHORAGE
 GEOTECHNICAL HAZARD ASSESSMENT
 SEISMICALLY INDUCED GROUND FAILURE
 ANCHORAGE

MUNICIPALITY OF ANCHORAGE
 GEOTECHNICAL HAZARD ASSESSMENT
 MASS WASTING - ANCHORAGE

MUNICIPALITY OF ANCHORAGE
 GEOTECHNICAL HAZARDS ASSESSMENT
 COASTAL EROSION, FLOODING AND WIND
 ANCHORAGE

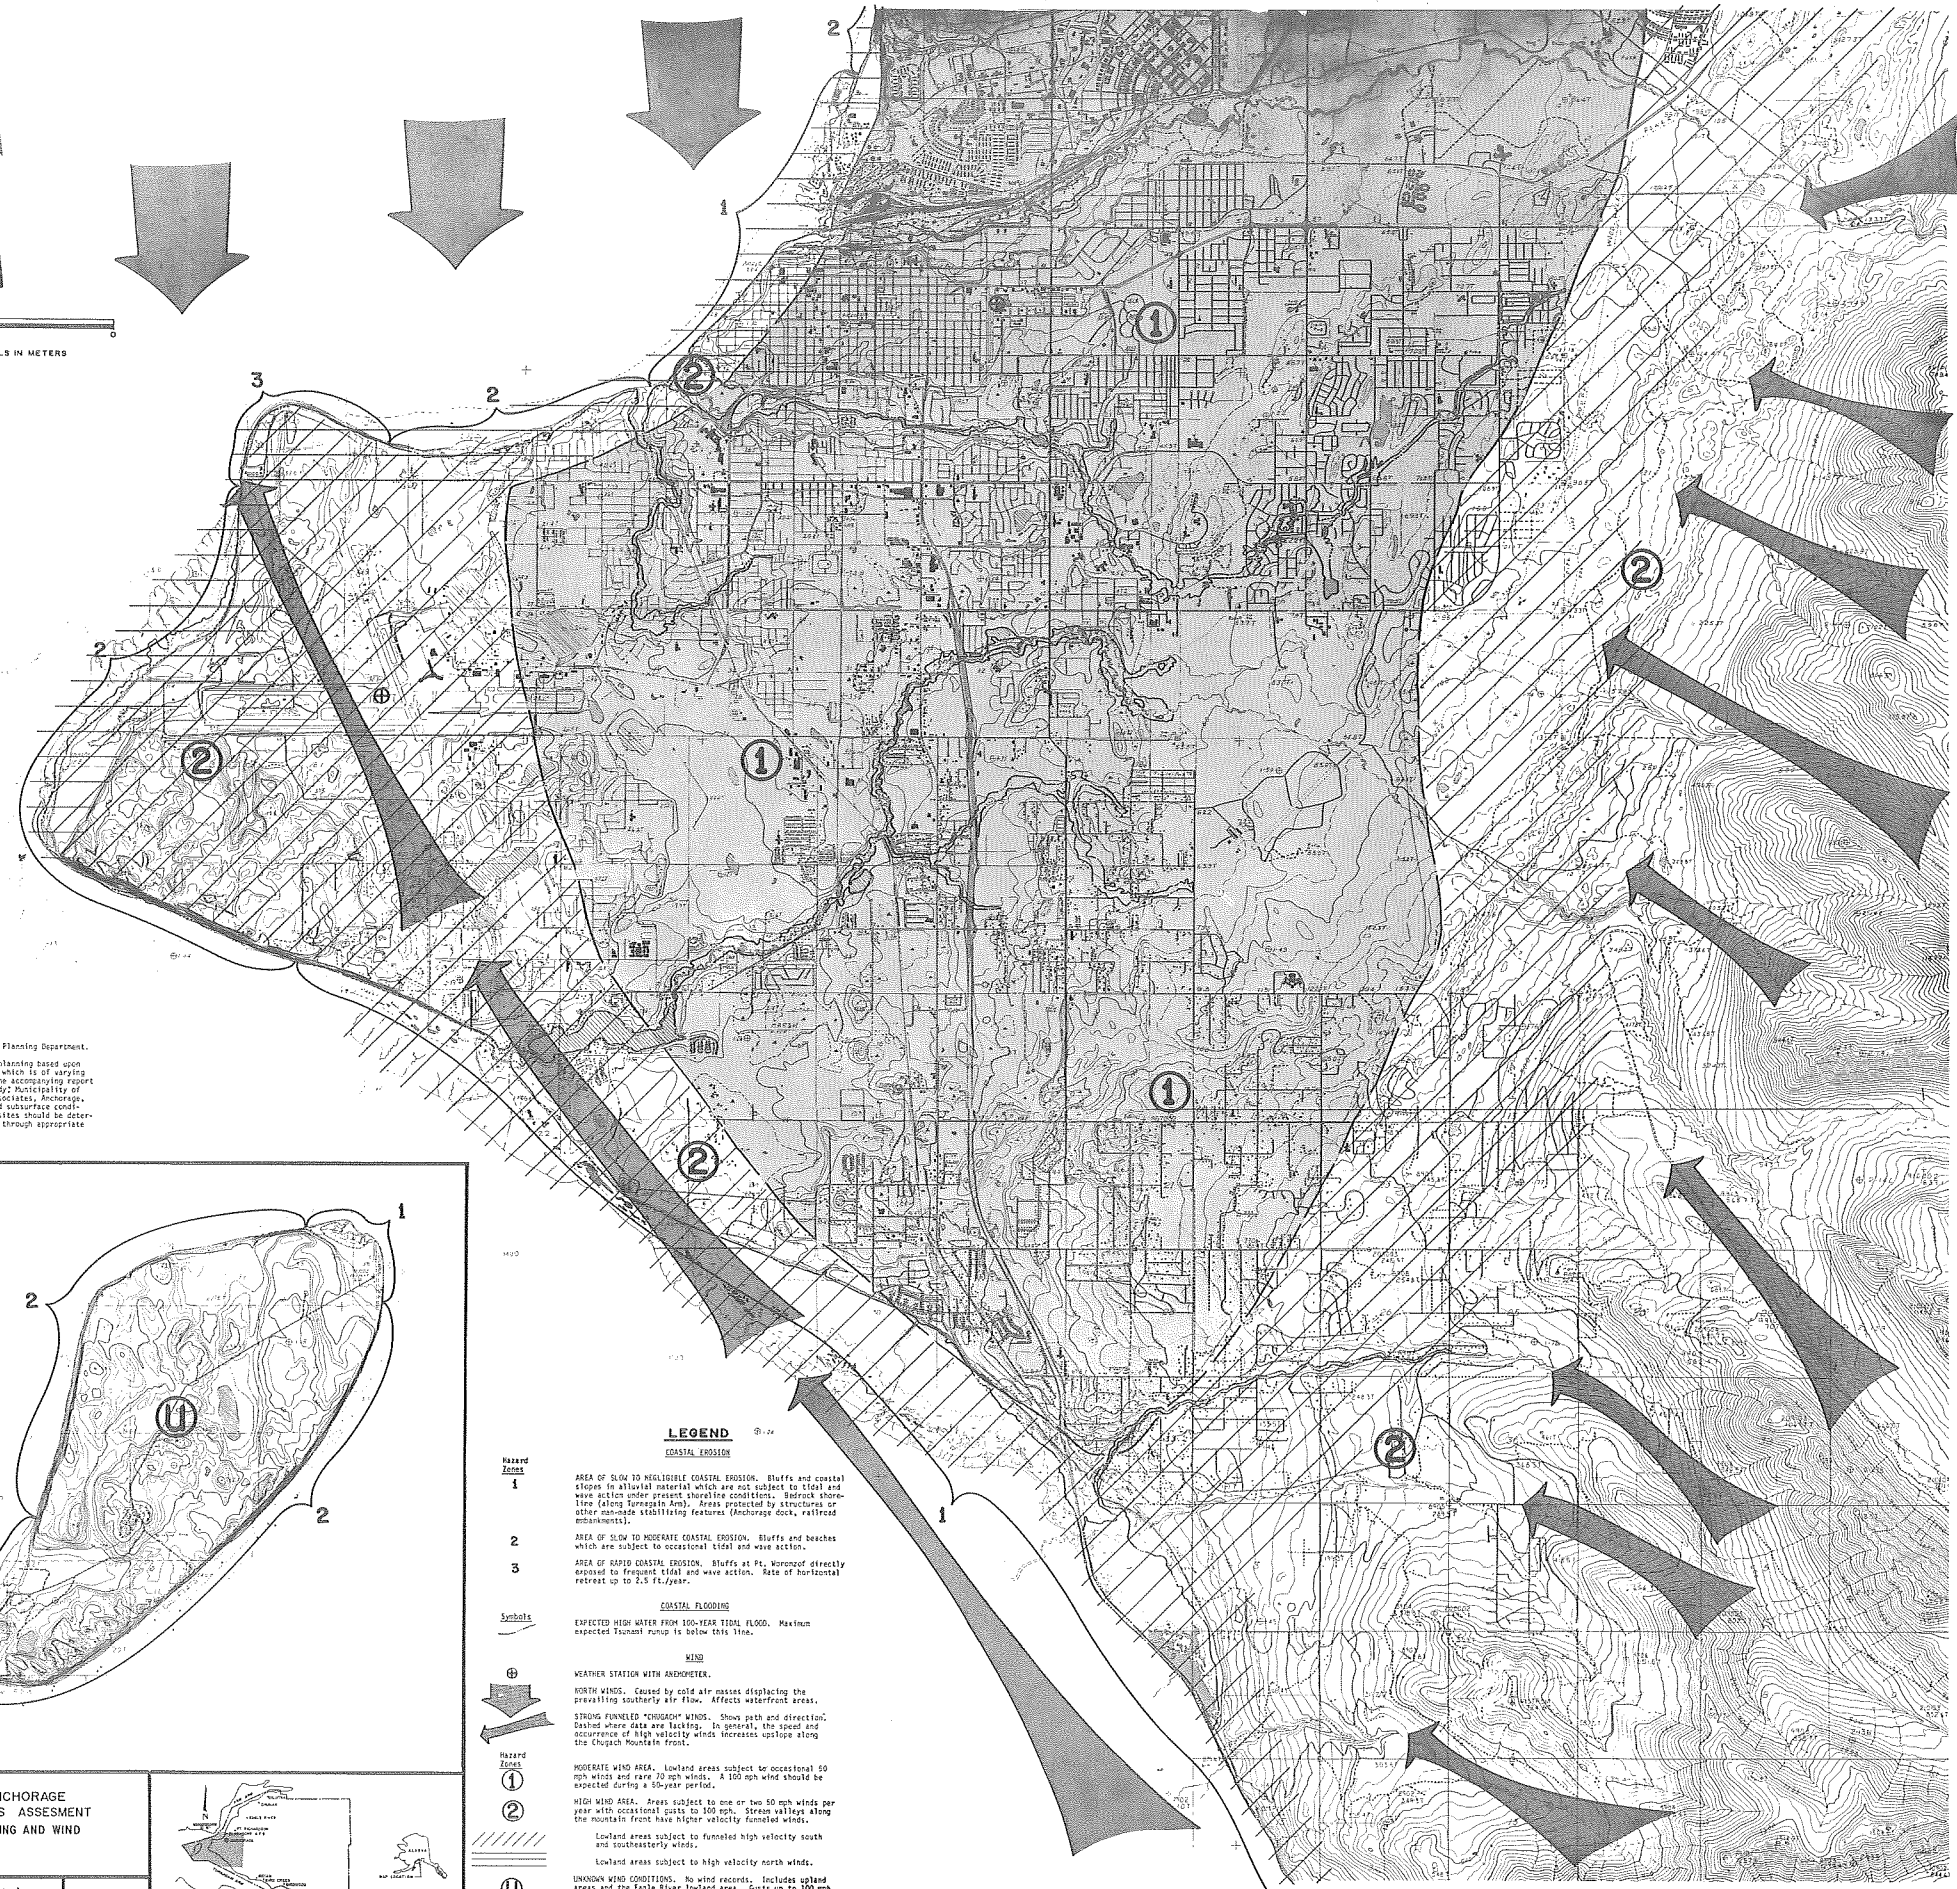
PLATE 4A
 Compiled by [signature]
 Checked by [signature]
 MARCH, 1979

1 AREA OF SLOW TO MODERATE COASTAL EROSION. Bluffs and coastal slopes in alluvial material which are not subject to tidal and wave action under present shoreline conditions. Bedrock shoreline (along Soropalee Arm). Areas protected by structures or other man-made stabilizing features (Anchorage dock, railroad embankments).

2 AREA OF SLOW TO MODERATE COASTAL EROSION. Bluffs and beaches which are subject to occasional tidal and wave action.

3 AREA OF RAPID COASTAL EROSION. Bluffs at Pt. Woronof directly exposed to frequent tidal and wave action. Rate of horizontal retreat up to 2.5 ft./year.

EXPECTED HIGH WATER FROM 100-YEAR TIDE FLOOD. Maximum expected tsunami runup is below this line.

NORTH WINDS. Caused by cold air masses displacing the prevailing southerly air flow. Affects waterfront areas.

STRONG FUNNELED "CHUGACH" WINDS. Show path and direction. Beached shore data are backing. In general, the speed and occurrence of high velocity winds increases upslope along the Chugach Mountain front.

1 MODERATE WIND AREA. Lowland areas subject to occasional 50 mph winds and rare 70 mph winds. A 100 mph wind should be expected during a 50-year period.

2 HIGH WIND AREA. Areas subject to one or two 50 mph winds per year with occasional gusts to 100 mph. Steep valleys along the mountain front have higher velocity funneled winds. Lowland areas subject to funneled high velocity south and southeasterly winds.

UNKNOWN WIND CONDITIONS. No wind records. Includes upland areas and the Eagle River lowland areas. Gusty up to 100 mph should be expected in the lowlands, and some high areas in the Chugach Mountains probably get funneled winds exceeding 100 mph.

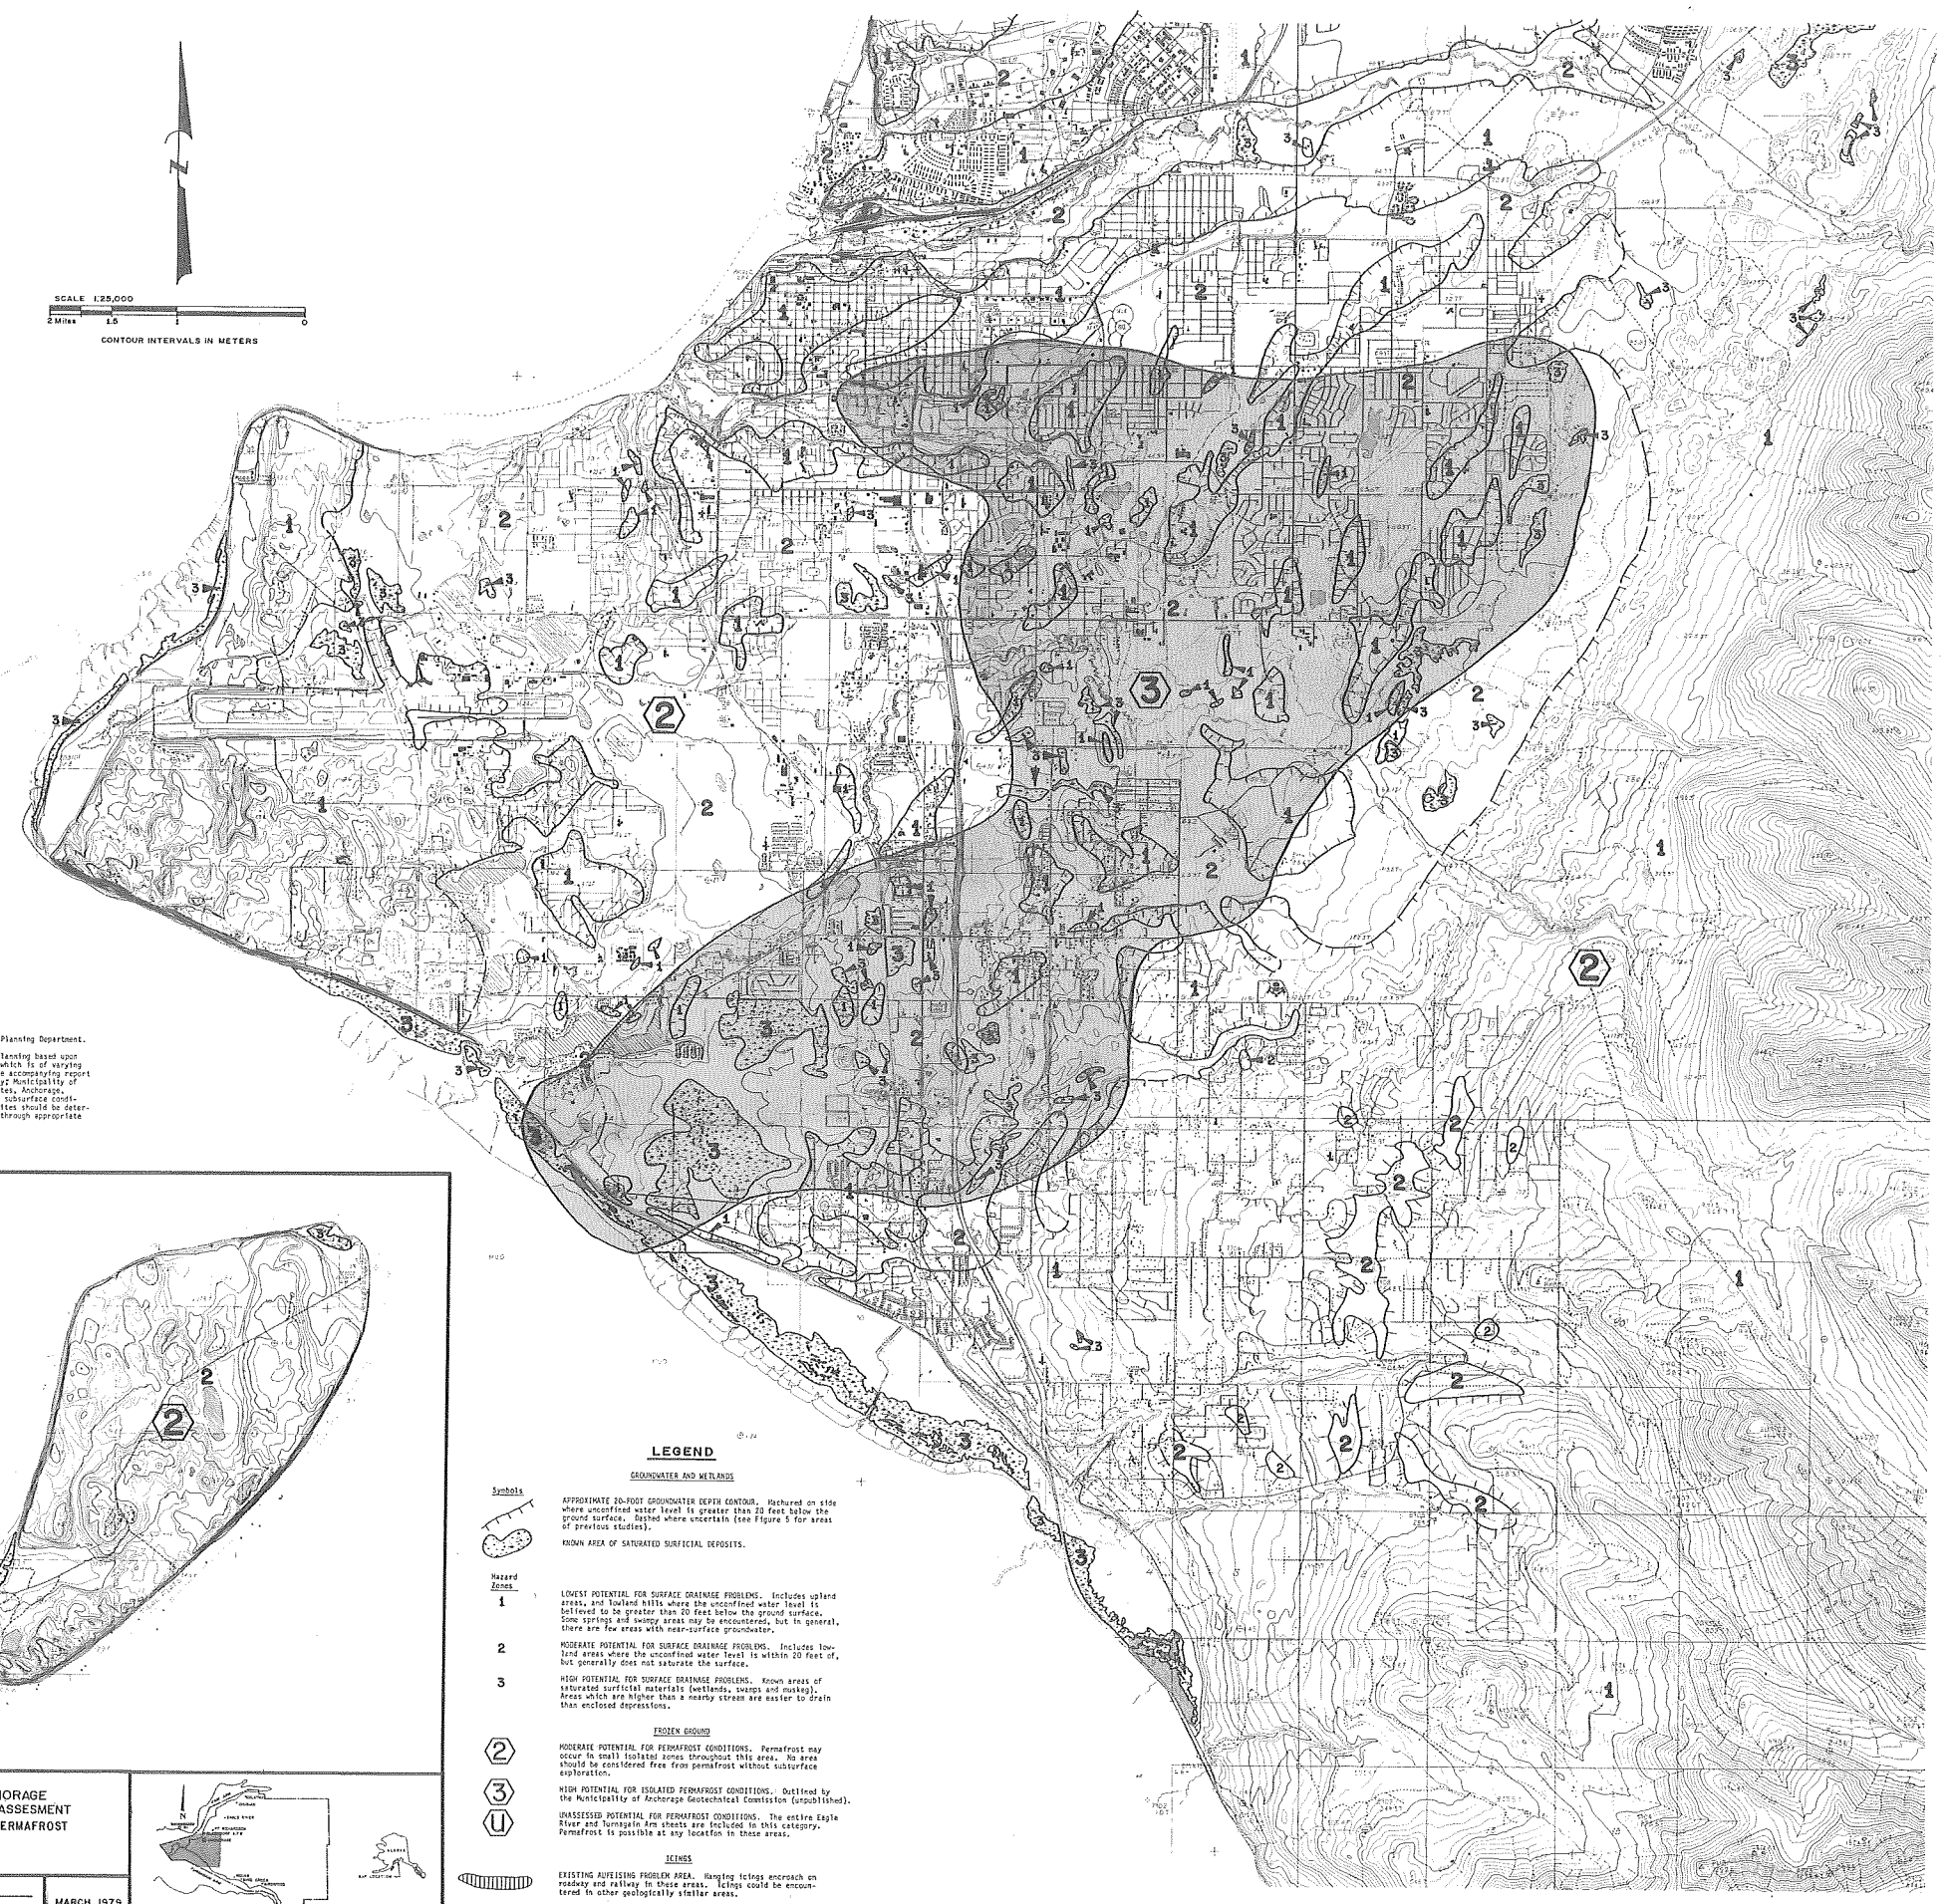
PLATE **5A** Compiled by Ted MARCH, 1979
 Checked by W

MUNICIPALITY OF ANCHORAGE
 GEOTECHNICAL HAZARDS ASSESSMENT
 GROUND WATER, ICINGS AND PERMAFROST
 ANCHORAGE

APPROXIMATE 20-FOOT GROUNDWATER DEPTH CONTOUR. Measured on site where unconfined water level is greater than 20 feet below the ground surface. Dashed where uncertain (see Figure 5 for areas of ground studies).

1 LOWEST POTENTIAL FOR SURFACE DRAINAGE PROBLEMS. Includes upland areas, and lowland hills where the unconfined water level is believed to be greater than 20 feet below the ground surface. Some springs and swampy areas may be encountered, but in general, there are few areas with near-surface groundwater.

2 MODERATE POTENTIAL FOR SURFACE DRAINAGE PROBLEMS. Includes lowland areas where the unconfined water level is within 20 feet of, but generally does not saturate the surface.

3 HIGH POTENTIAL FOR SURFACE DRAINAGE PROBLEMS. Known areas of saturated surficial materials (wetlands, swamps and meadows). Areas which are higher than a nearby stream are easier to drain than enclosed depressions.

2 MODERATE POTENTIAL FOR PERMAFROST CONDITIONS. Permafrost may occur in small isolated zones throughout this area. No area should be considered free from permafrost without subsurface exploration.

3 HIGH POTENTIAL FOR ISOLATED PERMAFROST CONDITIONS. Outlined by the Municipality of Anchorage Geotechnical Commission (unpublished).

U UNASSESSED POTENTIAL FOR PERMAFROST CONDITIONS. The entire Eagle River and Turnagain Arm sheets are included in this category. Permafrost is possible at any location in these areas.

EXISTING ADVISING PROBLEM AREA. Hanging icings encroach on roadway and railway in these areas. Icings could be encountered in other geologically similar areas.
