**MUNICIPALITY OF ANCHORAGE
GEOTECHNICAL HAZARDS ASSESMENT
TECTONIC HAZARDS AND MAXIMUM EXPECTABLE
EARTHQUAKE INTENSITIES - TURNAGAIN ARM**

PLATE **1C**

MARCH, 1979
Rev. 6/79

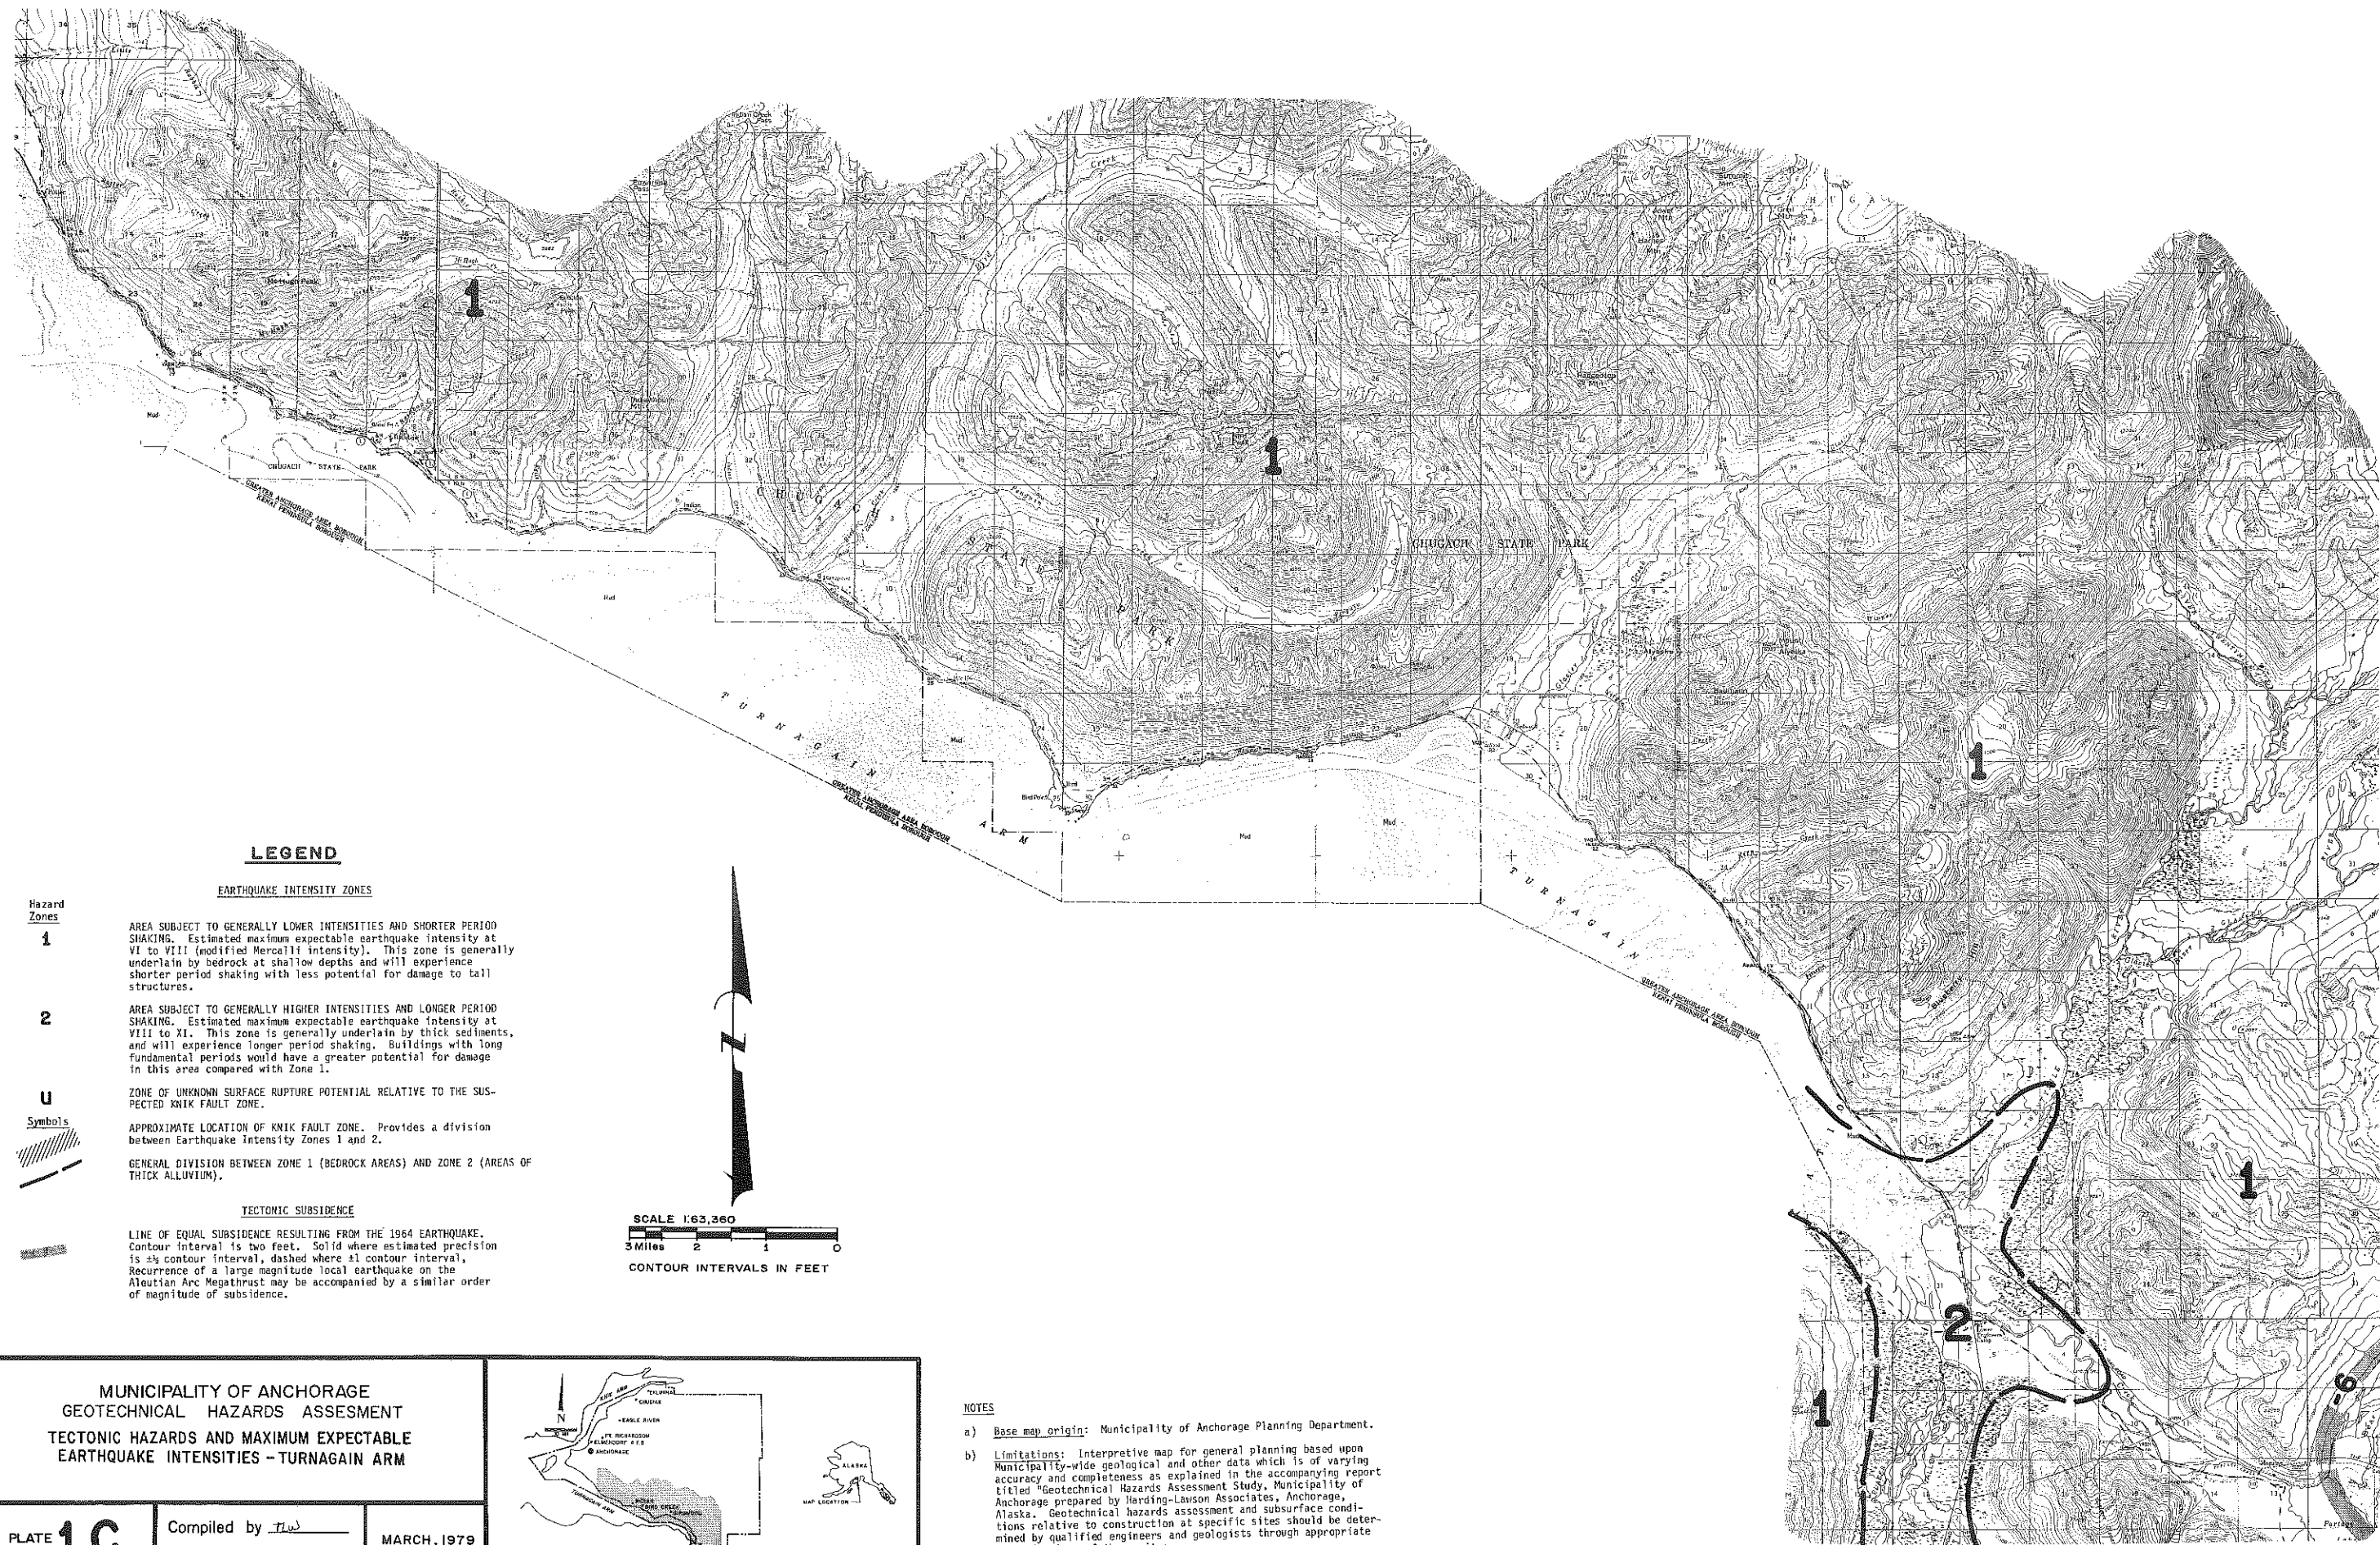
AREA SUBJECT TO GENERALLY LOWER INTENSITIES AND SHORTER PERIOD SHAKING. Estimated maximum expectable earthquake intensity at VI to VIII (modified Mercalli intensity). This zone is generally underlain by bedrock at shallow depths and will experience shorter period shaking with less potential for damage to tall structures.

AREA SUBJECT TO GENERALLY HIGHER INTENSITIES AND LONGER PERIOD SHAKING. Estimated maximum expectable earthquake intensity at VIII to XI. This zone is generally underlain by thick sediments, and will experience longer period shaking. Buildings with long fundamental periods would have a greater potential for damage in this area compared with Zone 1.

ZONE OF UNKNOWN SURFACE RUPTURE POTENTIAL RELATIVE TO THE SUSPECTED KNIK FAULT ZONE.

APPROXIMATE LOCATION OF KNIK FAULT ZONE. Provides a division between Earthquake Intensity Zones 1 and 2.

LINE OF EQUAL SUBSIDENCE RESULTING FROM THE 1964 EARTHQUAKE. Contour interval is two feet. Solid where estimated precision is $\pm 1/2$ contour interval, dashed where ± 1 contour interval. Recurrence of a large magnitude local earthquake on the Aleutian Arc Megathrust may be accompanied by a similar order of magnitude of subsidence.
