MUNICIPALITY OF ANCHORAGE

Development Services Department

Re: Proposed Amendment to ASME A17.1-2019 Section 2.7.6.2

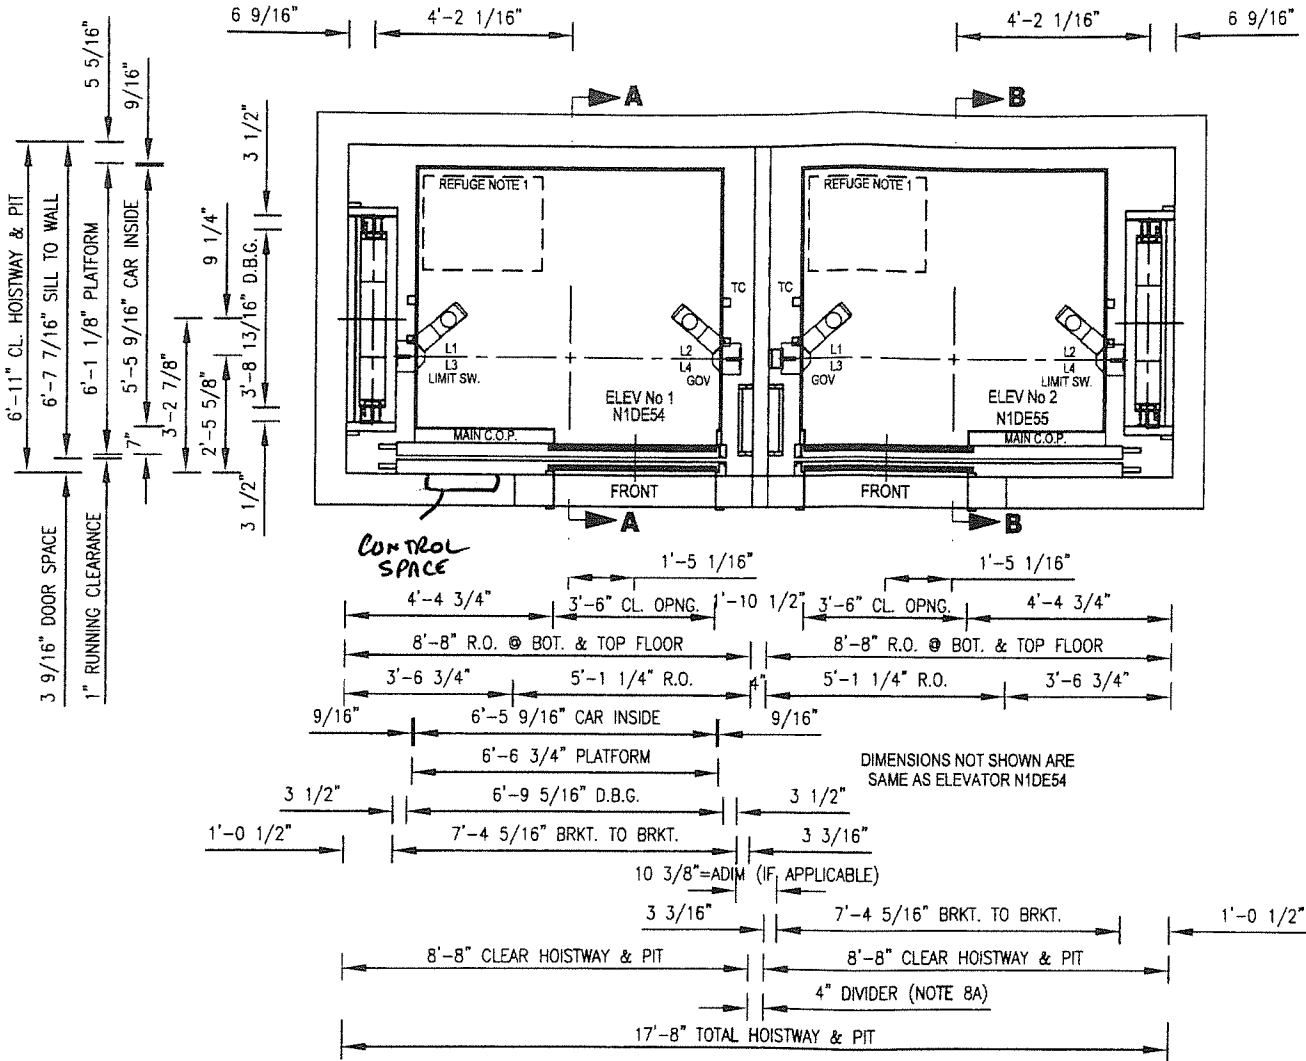
PLAN VIEW

A17.1 2022 FIRE EQUIPMENT UPDATE
IN JURISDICTIONS ENFORCING A17.1-2022/B44:22 OR LATER EDITIONS OF THE ELEVATOR & ESCALATOR SAFETY CODE, HOISTWAY LIGHTING SHALL BE PROVIDED AND INSTALLED BY OTHERS IN LOCATIONS THAT DO NOT INTERFERE WITH ELEVATOR EQUIPMENT. COORDINATE LOCATIONS WITH YOUR LOCAL OTIS REPRESENTATIVE AND REFER TO THE WORK BY OTHERS DOCUMENTATION FOR ADDITIONAL REQUIREMENTS.

A17.1 2022 FIRE EQUIPMENT UPDATE
IN JURISDICTIONS ENFORCING A17.1-2022/B44:22 OR LATER EDITIONS OF THE ELEVATOR & ESCALATOR SAFETY CODE, AND WHERE EMERGENCY RESPONDER RADIO COMMUNICATION DEVICES (COAX CABLE AND ACCESS PANELS) ARE LOCATED IN THE HOISTWAY, THESE DEVICES SHALL BE INSTALLED IN A LOCATION THAT DOES NOT INTERFERE WITH ELEVATOR EQUIPMENT.

A17.1 2019 FIRE EQUIPMENT UPDATE
IN JURISDICTIONS ENFORCING A17.1-2019/B44:19 OR LATER EDITIONS OF THE ELEVATOR & ESCALATOR SAFETY CODE, AND WHERE FIRE ALARM INITIATING DEVICES ARE LOCATED IN THE HOISTWAY, PLEASE REFER TO THE PWB0 INSTRUCTIONS FOR PANEL RATING AND LOCATION.

REFUGE NOTE 1
TYPICAL TOP OF CAR REFUGE SPACE 5.4 SQ. FT.
WITH NO SIDE LESS THAN 2'-0" AND HEIGHT NO LESS THAN 3'-7".

NOTE 8A
A STEEL SEPARATOR BEAM TO BE PROVIDED (NOT BY OTIS) AT EACH FLOOR AND AT THE TOP OF THE HOISTWAY. DISTANCE BETWEEN SEPARATOR BEAMS NOT TO EXCEED THE MAXIMUM RAIL BRACKET SPACING SHOWN ON DRAWING.
