MERRILL FIELD AIRPORT MASTER PLAN UPDATE AND NOISE STUDY

Merrill Field Airport
Municipality of Anchorage
Final December 2016

HDR, Inc.

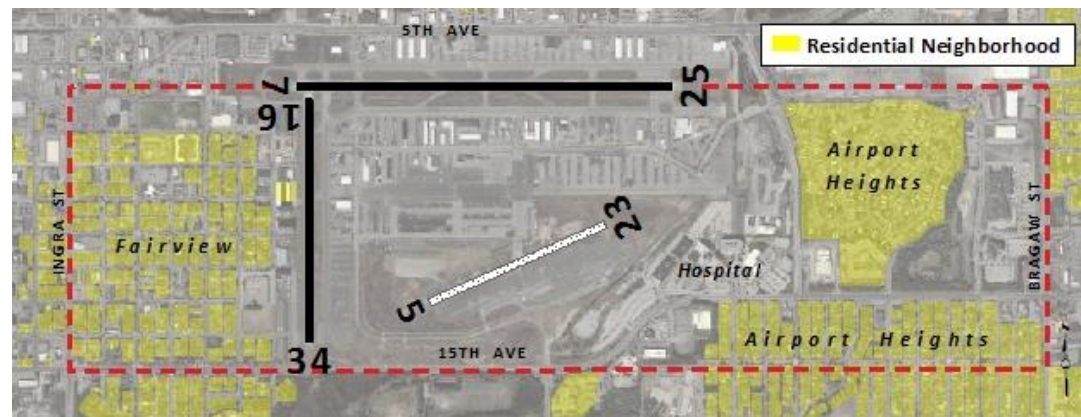
Figure 2-21 “Fly Friendly” Traffic Pattern

- ▶ Utilize the entire length of the runway; do not request intersection departures.
- ▶ Follow the established traffic pattern Figure 2-21; do not make an early cross wind turn on departure.
- ▶ Maintain the lowest propeller RPM setting necessary for safe flight; do not over power your aircraft.
- ▶ Plan training activity during daytime hours; do not conduct training activities (touch-and-goes) during late night hours.
- ▶ For helicopters, land long on Runway 7/25, use Runway 16/34 only when wind dictates and/or Runway 7/25 is closed. Land long (between Taxiways R and Q when northbound), follow the greenbelt instead of going straight in. Use steeper ascent and descent angles when practicable.

Source: MOA Merrill Field Fly-Friendly Noise Reduction Guidelines. Merrill Field ATCT Letter to Airmen No. 11-01.

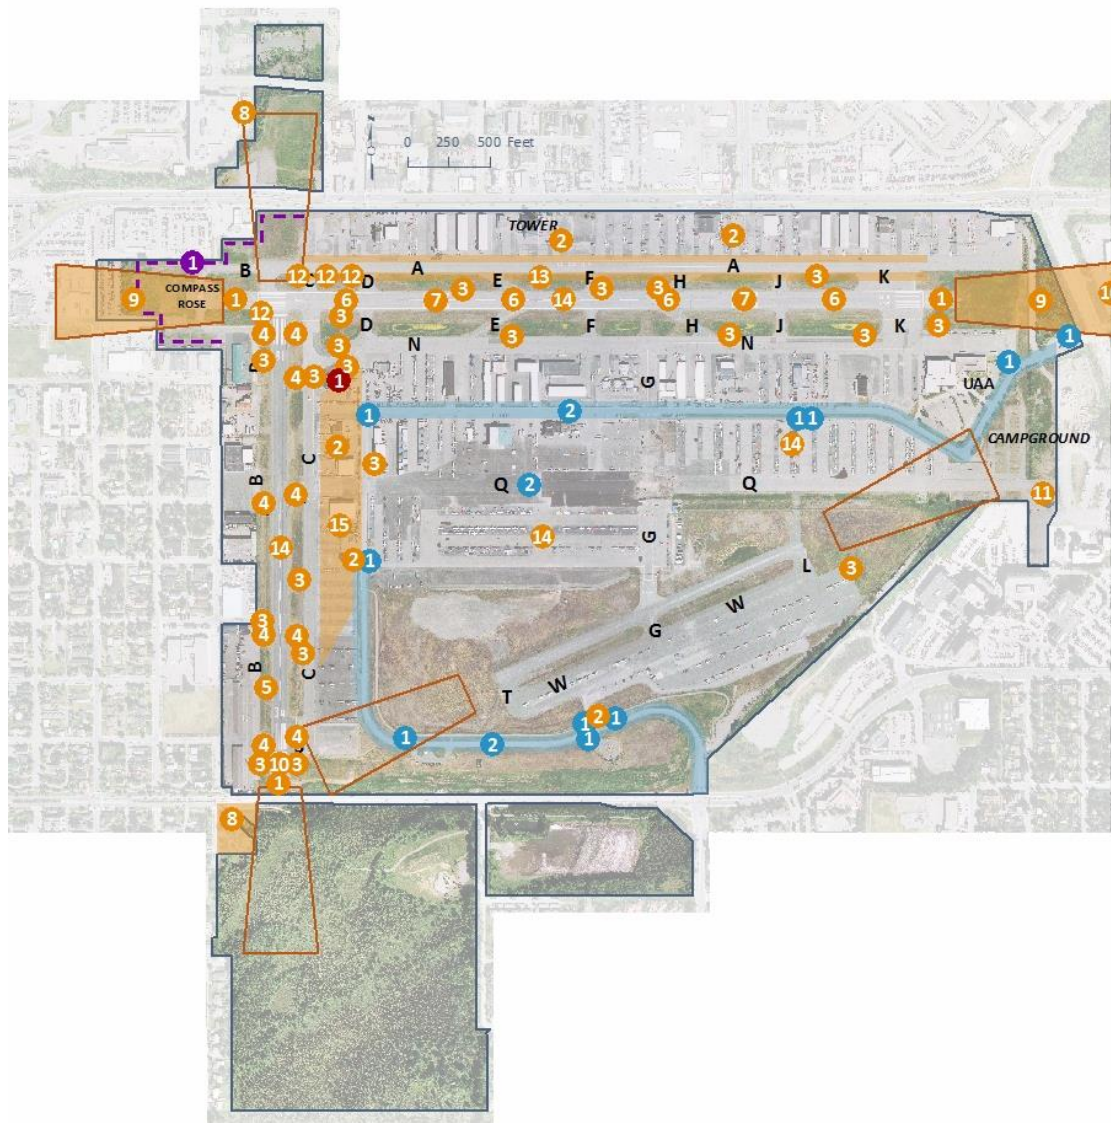
Figure 5-1 Safety, Standards, and Asset Preservation

As shown in Figure 5-1, this alternative consists of improvements in the following categories:

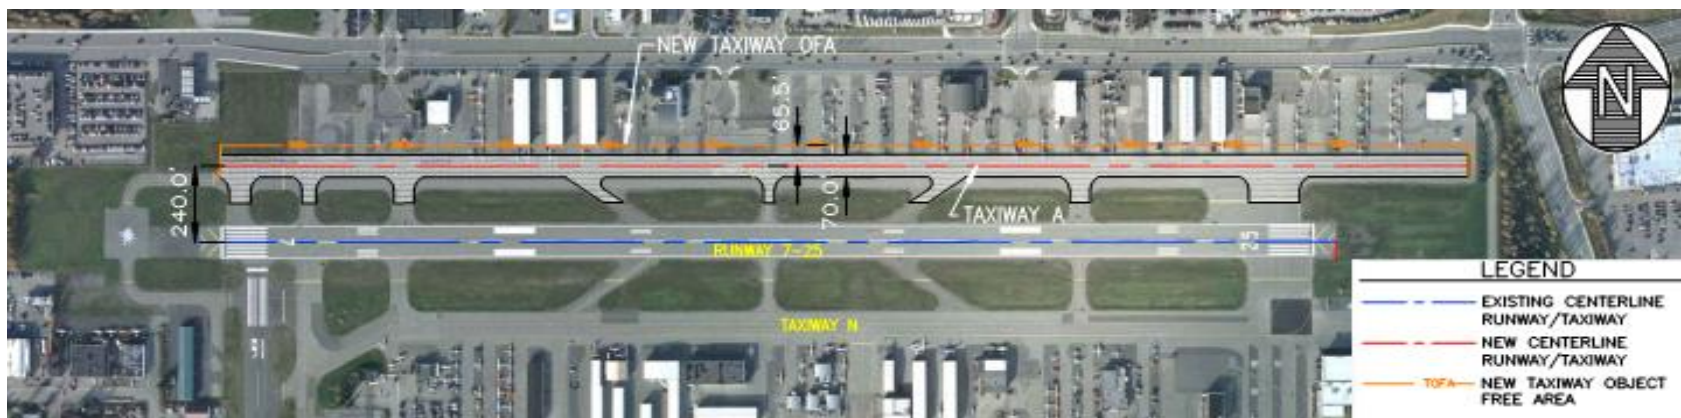
Figure 6-8 Increase Separation between Runway 7/25 and Taxiway A, Option A

As shown in Figure 6-8, this option would relocate Taxiway A 40 feet north

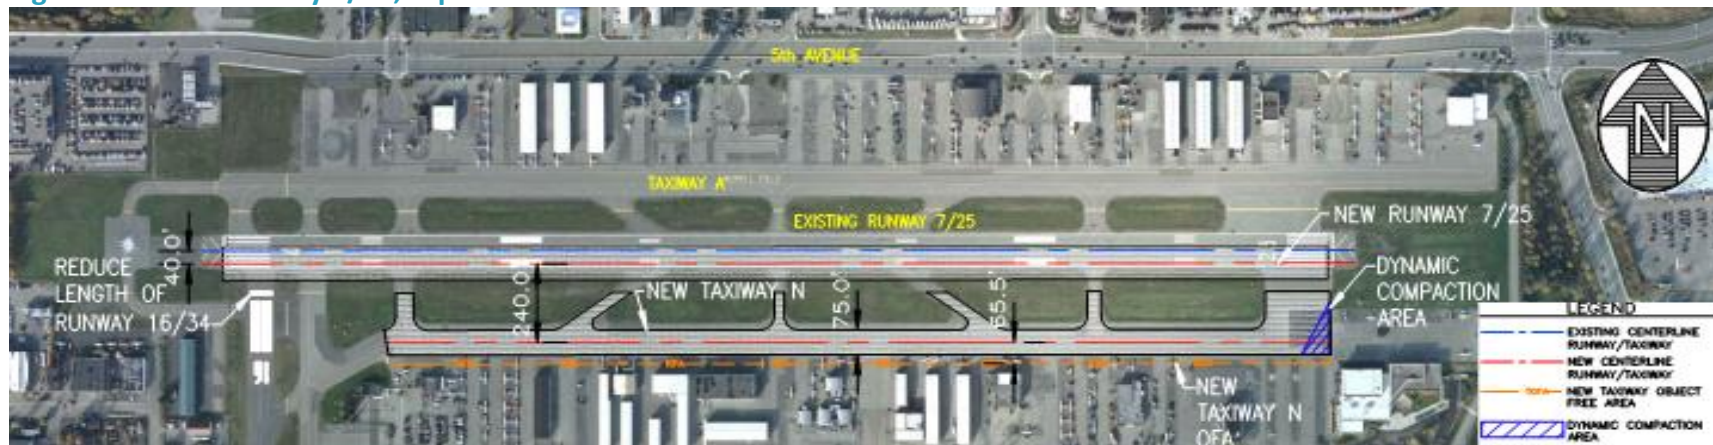
Figure 6-9 Shift Runway 7/25, Option B

As shown in Figure 6-9, this option would increase the separation distance between Runway 7/25 and parallel Taxiway A by relocating Runway 7/25

or taxiway configurations. The existing runway, RSA, ROFA, RPZ, and ROFZ dimensions would meet or exceed the requirements of an A/B-I-Small runway. This option is expected to cost less than \$100,000. However, the reduction in RDC would limit the type of aircraft that could use MRI and have other operational impacts to airport users.

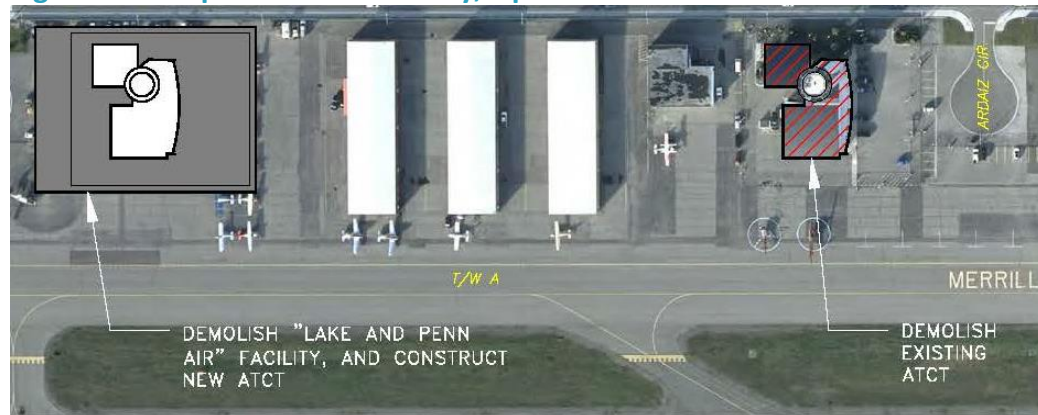
Figure 6-11 Improve ATCT Visibility, Option A

As shown in Figure 6-11, this project consists of demolition of the existing ATCT and construction of a new ATCT at a location to increase visibility along Runway 16/34 and Taxiway C from the tower cab. The best location for a new ATCT would be on airport property (Block 2, Tract 2C, Merrill Field Replat) west of the existing tower. This parcel is currently leased to Lake and Pen Air. Construction of the new facility would include lease negotiations with Lake and Pen Air to vacate its current lease;

demolition of existing Lake and Pen Air structures; construction of a new tower and supporting infrastructure; and demolition of the existing FAA tower and supporting infrastructure. Relocating the tower to the proposed site would allow ATC personnel to view the entirety of Runways 16/34 and 7/25 and greatly reduce visual obstruction of Taxiway C. Relocating the tower is estimated to cost more than \$500,000. A portion of the project cost, up to \$2 million, may be AIP-eligible. Relocation of the ATCT could be an initiative of either MRI or the FAA.

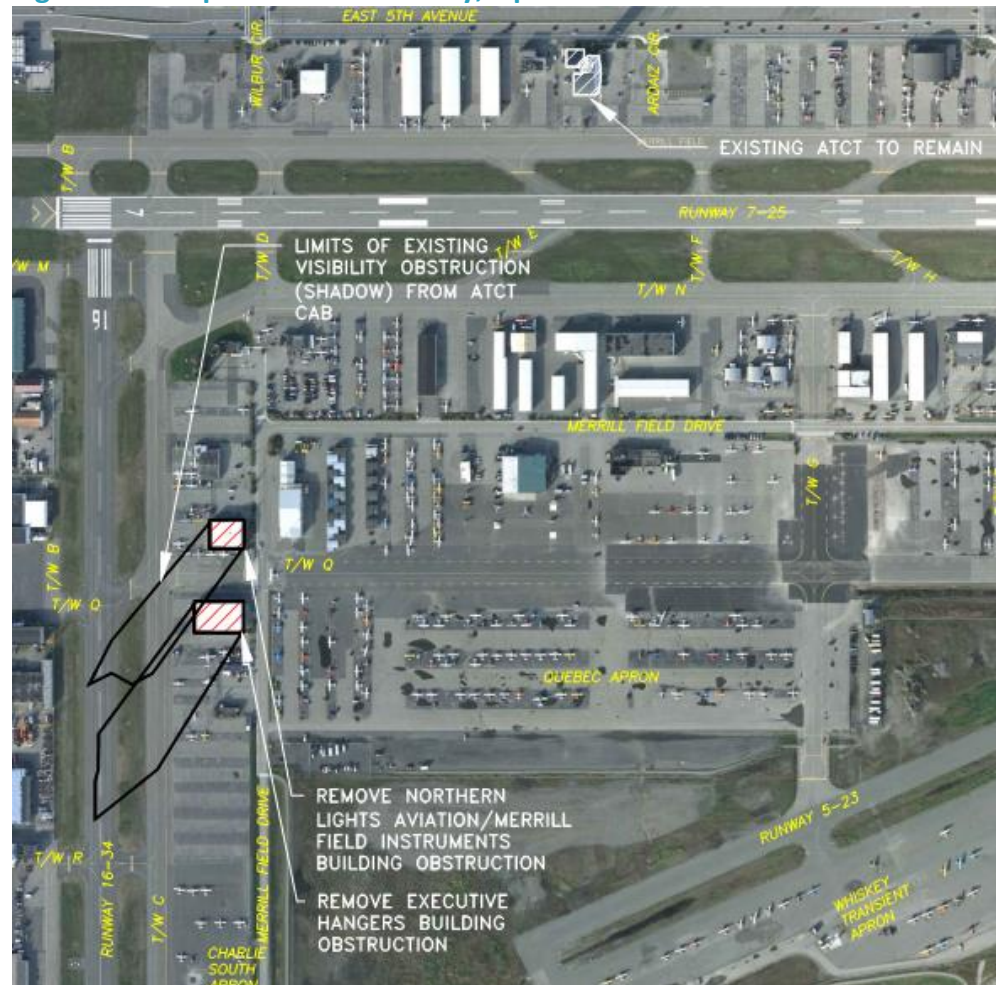
Figure 6-12 Improve ATCT Visibility, Option B

Demolishing these buildings would provide an unobstructed view of Taxiway C and Runway 16/34 from

the tower cab. However, it would eliminate two businesses from MRI. Additional work would be required to determine whether these businesses could be relocated on MRI or if other businesses or tiedowns could be developed on these lease lots without interfering with ATCT visibility. MRI is also in the process of permitting the construction of additional structures south of the Executive Hangars Building that would further reduce ATCT visibility. This is a much-needed leasable area.

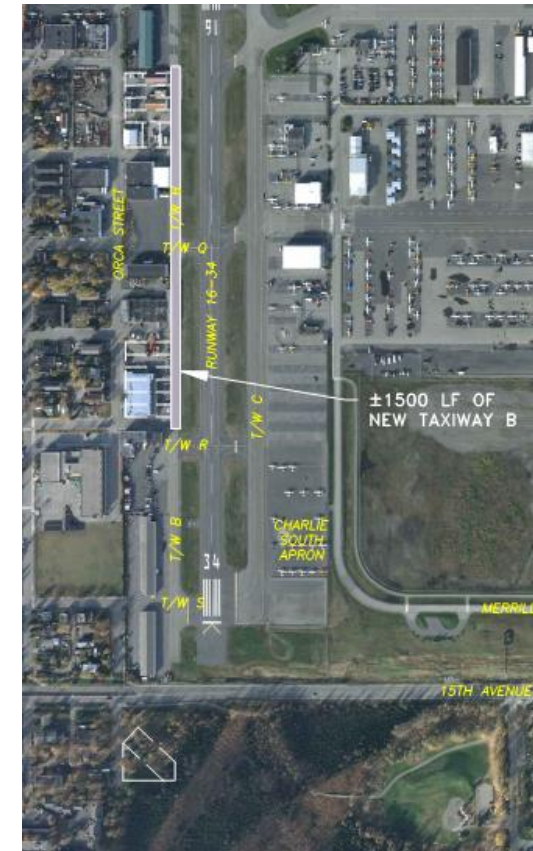
Figure 6-18 Acquire Property on Orca

Street (west of Runway 16/34). This property is needed for future development of a full-length and complete Taxiway B. The project would require removal of existing obstructions, support future development, and ensure compatible land use inside the BRL west of Runway 16/34. Specific properties to be acquired are shown in Figure 6-18 and Table 6-1.

Conclusion: MRI plans to acquire the remaining Orca Street properties (see Figure 6-18) on a willing seller/willing buyer basis and to ultimately develop a full-length Taxiway B when these acquisitions are completed.

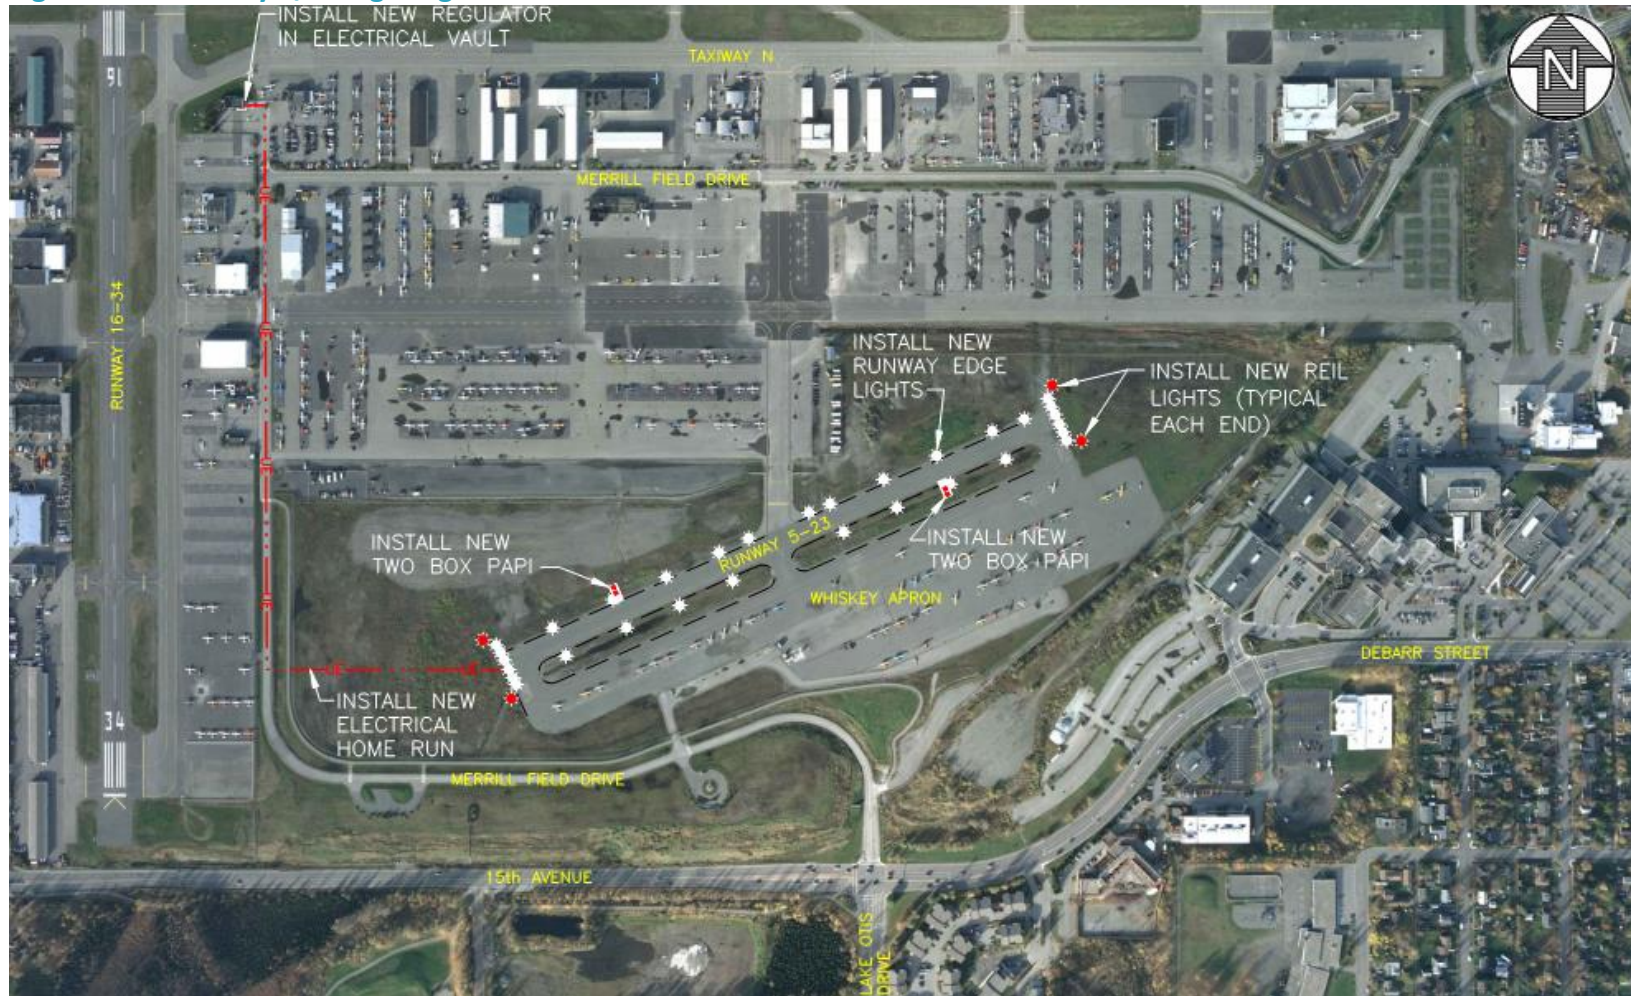
Figure 6-20 Runway 5/23 Lighting

This project would install runway edge lighting and nav aids on existing gravel/ski Runway 5/23 (see Figure 6-20). It will include installing edge lights, threshold lights, REIL, and a two-box PAPI on each runway end. Edge lighting would be uniformly spaced and symmetrical at 200 feet. The PAPIs would be located approximately 450 and 350 feet down-runway from the thresholds of Runways 23 and 5, respectively. The REIL would be installed 40 feet from runway edge, in line with the runway threshold lights.

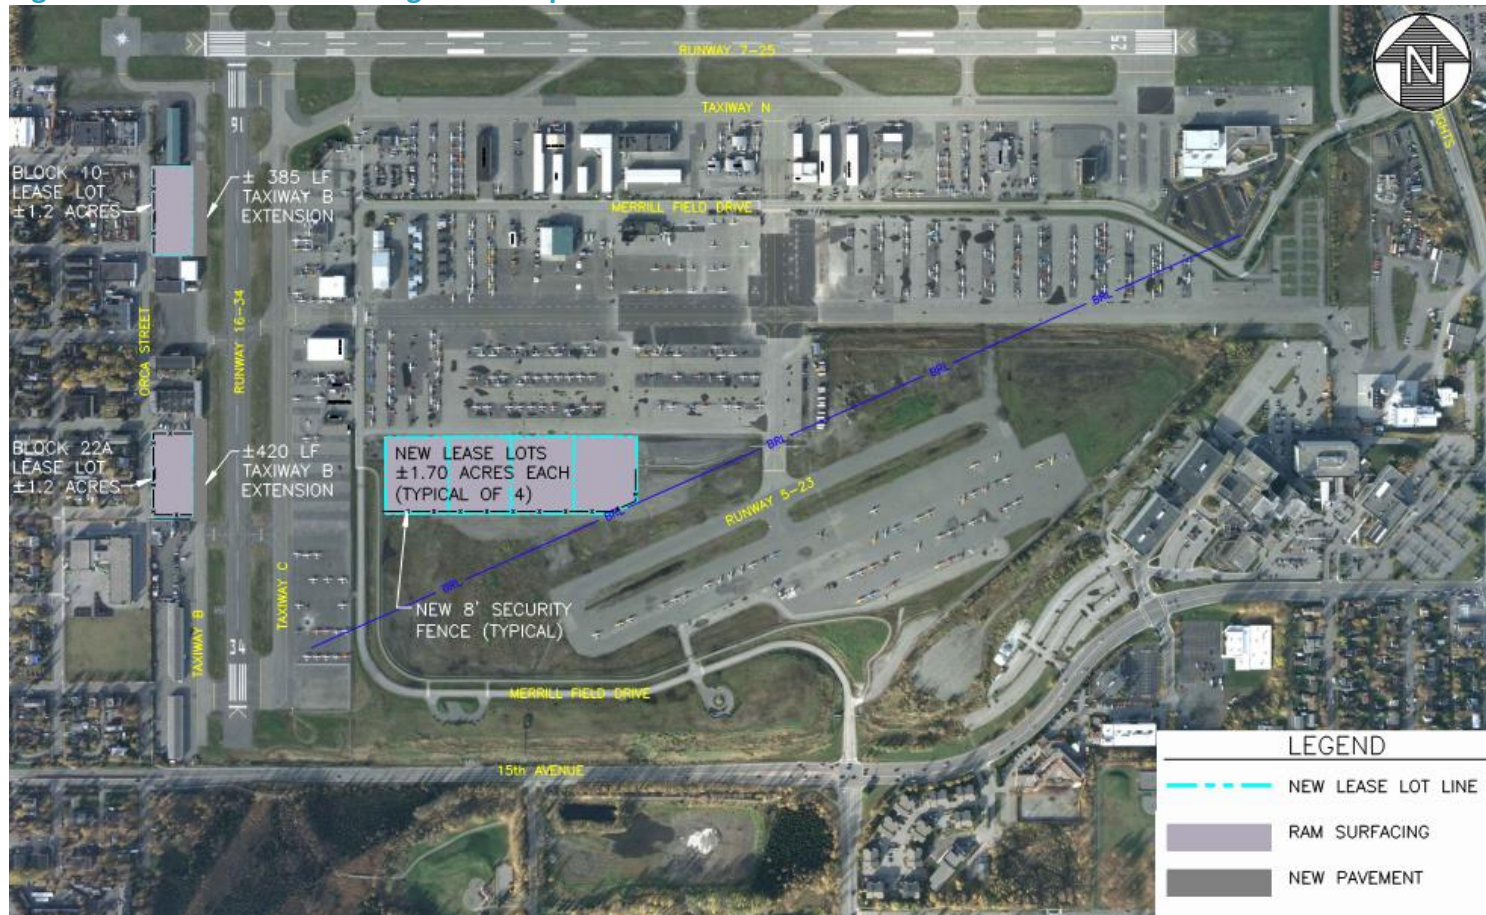
Figure 6-21 Lease Lots for Hangar Development

This project would create two new lease lots from property proposed to be acquired on Orca Street and four new lease lots on 6.8 acres of existing airport property south of the Quebec Apron for new covered aircraft parking or hangar development (see Figure 6-21). For the lots near Orca Street, the project would demolish existing structures, and install new perimeter fencing and security gates. For the lease lots near Quebec Apron, a new taxiway would be needed to provide runway access. One negative aspect of this development is this area is currently used for snow storage; an alternate snow storage area would need to be identified.

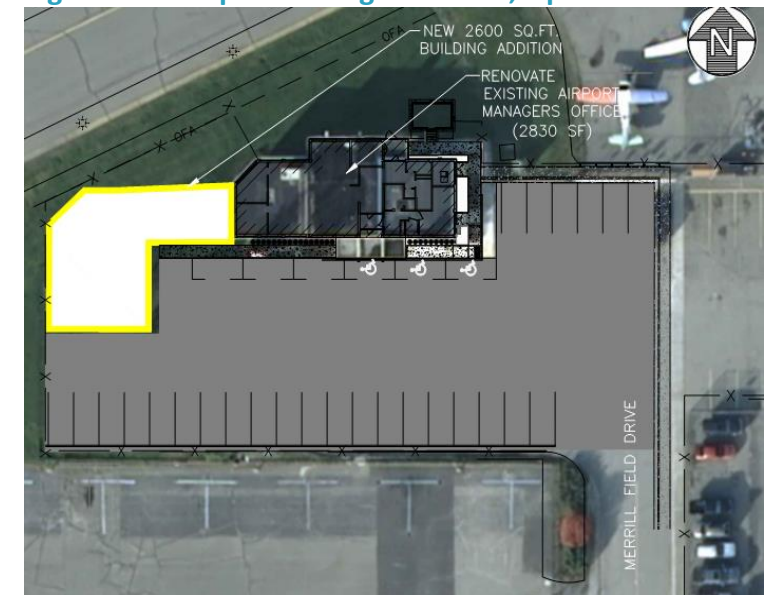
Figure 6-25 Airport Manager's Office, Option A

As shown in Figure 6-25, this project would renovate and expand the

existing Merrill Field Airport Manager's Office. Construction would include a 1,200-square-foot addition and renovation of the existing office space to provide a modern exterior design and an internal configuration to meet MRI needs. The existing paved parking areas and sidewalks would be relocated approximately 20 feet to the south to accommodate the building expansion. This would impact three aircraft tiedowns on the Charlie-Transient Apron.

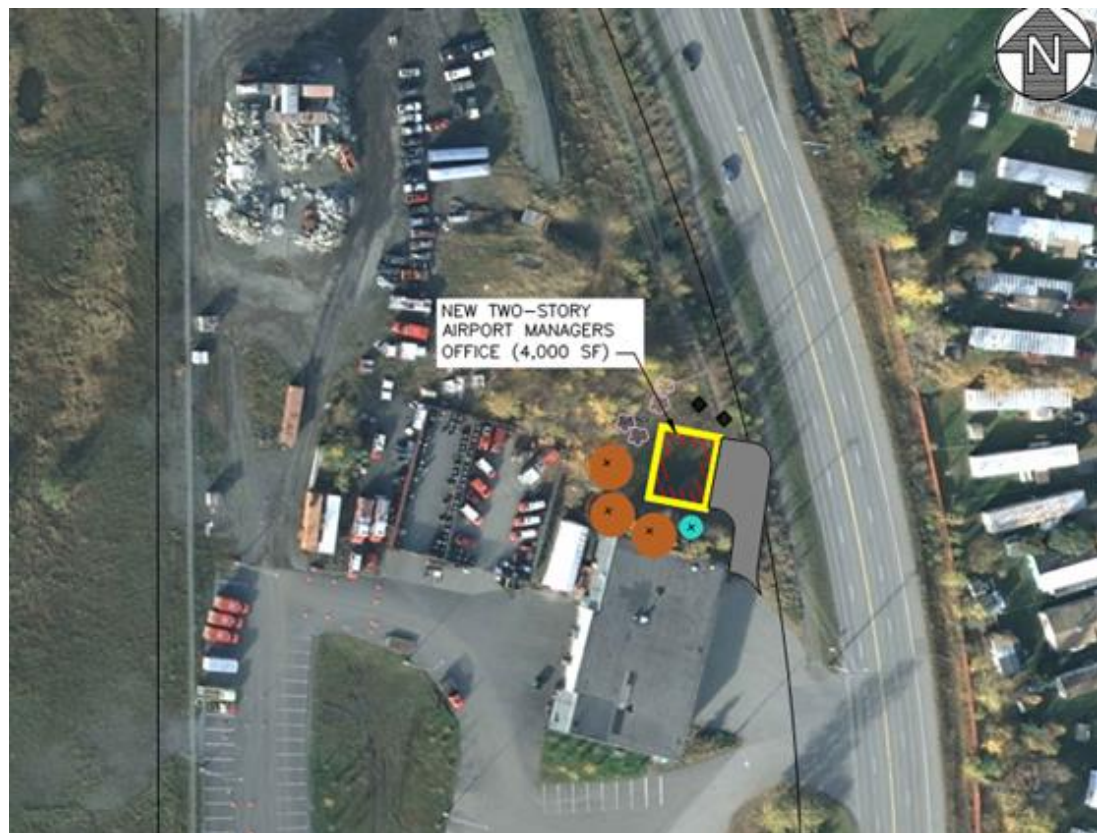
Figure 6-26 Relocation of Airport Manager's Office, Option B

This project would relocate Merrill Field's Airport Manager's Office to a new location on or near airport property in concert with AFD's Station #3 (see Figure 6-26).

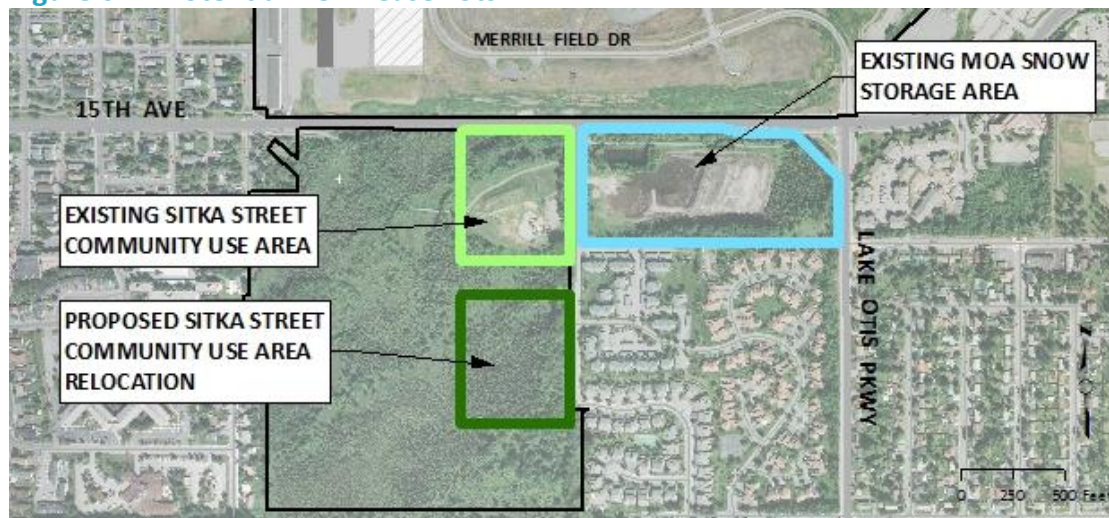
Figure 6-27 Potential New Lease Lots

This particular project recommends developing two parcels of airport land south of 15th Avenue (the existing MOA snow storage area and Sitka Street Community Use area) for non-aviation-related, office-building-related revenue generation purpose (see Figure 6-27), as it is impractical to use these parcels for direct aviation purpose due to significant terrain elevation differences (30+ feet below the prevailing airfield elevation) and practical non-accessibility to the MRI AOA's. These identified-for-future-lease land parcels when leased would become a revenue-generating cost center when leased, revenues from which would be used to support airport operating costs. The adjacent parcel areas fronting 15th Avenue are proposed for such development: One is an existing snow storage area, presently leased to the MOA (at a reduced, snow storage site rate) and

The aforementioned second 15th Avenue parcel (see Figure 6-27), presently used as the “Sitka Street Community Use Area,” located south of and fronting 15th Avenue, immediately west of and fronting Sitka Street, is within the designated green belt that is south of MRI Runway 16/34 and north of the Chester Creek greenbelt. This Sitka Street Community Use Area – mislabeled a “park” – is not actually a park, per se, but rather this MRI owned land is a “public use area,” which area has park-like features of playground equipment and a small hill that is used for sledding. (The distinctive difference is a Park is defined as “an area of land set aside for recreation” and a public use area is defined as use for “purposes designated as beneficial to the public.” Distinctively, the former is *not* airport

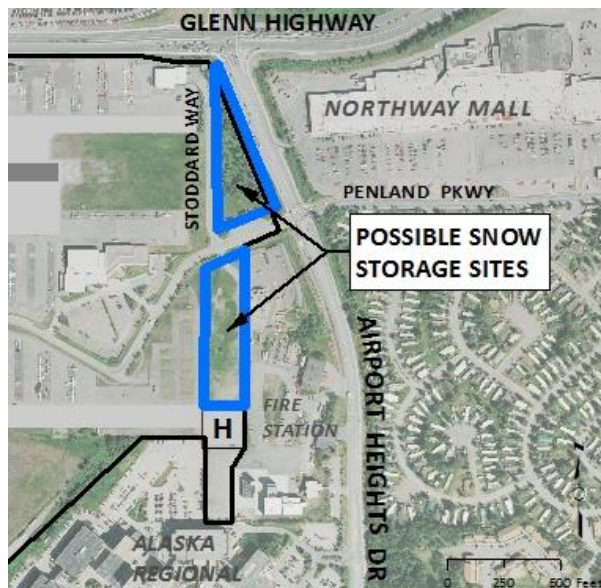
Figure 6-28 Possible Alternate Snow Storage Sites

Regarding alternatives for the existing snow storage area, two potential areas for a relocated snow storage site on MRI are identified (see Figure 6-28). Regardless of where such construction would occur – on field or otherwise – any development of a new snow storage site requires specific snow storage site planning, including

only occur *after* an alternate “beneficial-to-the-public” site is developed (see Figure 6-28).
