Government Hill Community Traffic Calming Study

The Boutet Company
800 E. Dimond Boulevard, Ste. 3-520
Anchorage, AK 99515

April 2003

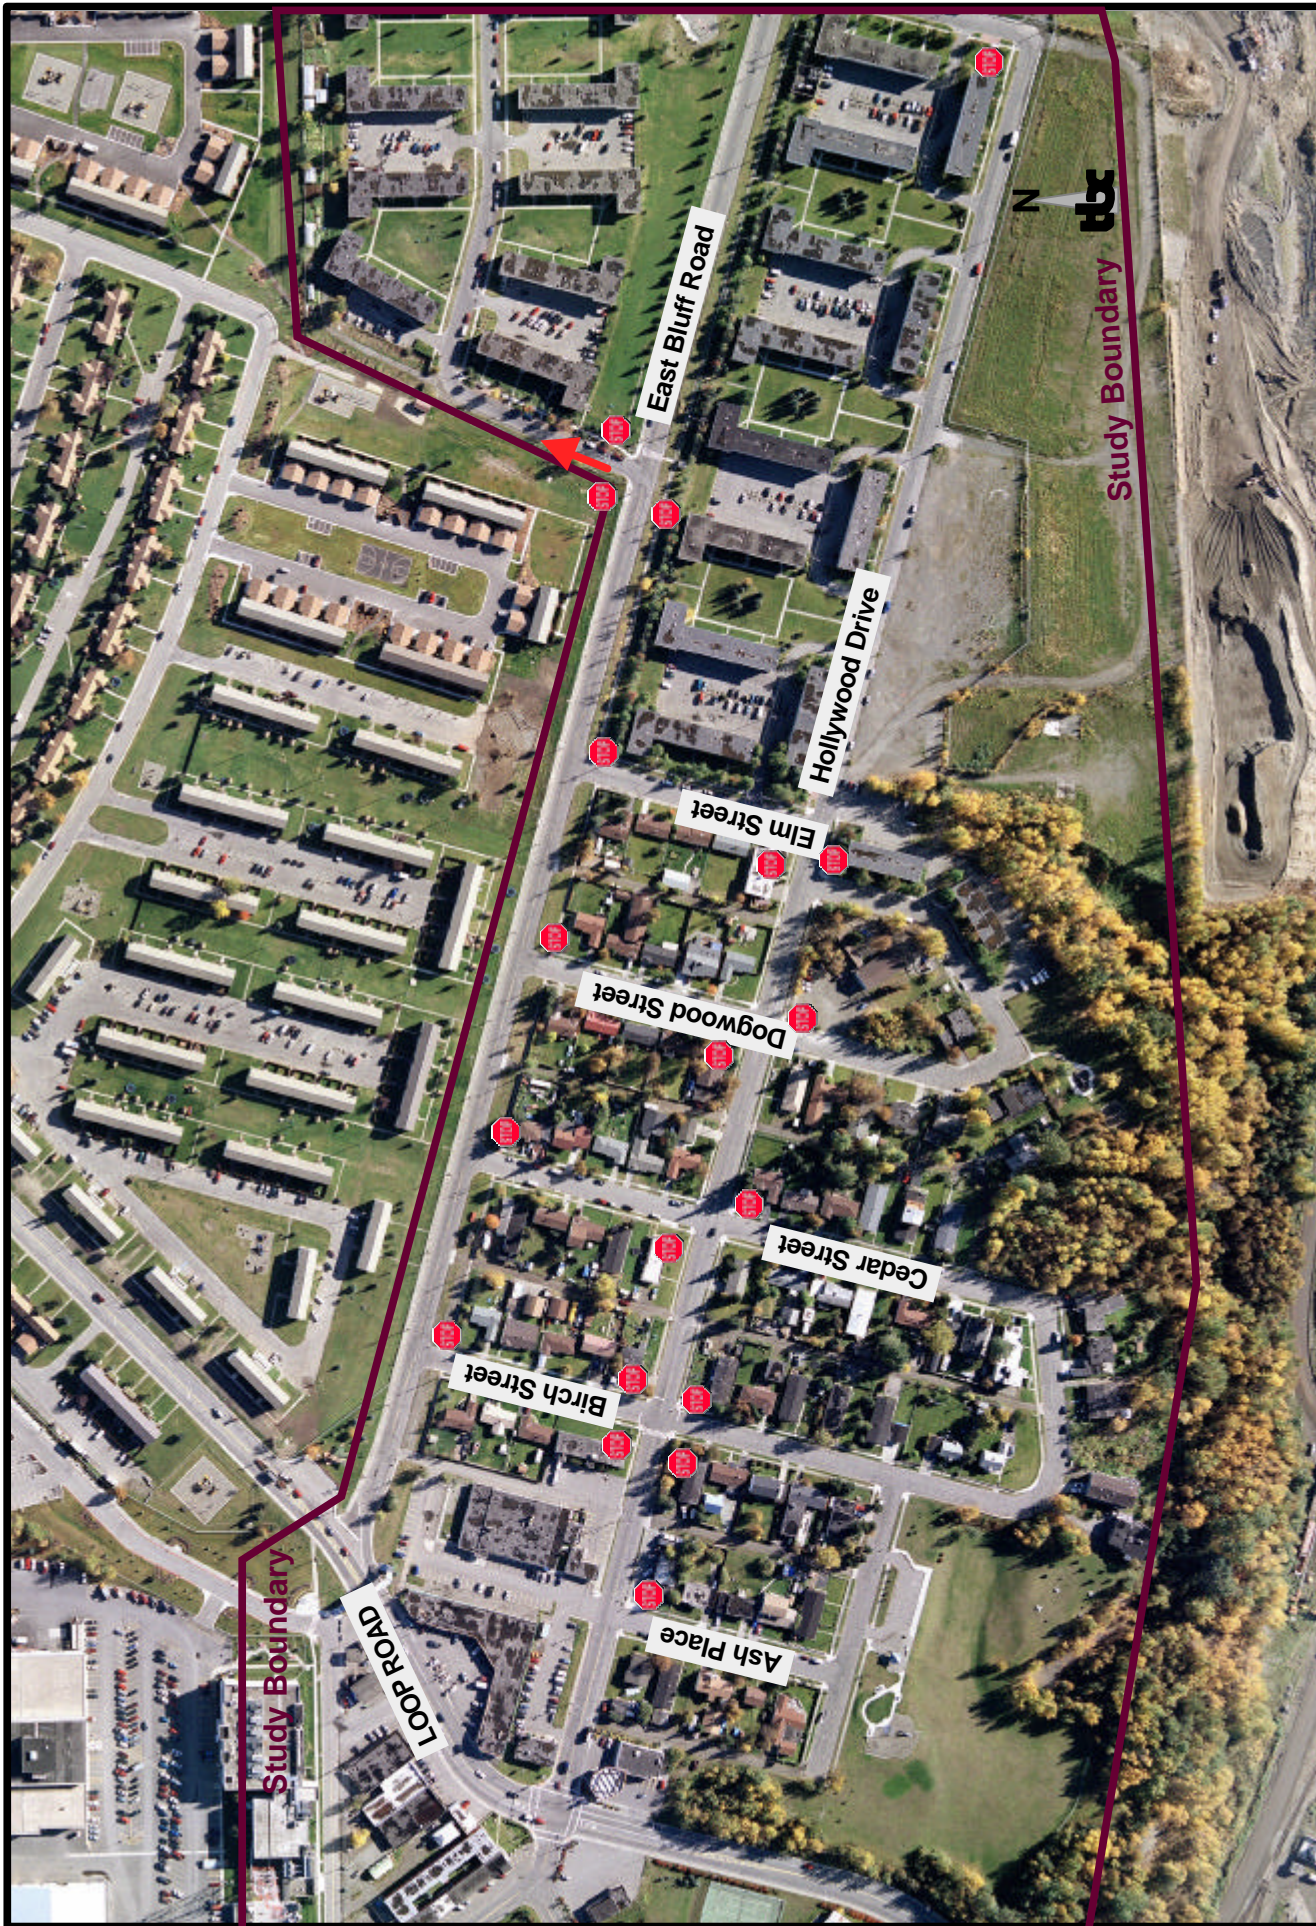
Figure 2
Existing Eastern Study Area

Figure 2 is an aerial photo of the eastern study area. The roadway layout in this study area is primarily a grid pattern with two connecting loops. The two main streets are Bluff Road and Hollywood Drive which are oriented primarily east-west. The intersecting streets are short and all of the Bluff and Hollywood intersections are right-angle intersections. The existing traffic control is also shown in Figure 2.

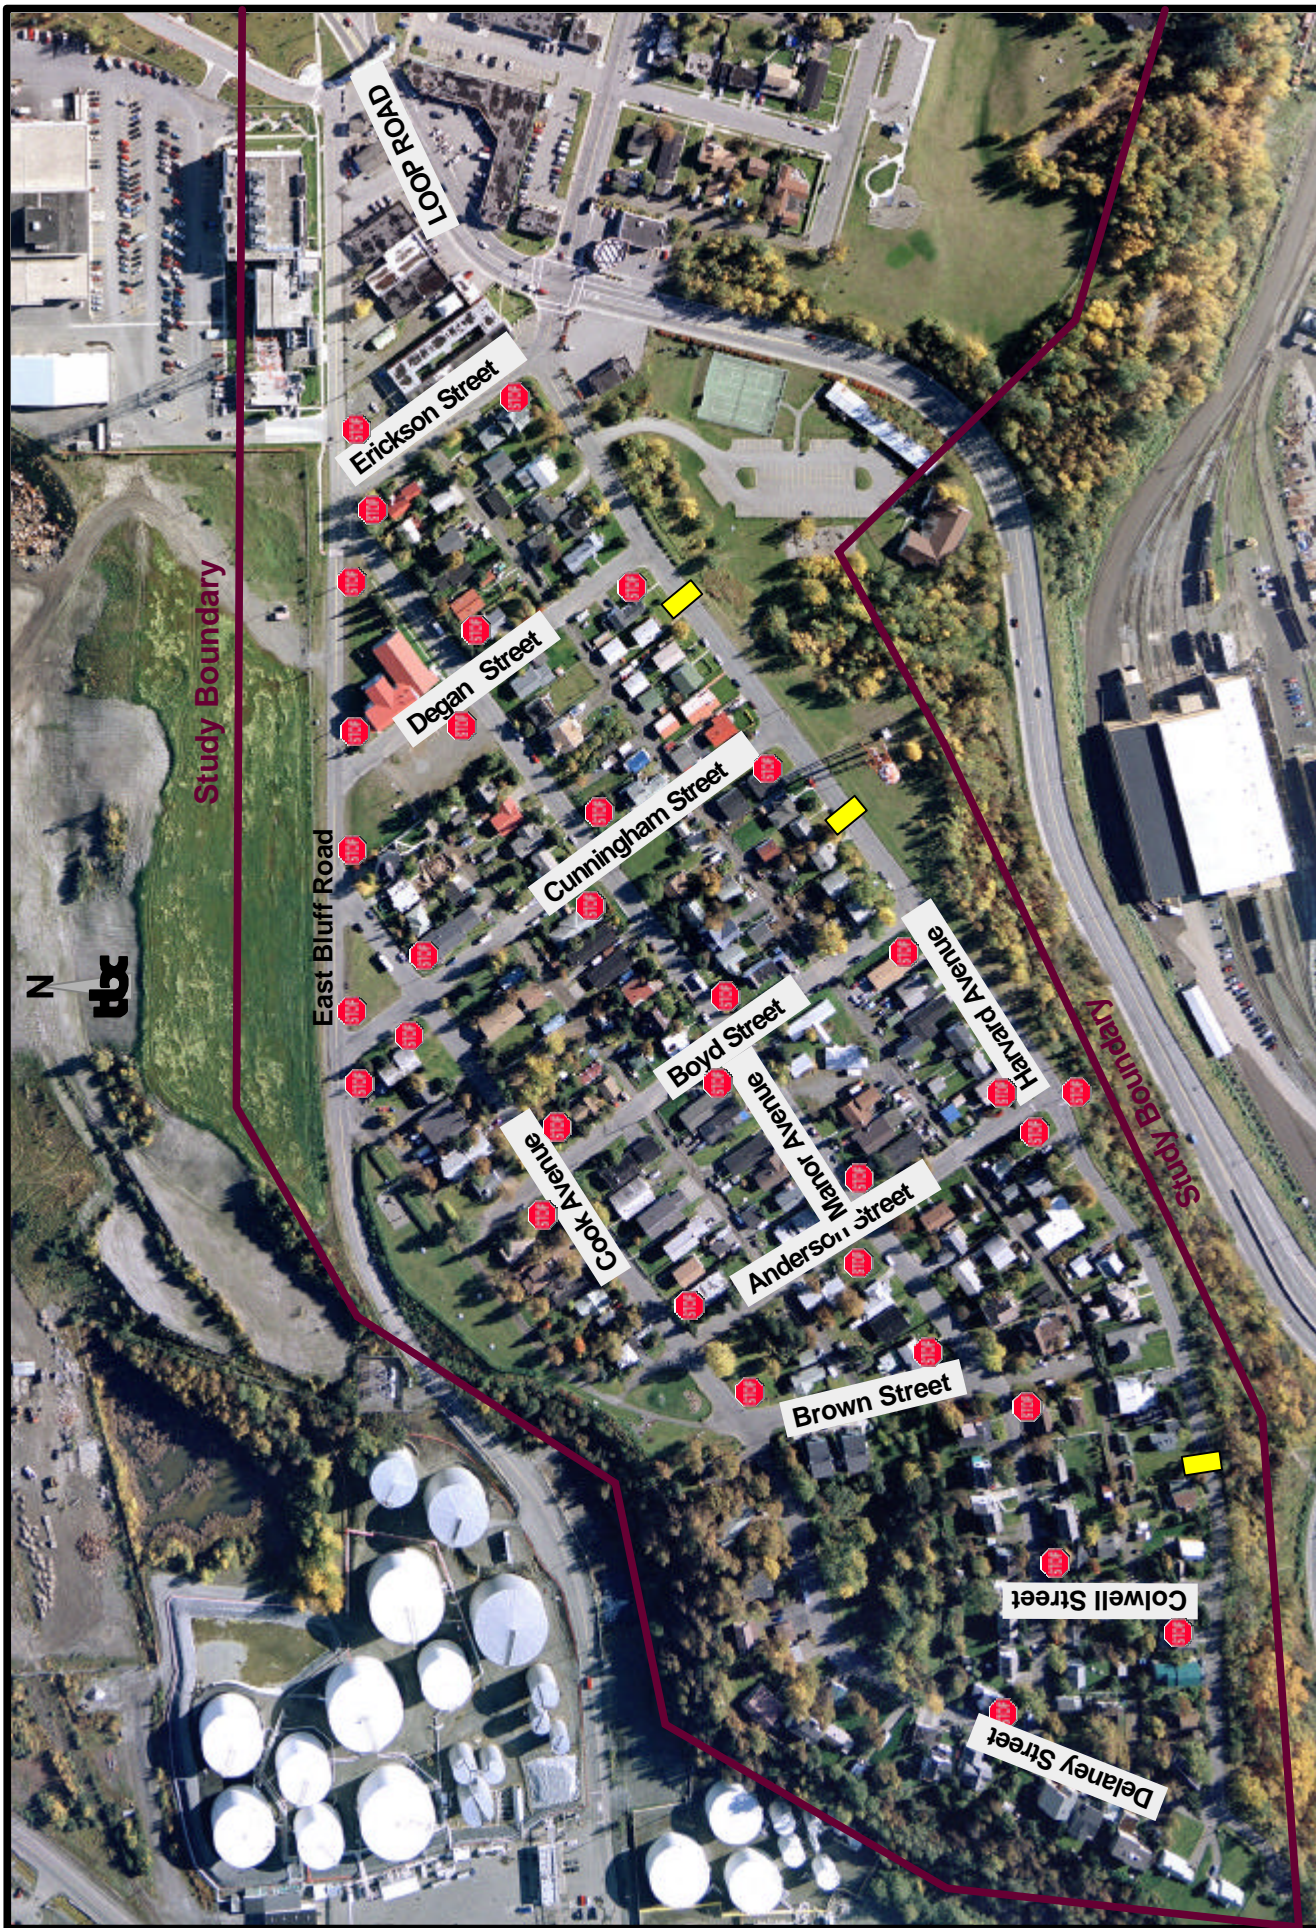
Figure 3
Existing Western Study Area

As shown in Figure 3, there are many intersections in the western study area that do not conform to the standard grid pattern. The road system was developed to maximize access to all of the development in the area. The existing traffic control for this study area is shown in Figure 3. The three permanent speed humps installed in the summer of 2002 are also shown in this figure.

As previously discussed, three speed humps were installed on Harvard during the summer of 2002. These humps are located between Degan and Cunningham, Cunningham and Boyd, and Anderson and Colwell, as shown in Figure 3. The GHCC had initially requested that traffic calming devices, in the form of traffic circles, to be installed at the intersections of Cunningham and Boyd with Harvard. Because the MOA had additional funds and was implementing a speed hump program in that summer, they installed humps in the vicinity of the locations where other traffic calming measures were requested. They also installed an additional (third) hump in a location where they had placed temporary speed humps in the past.

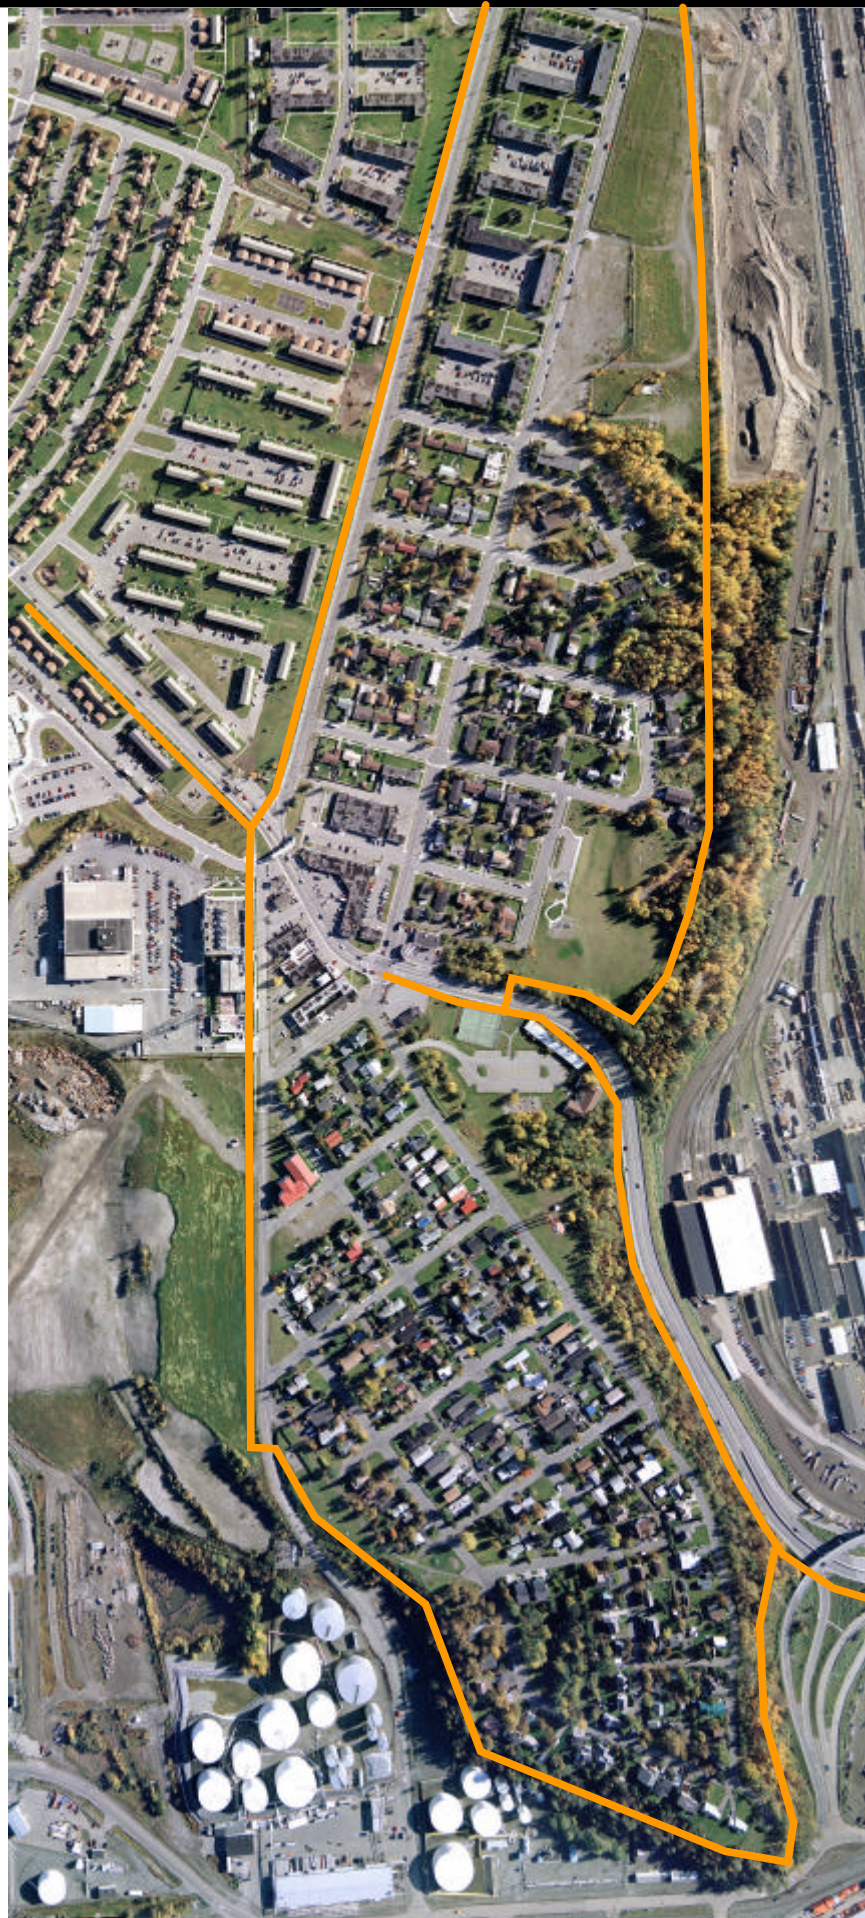
Figure 6
Trails Identified in the Current Trails Plan

The MOA has adopted a trails plan to identify locations in the future where trails should be constructed. The plan identifies several locations within the study area for future trails. The trails that are currently identified in the plan are shown in Figure 6.

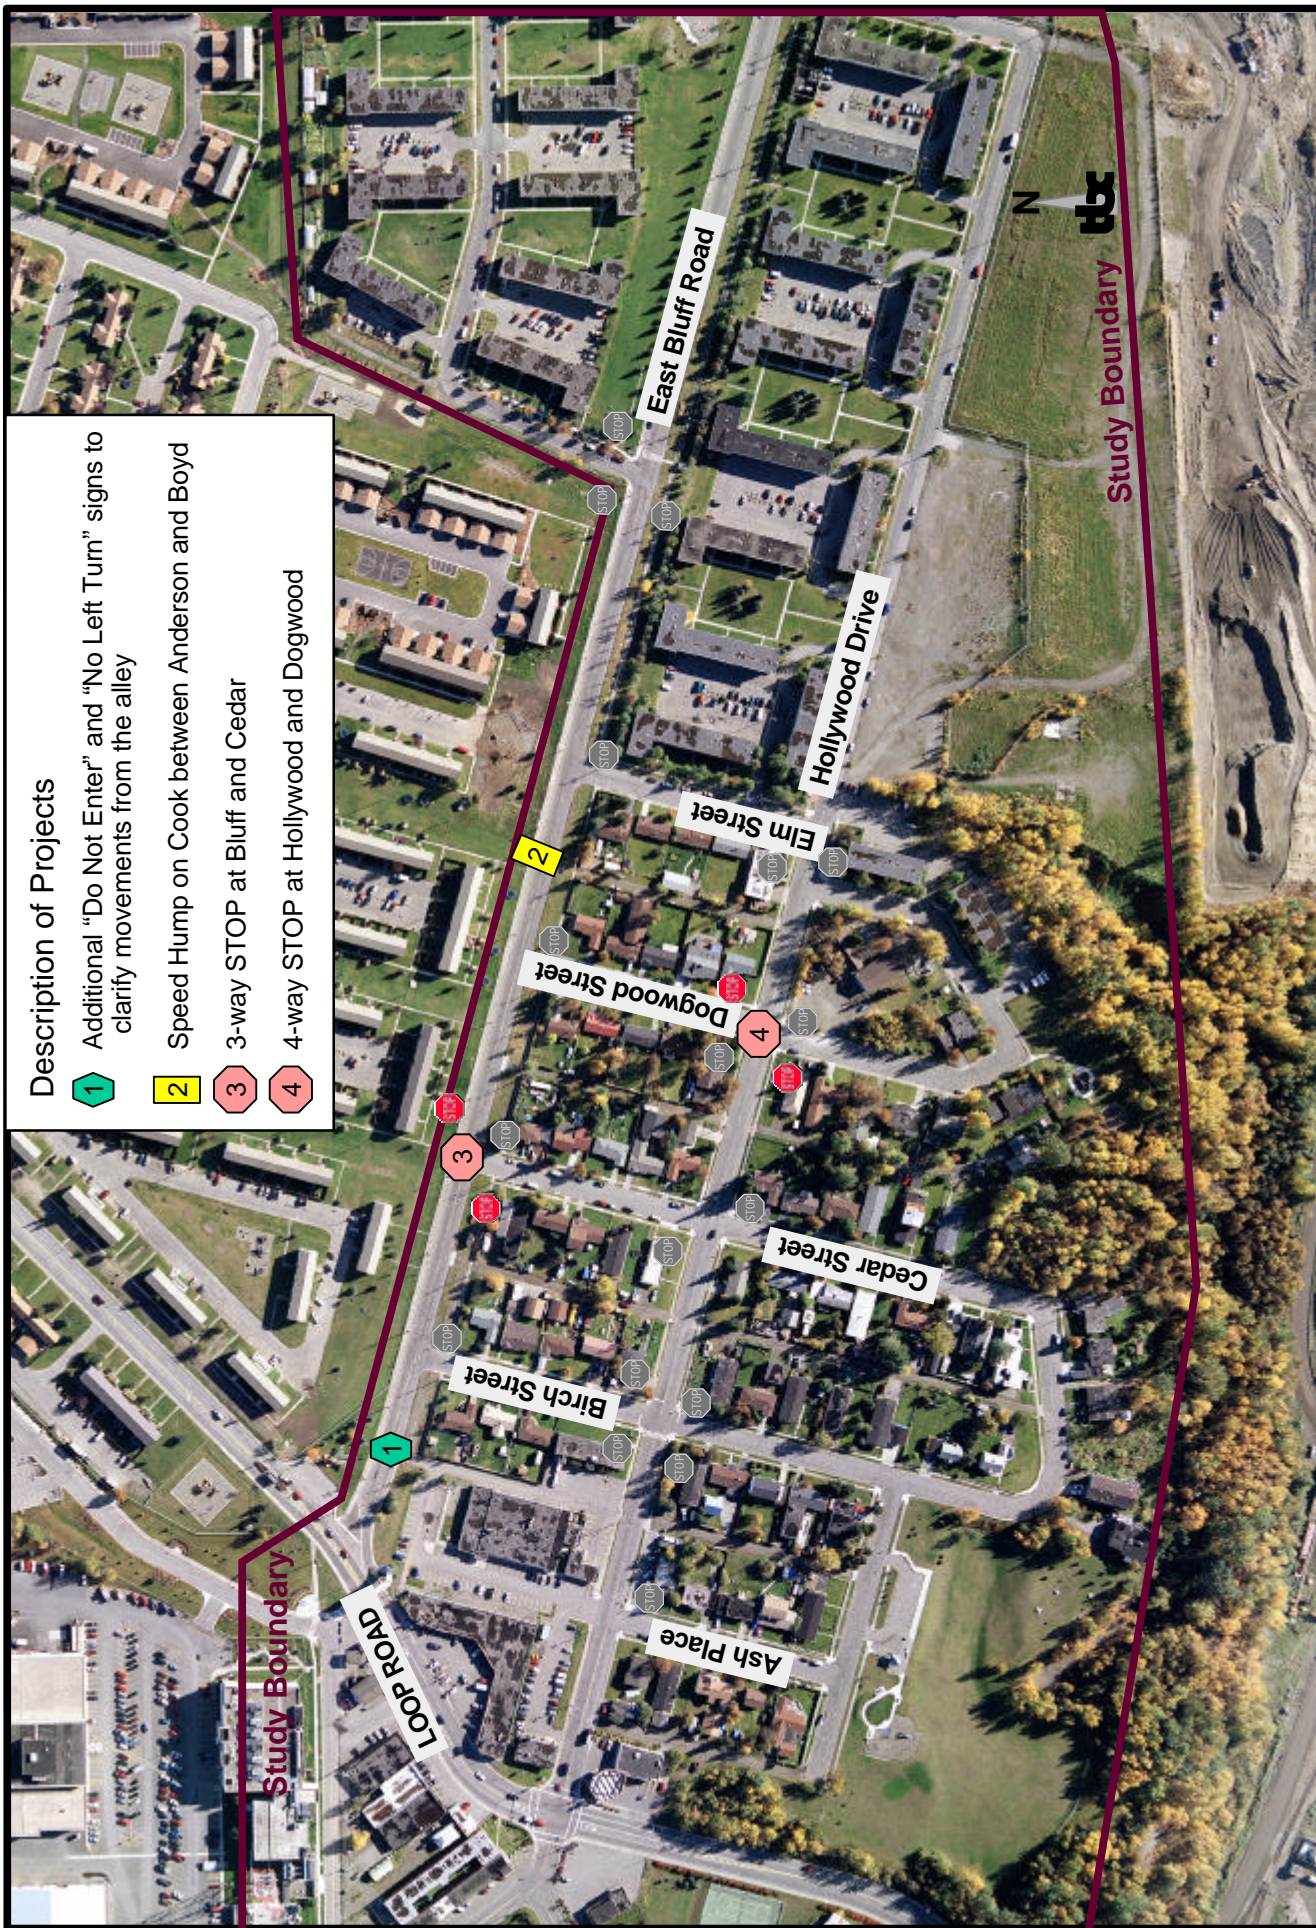
Figure 7
Proposed Short Term Alternatives – Eastern Study Area

- Description of Projects**
- 1** Additional "Do Not Enter" and "No Left Turn" signs to clarify movements from the alley
 - 2** Speed Hump on Cook between Anderson and Boyd
 - 3** 3-way STOP at Bluff and Cedar
 - 4** 4-way STOP at Hollywood and Dogwood

Several stop sign reconfigurations are included as part of this study. The proposed changes are shown in Figures 7 and 8. Due to the limited sight distance at Delaney and Harvard, the westbound Harvard movement was stopped. Due to the proximity of the intersection, the GHCC requested three-way stop at Colwell and Harvard was not recommended.

The GHCC also requested that some sign configurations be modified. Consequently, an additional “Children at Play” sign is recommended on Harvard at Anderson. The signing on East Bluff at the exit from the alley behind the businesses on Loop will also be modified by installing additional one-way signs to clarify the available movements. The locations of the signing changes are also shown in Figures 7 and 8.
