## 2017 fire at 4411 Edinburgh Drive

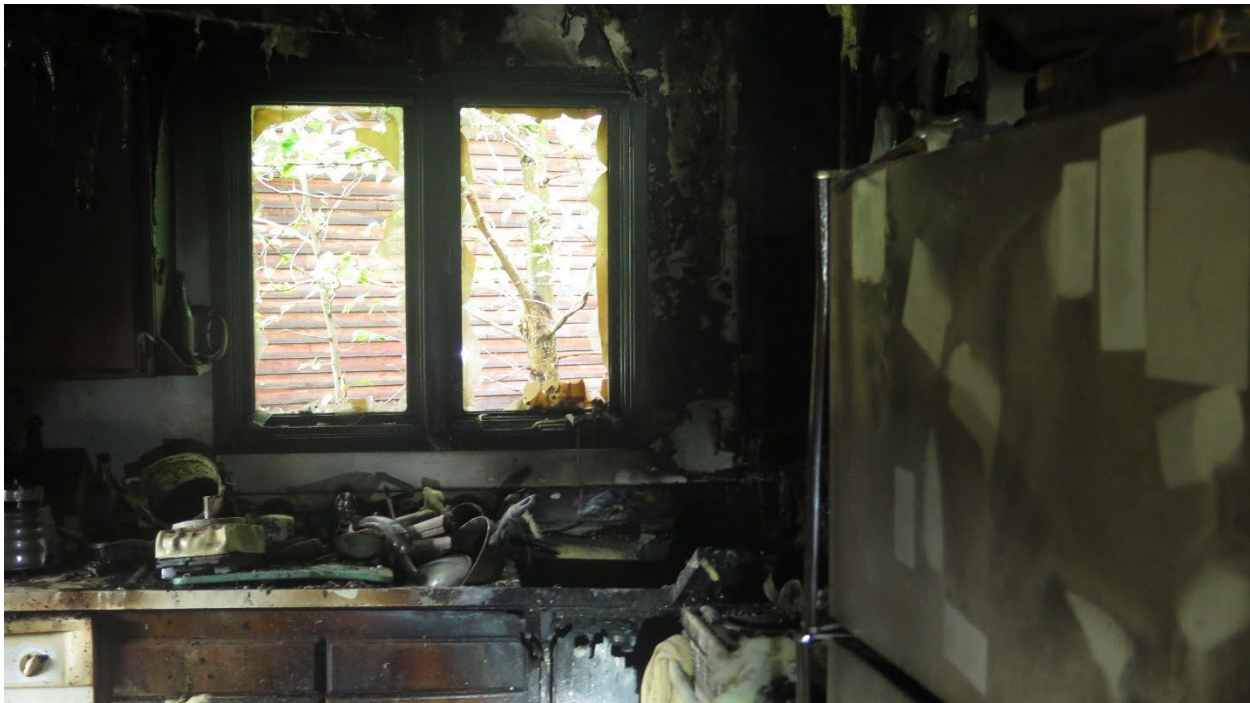
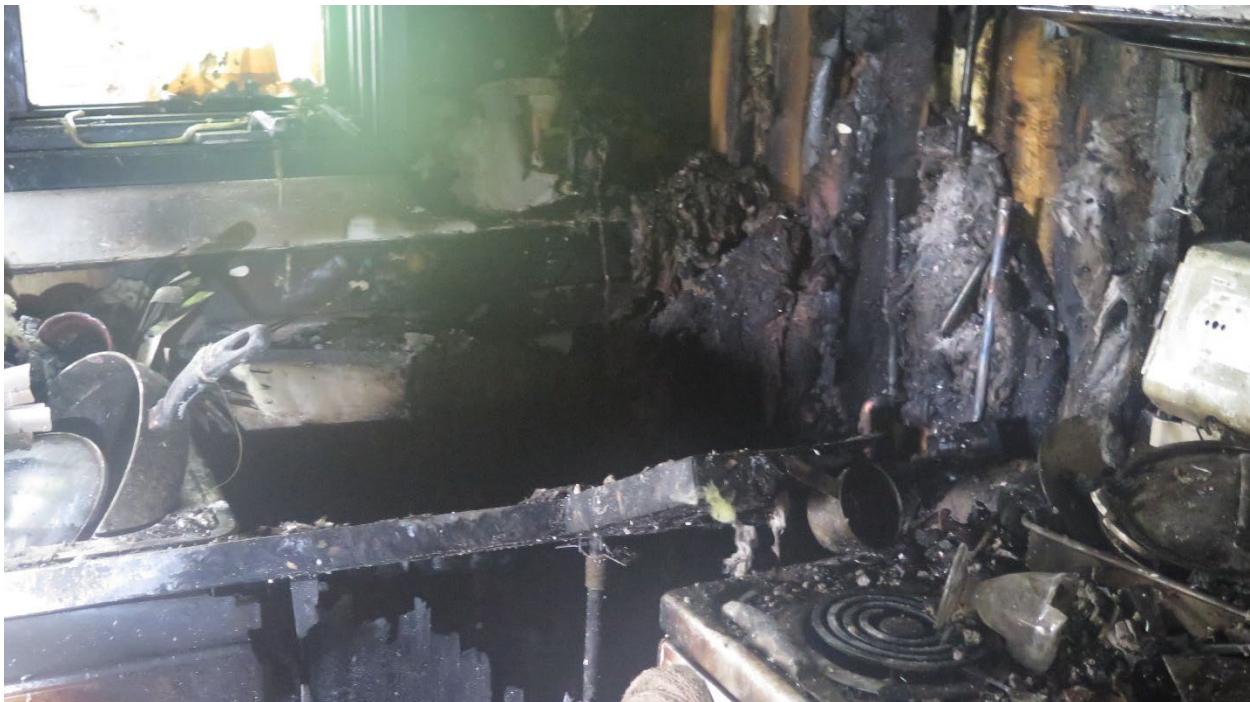
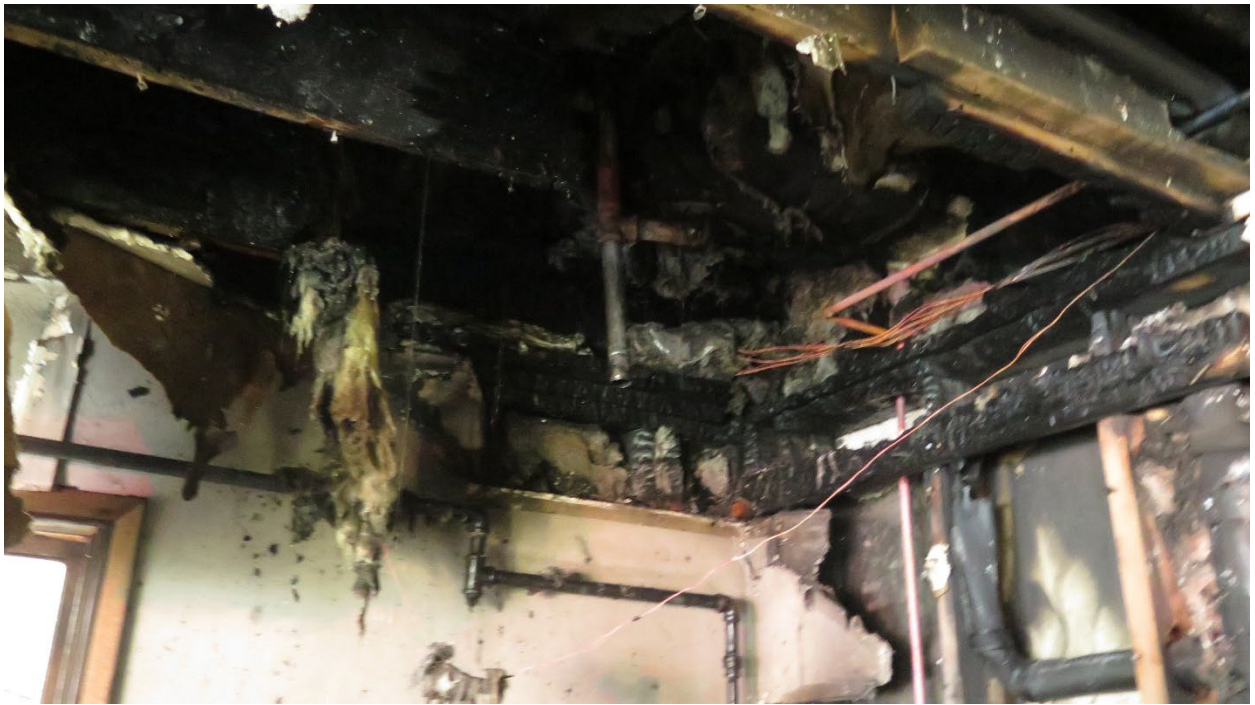
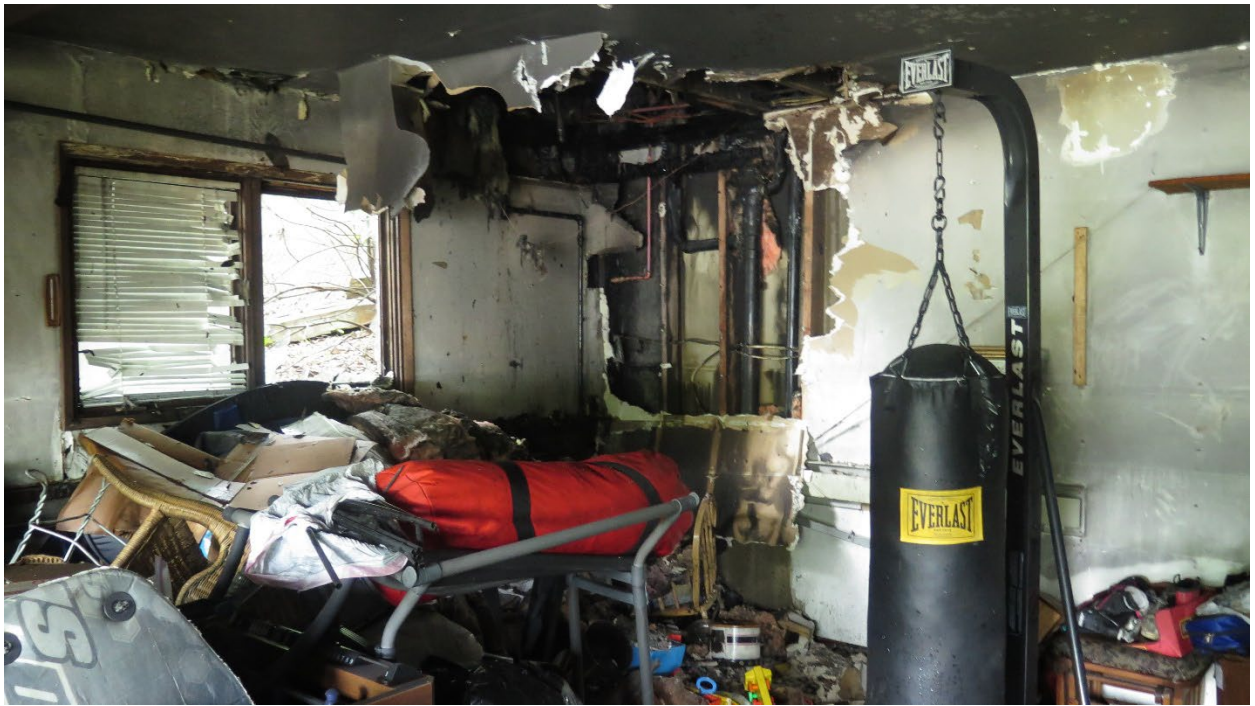
There was a fire in the kitchen that consumed the corner upper and lower cabinets and extended into the wall and ceiling structural framing. The fire also extended through plumbing penetrations in the floor to the garage below. Where the fire extended into the corner of the garage, there is damage to garage wall framing to include top plates and floor/ceiling joists. It was reported that fecal matter may have been present in the home. The current interior condition is unknown.
