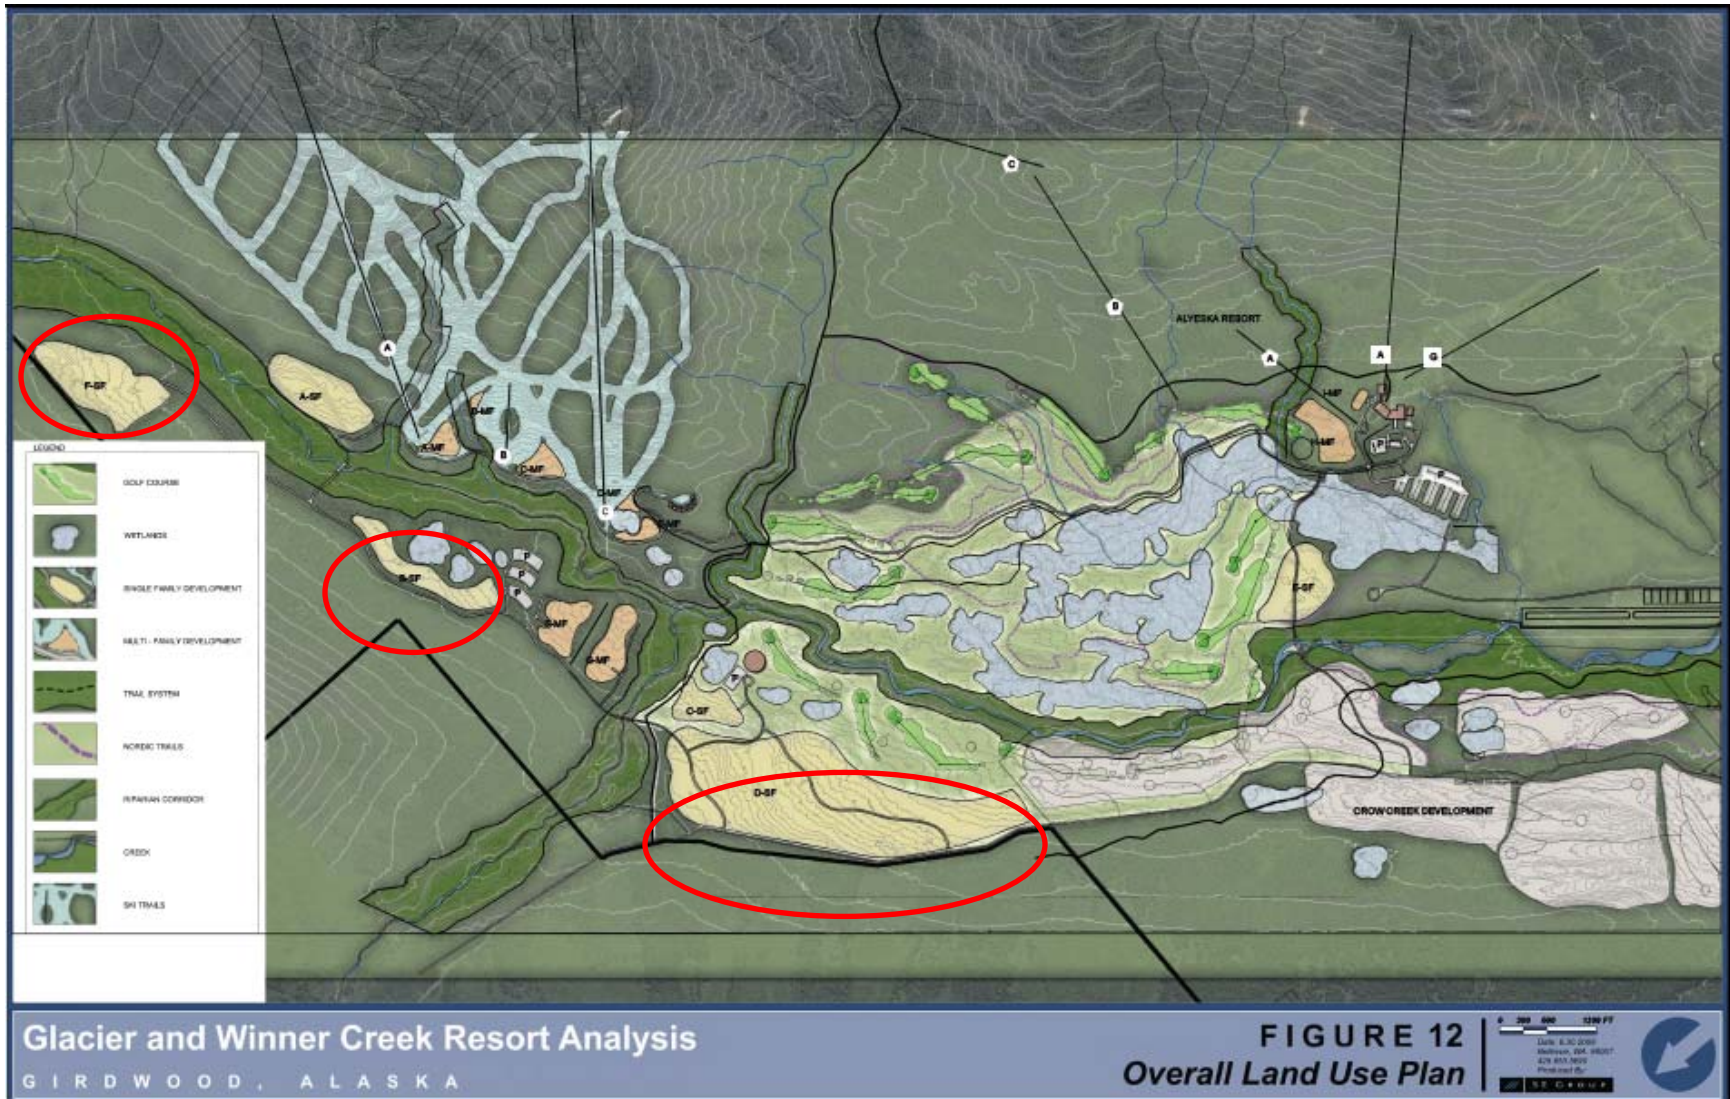
Figure 3: Avalanche Risk and Land Use: Pods “B”, “D”, and “F” (circled in red) have the same issues as those described in Figure 2. These same areas are shown in Figure 13 of SE Group’s Glacier-Winner Creek Resort Development Suitability Study, but not reproduced here. (Source figure: Adapted from SE Group report, 2006, by permission of MOA/HLB.)
