CAP GENERAL CONSERVATION ASSESSMENT REPORT  
OSCAR ANDERSON HOUSE MUSEUM  
ANCHORAGE, ALASKA  
*September 2019*

**CAP Assessment Report**

Oscar Anderson House Museum  
September 2019

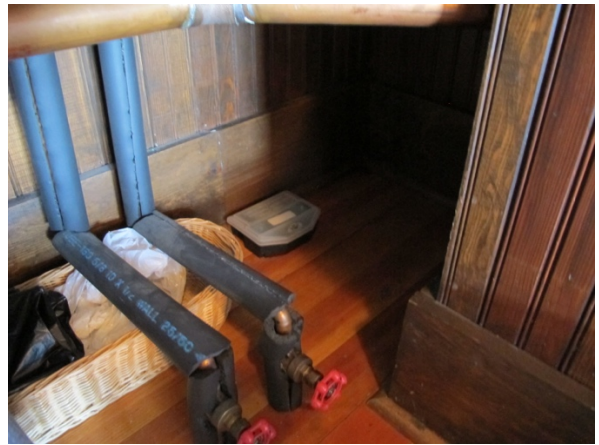
doors. A pest control company was employed by the Municipality to address the rodent infestation. Rodent droppings were observed in the house during the March 2019 deep cleaning, and further rodent activity has not been observed since.

Placement of a rodent poison trap underneath the countertop in the southeast corner of the kitchen.

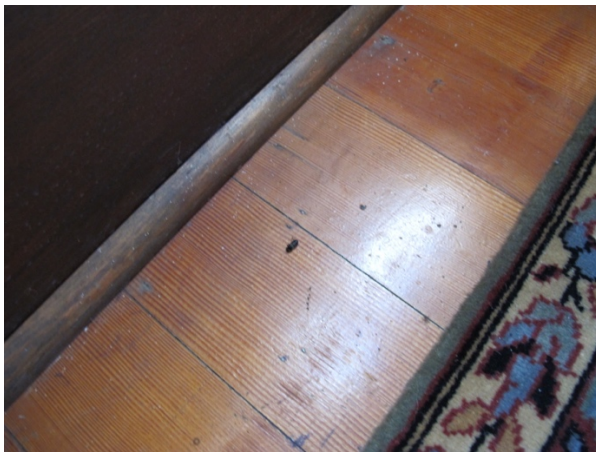
It was observed during the assessment that the museum may have an active larder beetle infestation in the wool rugs in the living room. Multiple larder beetle carcasses were found along the edges of the wool living room rug below the south facing windows. It is possible that the beetles have been living in the carpet pads underneath the rugs and have been feeding off of the rug pile. It was noted by visiting former docent Mary Flaherty that previous vacuuming attempts had resulted in pile loss. This suggests that the larder beetles may have eaten the bottom of the carpet pile, leading to pile detachment.

Dead insect carcasses around the south edge of the rug in the living room.

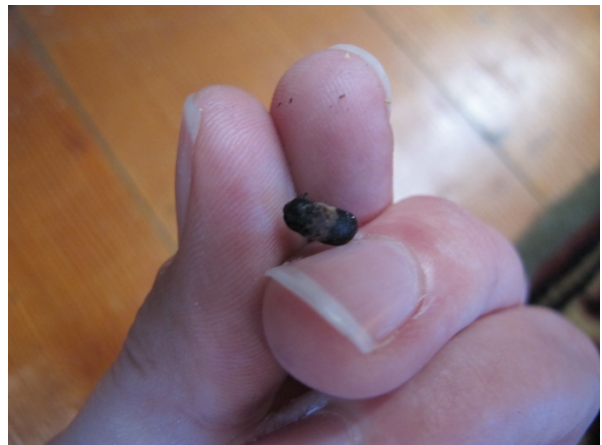
Detail view of the insect carcass identified as a larder beetle.

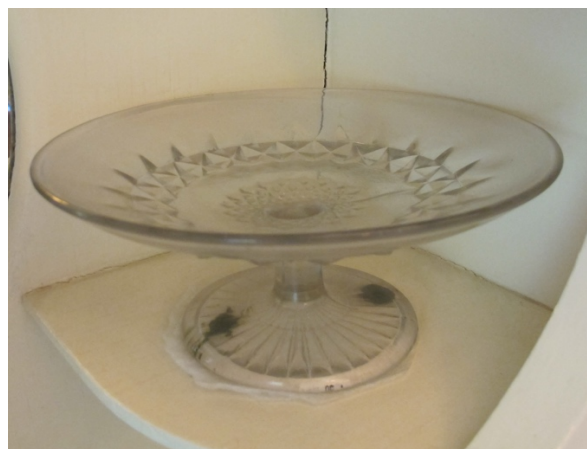
Decorative glass pastry stand in the dining room built-in cabinetry with darkened safety wax.

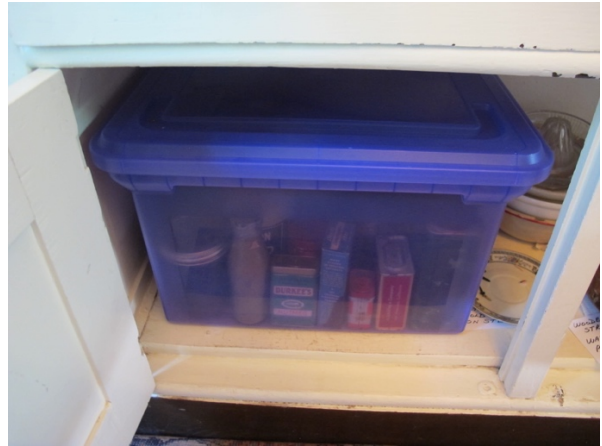
Collection storage in a plastic tub inside of the cabinetry.

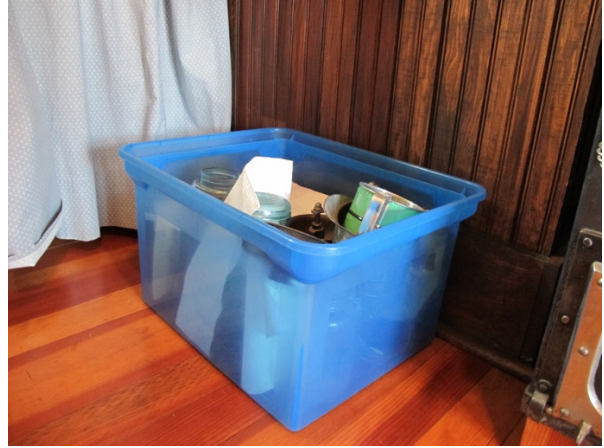
Collection items stored in a plastic tub on the floor of the kitchen.

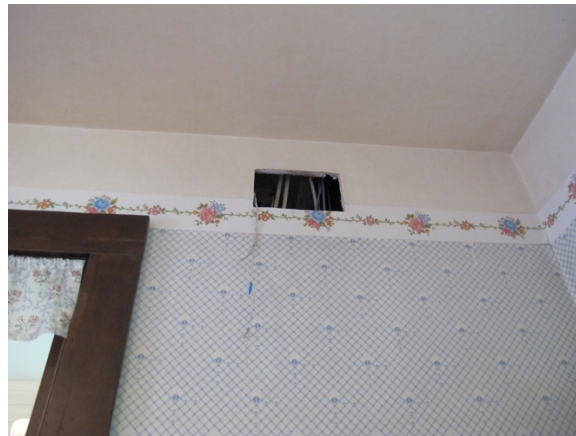
Across from the Dining Room, along the east wall is the Kitchen. The Kitchen houses a large historic stove as well as a butcher block table with butcher's equipment that had been the property of Oscar Anderson at his butcher's shop in town. There are also assorted food tins and storage items, though food is not on display, with the exception of coffee beans stored in a closed jar. The area under the sink and counter along the east wall doubles as storage for objects and cleaning supplies and is discretely covered by a curtain. There is a cut-out hole at the top of the north wall near the sink where access to electrical wiring was required and the hole has yet to be patched. This hole could serve as a point of entry for rodents and other pests moving through the walls.

Cutout hole in the north wall of the kitchen that allows access to wiring.

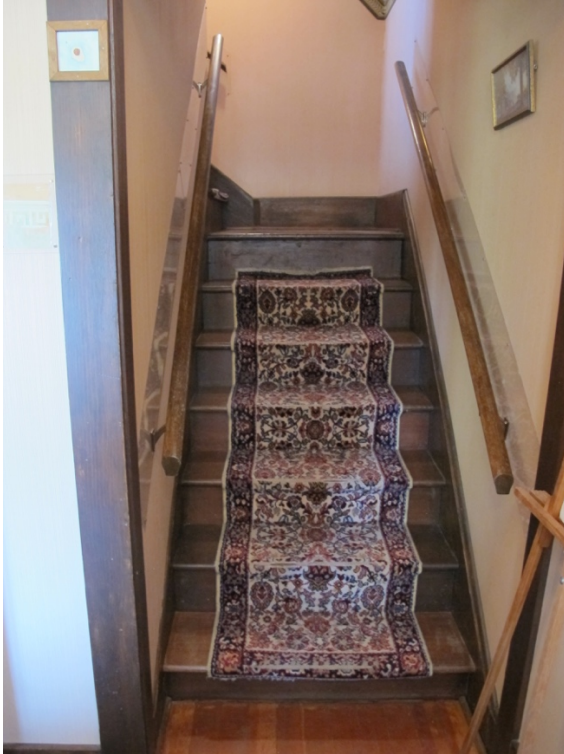
The Second Floor is accessed via a staircase on the east side of the house. The staircase is covered with a rug runner that has been stapled to the stairs in order to prevent the runner from slipping. The runner is showing serious signs of age from visitors walking on the surface. It now poses a serious safety hazard as the runner is tearing at the stair edges, which can lead to tripping. The staircase opens into the east side of the parents' bedroom.

Interior view of the staircase facing north. The upper half of the staircase to the upstairs makes a sharp ninety degree turn at the landing.

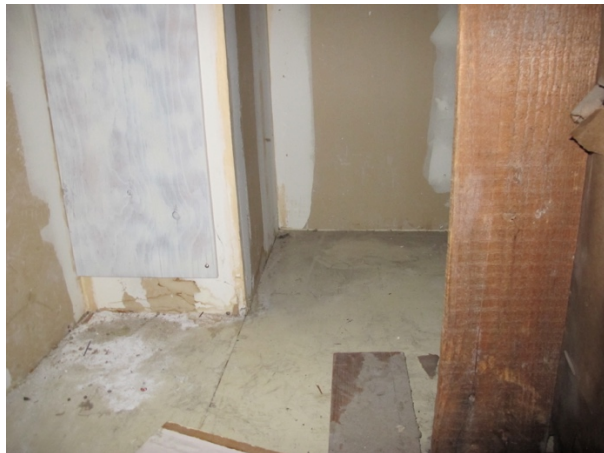
The Girl's Room is located on the north side of the house underneath the pitch of the roof. The room display is meant to resemble the set-up of the room while the Anderson daughter lived in the house. There is a small bed on the west side of the room with various toys and books displayed on the bed. The books have sheets of cut Mylar® underneath them to prevent the acidic paper from staining the bedsheet. There is also a small table on the east side of the room with small toys displayed and a small dresser along the north wall. There is a small cubby/crawl space in the southeast corner of the room that currently has nothing stored inside. The cubby has evidence of previous water damage along the west wall including tidelines, potential mildew staining, and loose insulation material. It is unclear when this water damage occurred, but it is most likely due to damage to the roof.

Interior of the cubby hole in the southeast corner of the room.

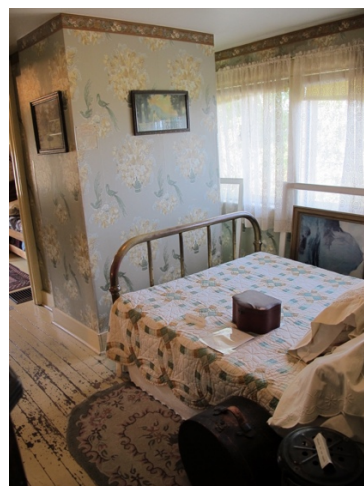
The most visibly disturbing modern addition to the room is the space for the fireplace flue that goes through the middle of the room. The flue is entirely walled in, which creates a large square box structure that goes through the middle of the room. To make space for the flue, the bed has had to be shortened and the amount of space in the upstairs area is significantly restricted. The open area between the flue and the west windows is used for storage of non-displayed paintings and removed storm windows. There are two windows along the west wall of the Parents' Room that look out onto the inlet. The southernmost of these two windows has multiple structural problems, which has led to Museum staff duct taping the window closed. There is also attic entry through a door on the west wall of the flue structure, creating a small closet. It is difficult to reach the door as the space between the flue structure and the west wall of the house is very constricted.

Interior view of the parents' room facing southwest. The large rectangular wall in front of the bed is the flue structure.

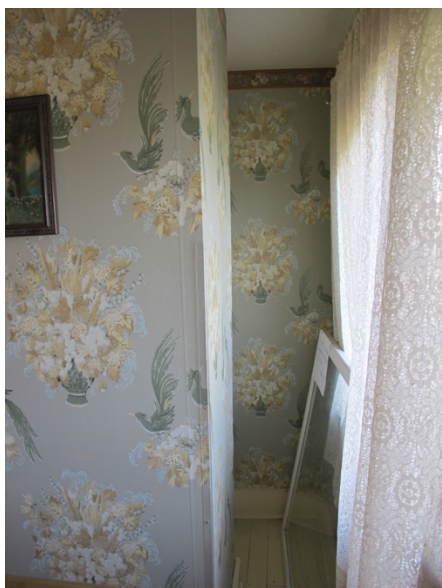
The space between the flue structure and the west wall where paintings and storm windows are stored.

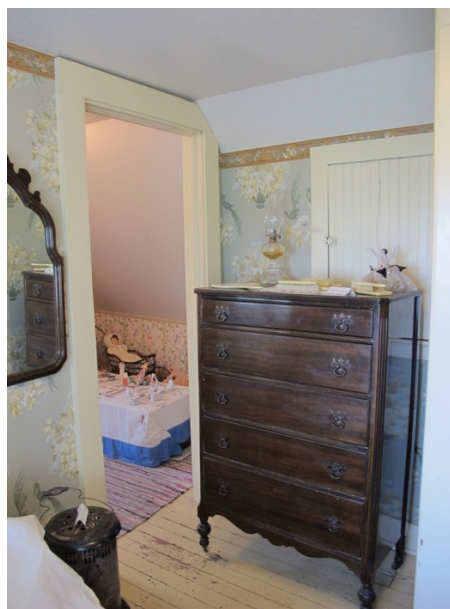
Dresser with objects made out of early plastic displayed on top, in direct view of the western facing windows.

The Parents' Room is warm at approximately 78°F but within an acceptable humidity range at 49.5% RH. Nevertheless, it is very bright with levels above the recommended visible light range of 200 Lux and high positive UV readings. The high UV can be damaging to some of the artifacts on open display. Of primary

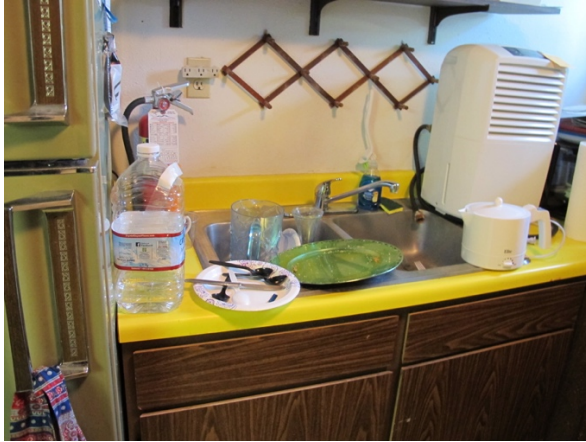
Although there are no collection objects stored in the basement offices there are multiple potential environmental issues that could result in condition problems for the space above. A major issue is the presence of open food, dirty dishes, and unemptied office garbage cans with food items. The presence of food outside of sealed containers can be attractants for both rodent and insect pests. Because the offices are connected to the Museum space above, pests initially attracted by the food may move into the Museum space and begin damaging collection objects.

Dirty dishes left in the sink in the staff kitchen.

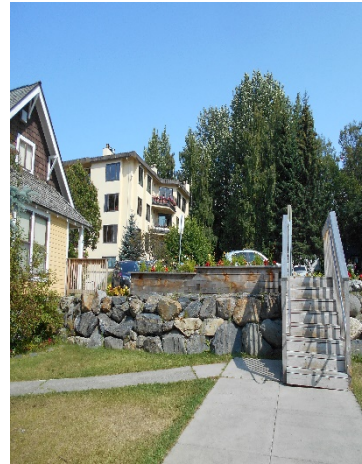
**View of Planters & Stairs  
(to south)**

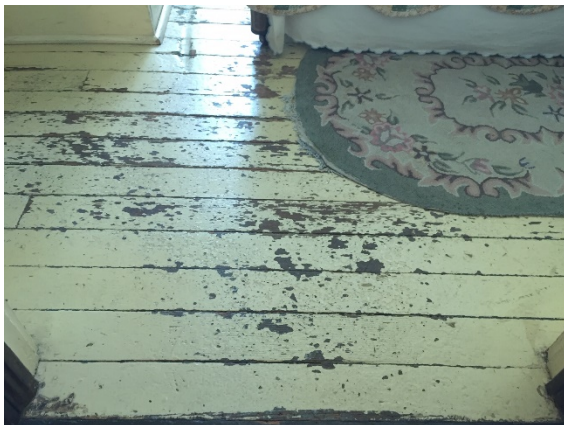
**Parents' Bedroom (floor to refinish-  
typical on second floor)**

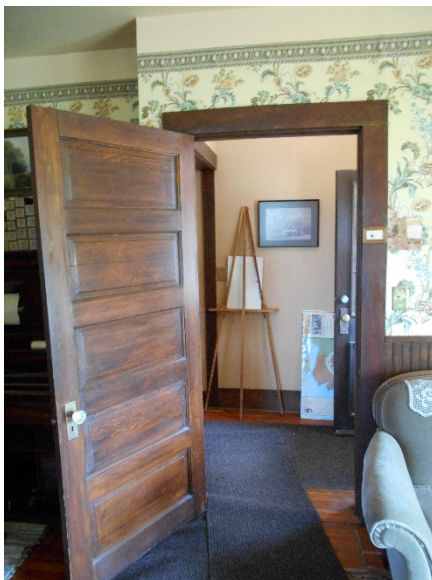
**Existing Main Floor Panel Doors  
& Hardware (original)**

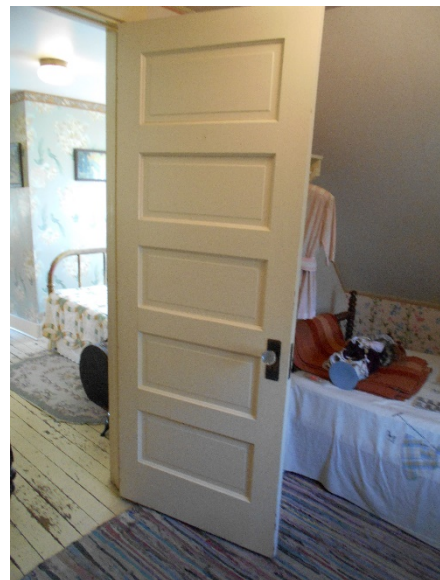
**Existing 2<sup>nd</sup> Floor Panel Doors  
& Hardware (original)**
