# **2014 Dry Weather Screening Report**

## **APDES Permit No. AKS-052558**

**MUNICIPALITY OF ANCHORAGE**  
**WATERSHED MANAGEMENT SERVICES**

November 2014

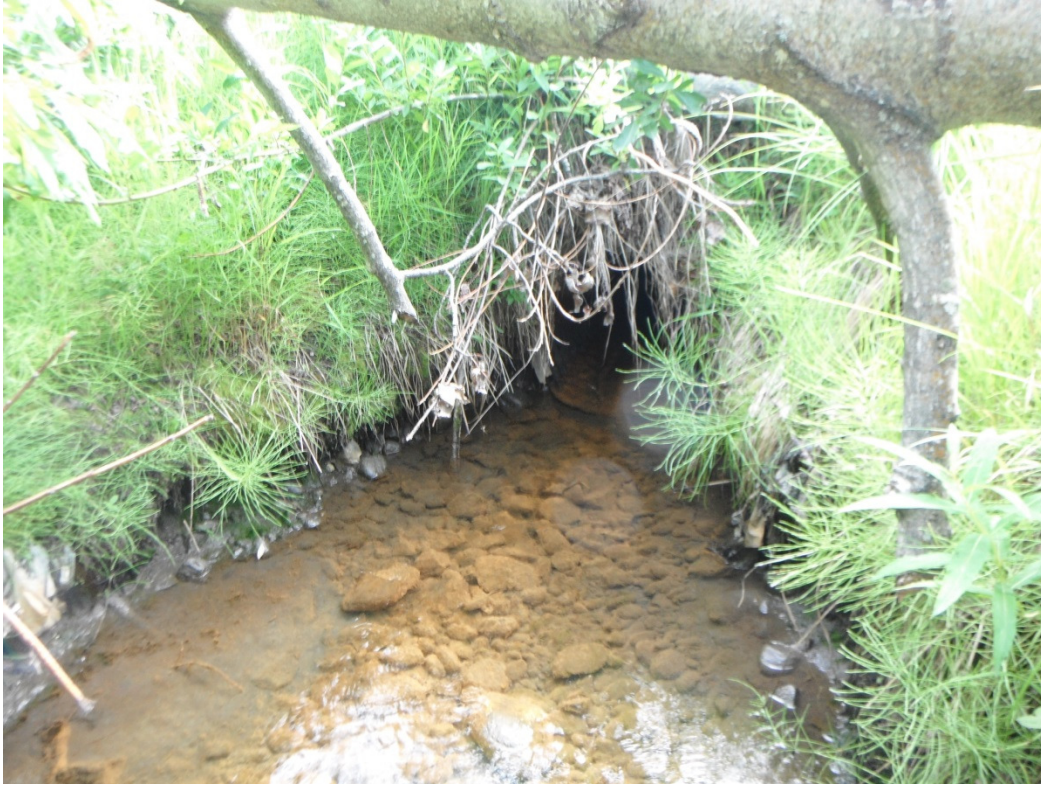
Ship Creek **213-1**: North of Allied building.

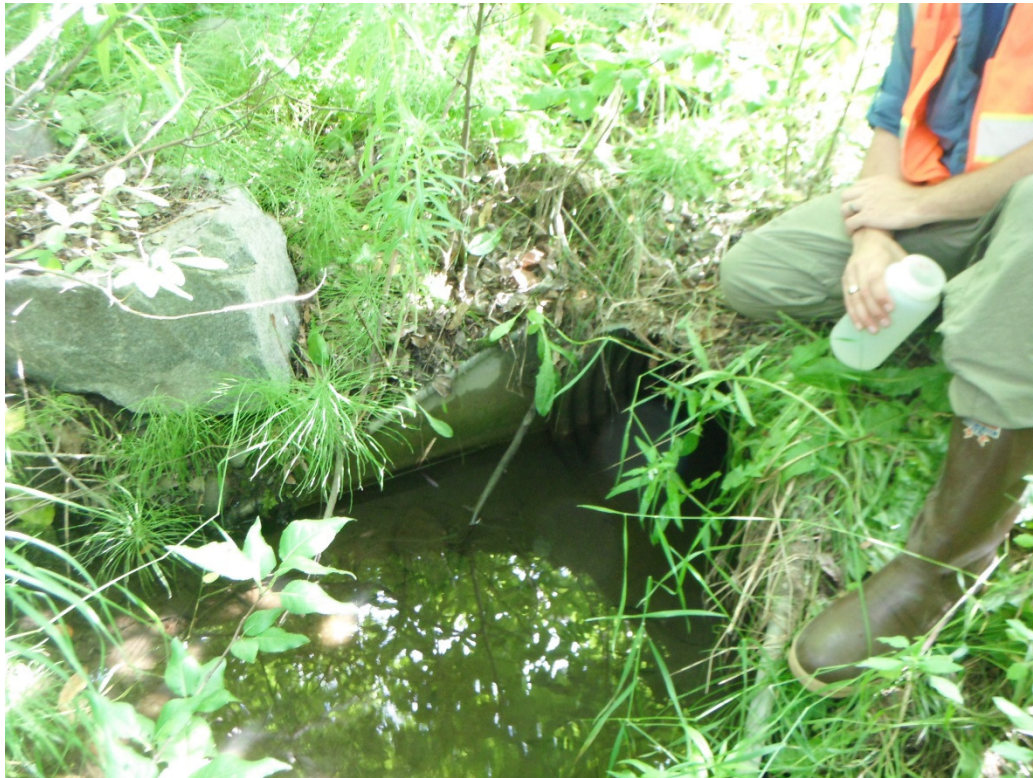
Ship Creek **491-1**: On Ship Creek trail near Alaska Flo-Wall Distributors.

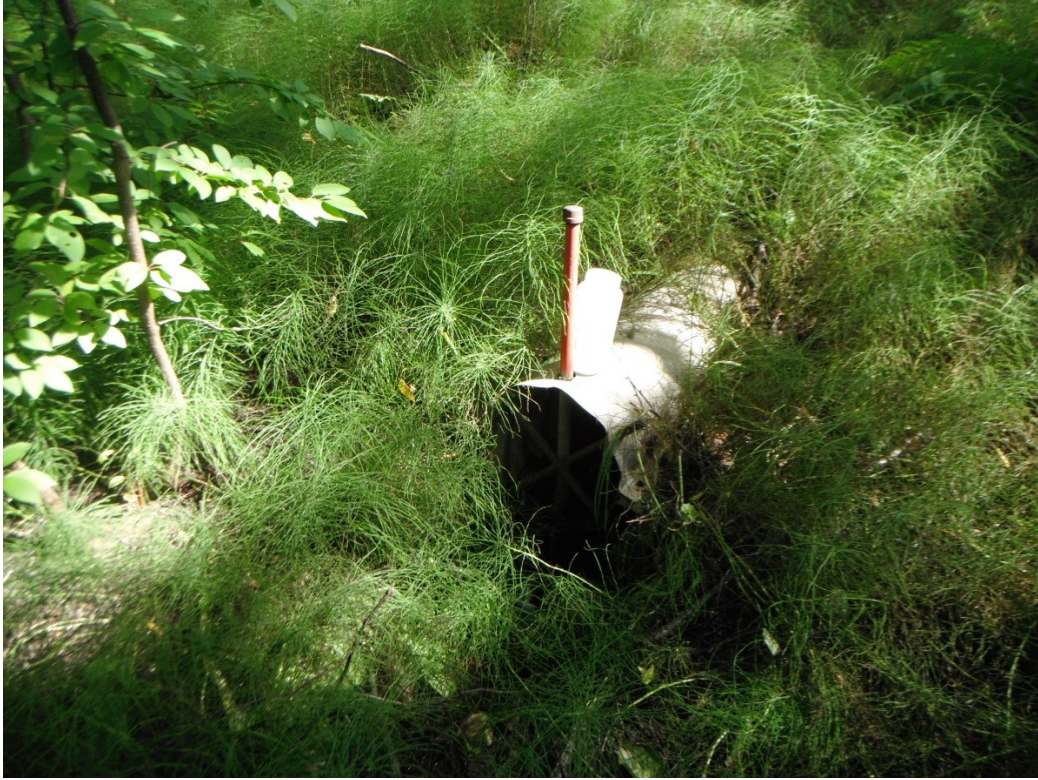
Fish Creek **595-1**: Between W 34<sup>th</sup> Avenue and Kona Lane.

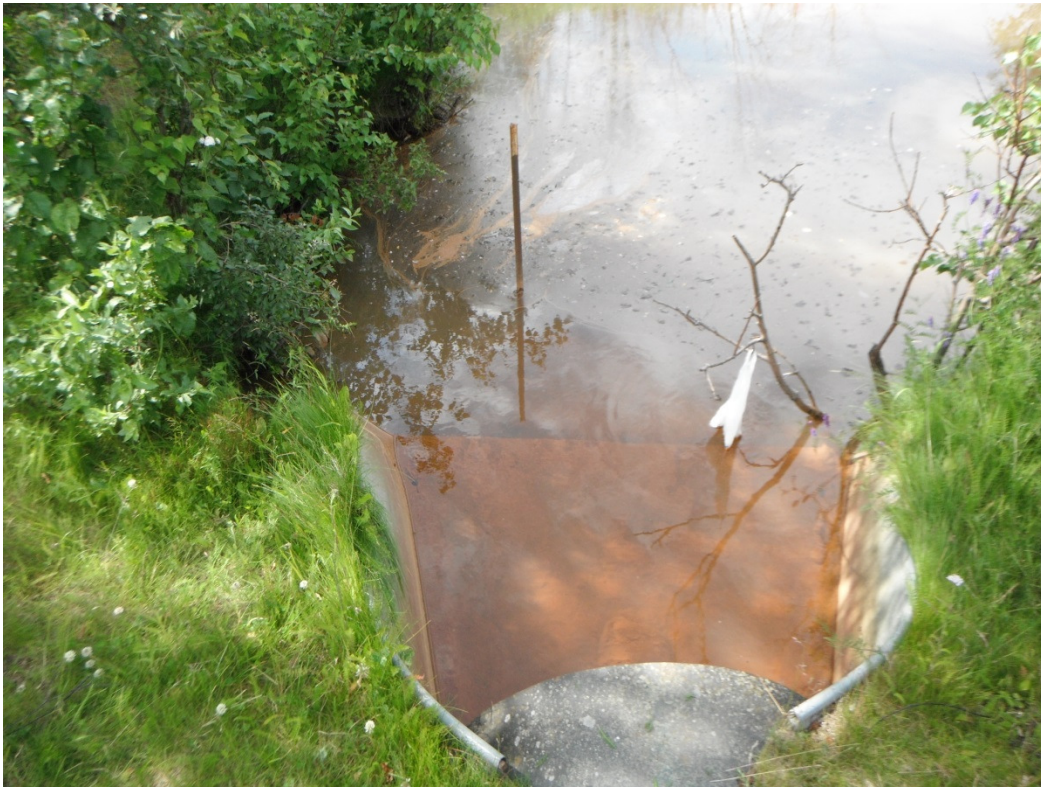
Fish Creek **388-201**: Corner of Northwood Drive and Haru Lane.

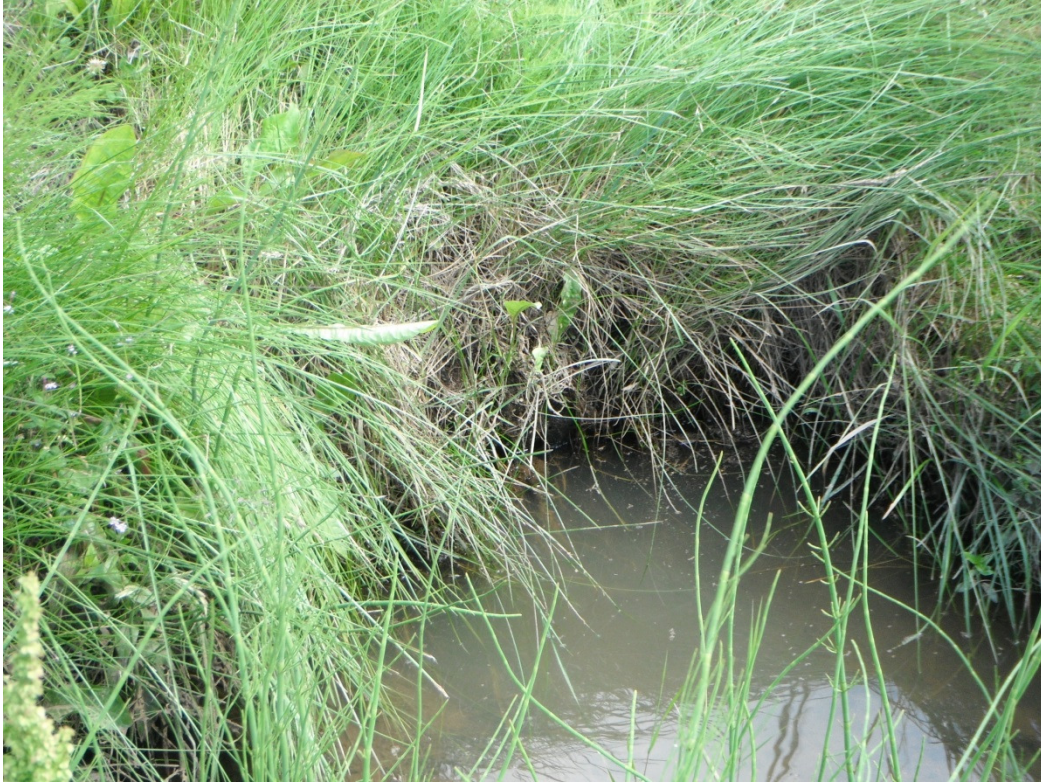
Fish Creek **37-1**: Chugach Way near Spenard Road.

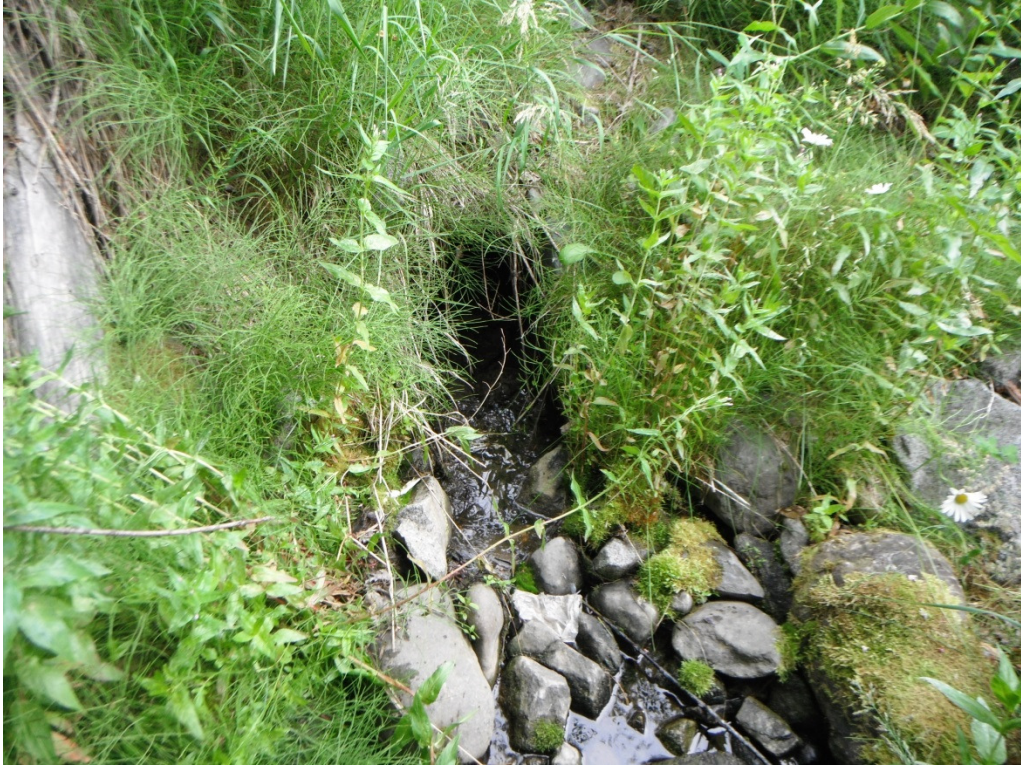
Eagle River **1417-1**: South of Eagle Place addresses 19920 and 19862 Driftwood Bay Drive.

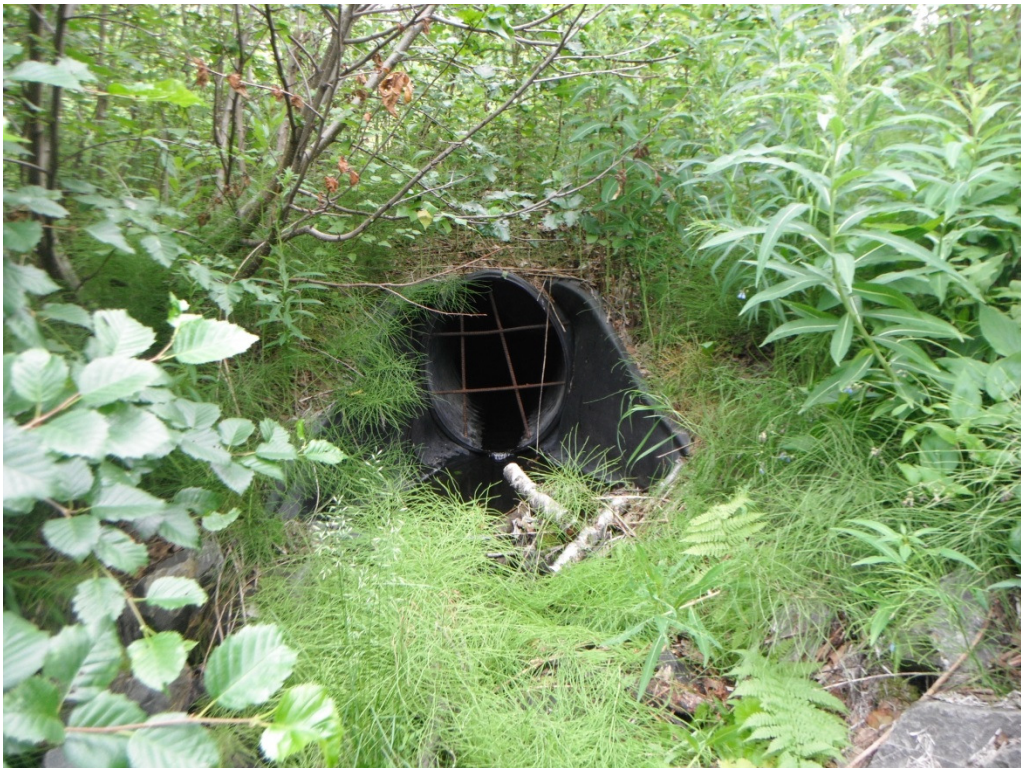
Eagle River **1451-1**: Near west corner of Riverside Drive.

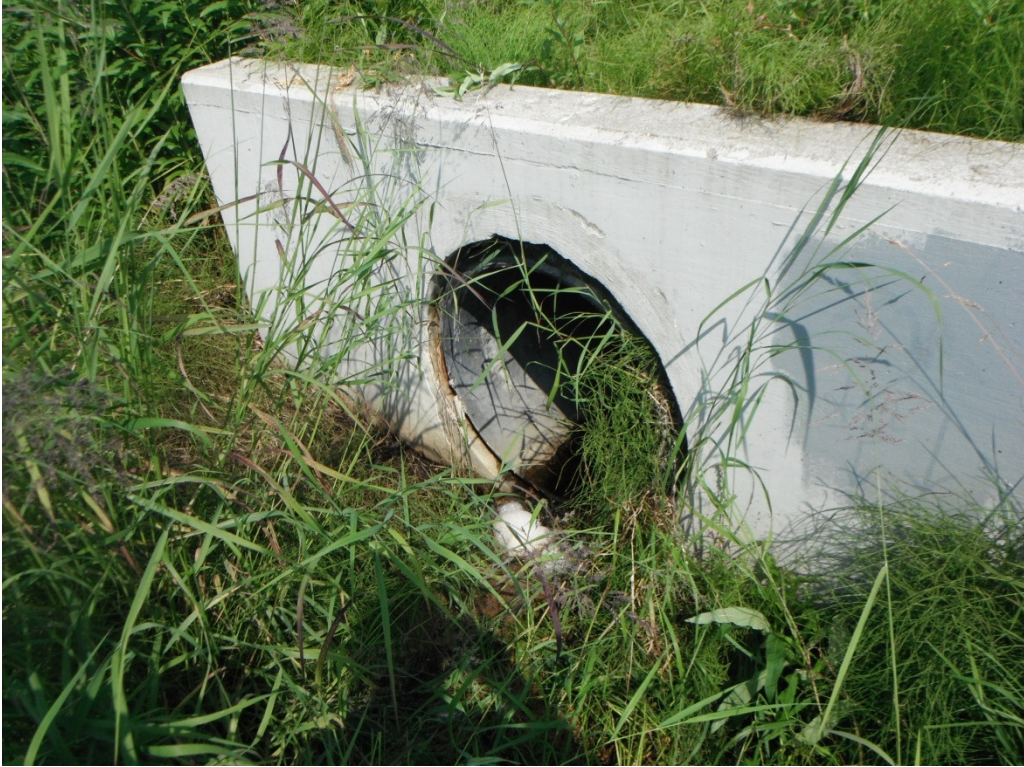
Campbell Creek **581-1**: Near bike path at Arctic Blvd

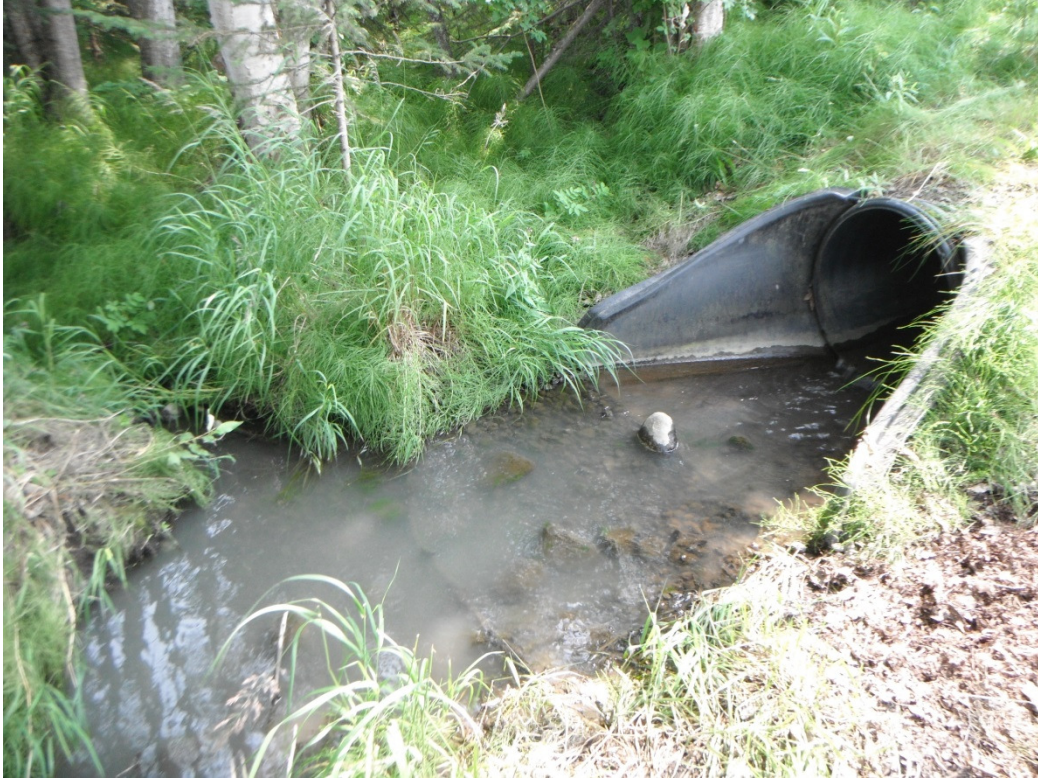
Campbell Creek **496-1**: Adjacent to Nadine Street.

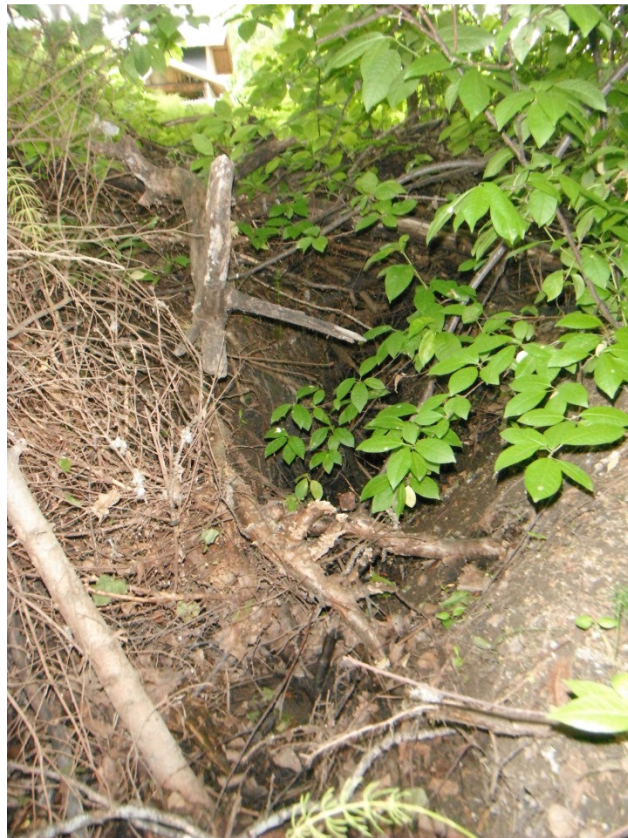
Fish Creek **584-1**: Before clearing
