# MOA and ADOT&PF 2015 Low Impact Development Project Performance Monitoring Report

The Municipality of Anchorage

*January 2016*

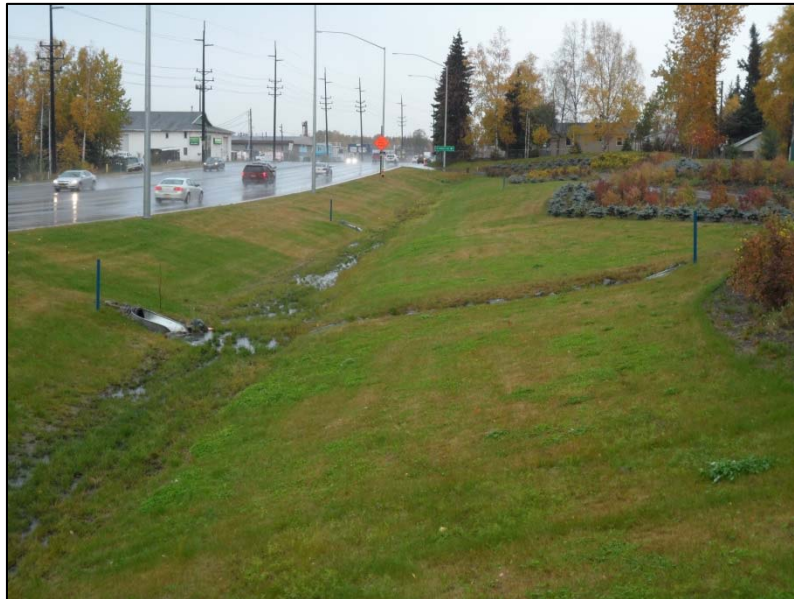
**Figure 5: Bioswale Overview 9/28/15**

During the observations on September 12 and September 28, water was slowly and steadily entering the bioswale from four of the five storm drain outfalls that discharge to the swale. Water was ponding on the swale bottom and slowing trickling toward the swale outlet. Figures 5 through 8 provide an overview of the swale and photos of the outfalls. The slow movement of water through the existing vegetation allows sediment to fall out of the water. It was noted that most of the grassy vegetation is being mowed and kept very short. One outfall was observed to be partially blocked by vegetation, but did not appear to be causing any problems. Water downstream of the bioswale was observed to be ponding on the surface instead of flowing into Campbell Creek, allowing for additional treatment potential.

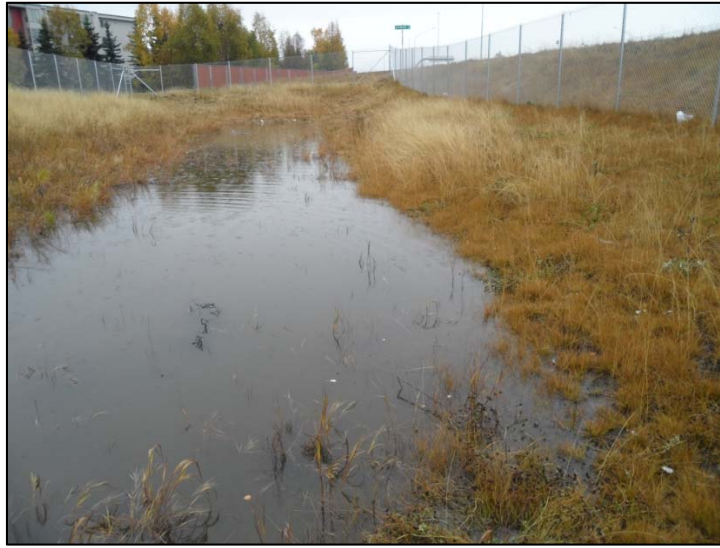
Figure 15: Infiltration Basin 9/28/15

For the 2015 monitoring program, the infiltration basin was visually inspected during each of the monitoring events discussed in Section 2. Generally the infiltration basin was observed to be performing well and exceeding design expectations. The basin continues to fully capture small to moderate storm events while providing detention of peak flows from larger events.

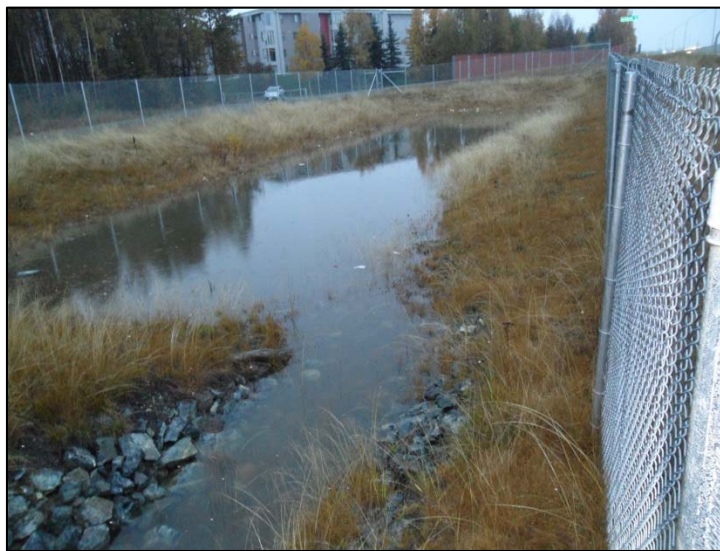
Figure 16: Infiltration Basin 9/29/15

During the September 12 site visit, water was flowing into the facility via the culvert inlet, and the basin was storing a small amount of water on the basin floor. The outlet was not flowing, indicating that all inflow was being either infiltrated or stored. Similarly, on the September 28 site visit, water was flowing into the facility, but the outlet was not flowing. The basin was holding significantly more water than was previously observed. Standing water depths were approximately 13 to 15 inches. Generally, this indicates that the facility was still infiltrating and storing all of the basin inflow. The September 12 event was generally close to the rainfall event the facility was designed for. However, the rainfall that occurred from September 26 to September 28 was approximately 1.41 inches (based on ANC date), which exceeds the design event in both magnitude and duration.

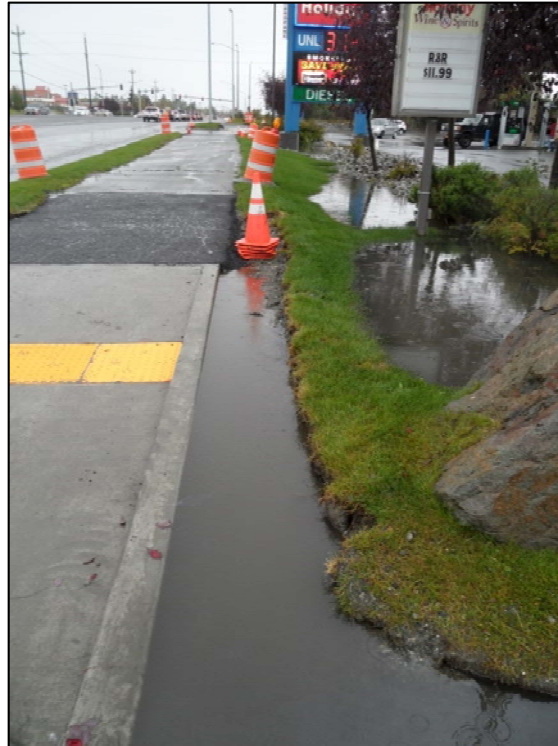
**Figure 31: Holiday Rain Garden Overview**

Visual inspections of the Holiday Gas Station were completed on September 12 and September 28<sup>th</sup>. Based on observations made on September 28, a visit on September 29 was determined to be unnecessary. Generally, the facility did not appear to be functioning well.

way to drain between rainfall events. Without an underdrain, the facility presents little to no treatment benefits. Once the basin is filled, it also provides no detention benefit, as water simply flows in and then overflows. Photos of the facility are provided in Figures 30 through 32.

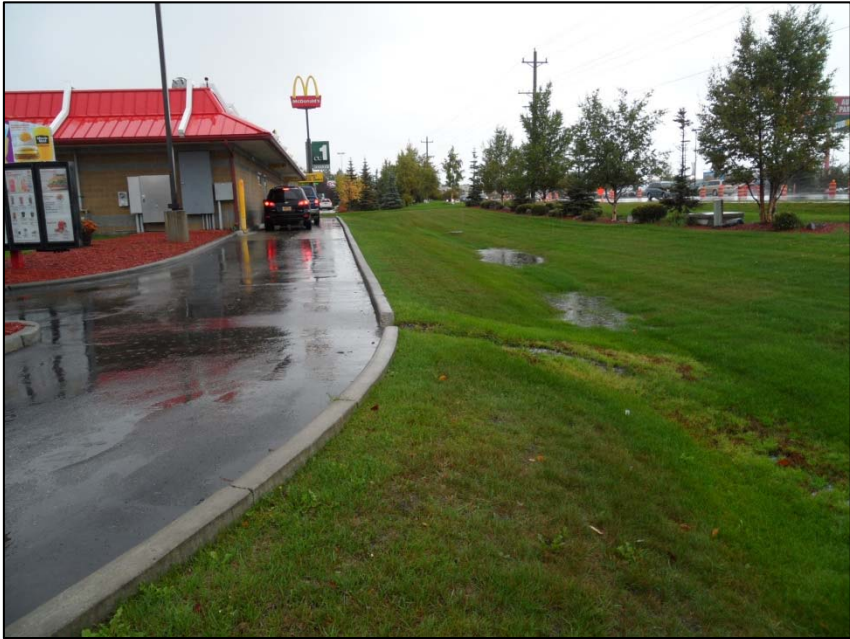
Figure 35: Vegetated Swale

The vast majority of the site was very well-drained. Landscaped areas and the large vegetated swale were taking in large quantities of runoff and effectively providing infiltration and filtration. The swale provided a slow movement of water toward the swale’s center low point where there appears to be two storm drain inlets. One is at the lowest point, and one is elevated above the flow line. However, the one at the lowest point was not flowing. This beehive-style casting is either not connected to a piped system, or is blocked by an old sediment trap or something similar. Flow was observed to be ponding in this area. When ponding becomes roughly 8 inches deep, the elevated storm drain begins to flow. This was observed only during the September 29 site visit. These observations indicate that the facility is providing both stormwater treatment through infiltration and filtration, as well as significant reduction in peak flows through onsite storage. Site photos are provided in Figures 34 through 37. Additional information from the visual monitoring is presented in the Site Monitoring Reports in Appendix B.

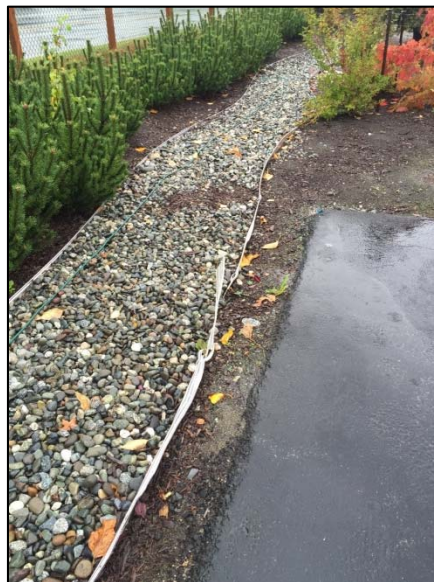
**Figure 42: CFAB Landscape Edging**

The facility is a great example of incorporating landscaping into stormwater management features and keeping those facilities well-maintained. However, the success and optimal performance of these types of GI facilities can often be impacted by small things, such as the landscape edging in this situation. Providing an unobstructed flow path would improve facility performance and should be noted for future landscape applications.

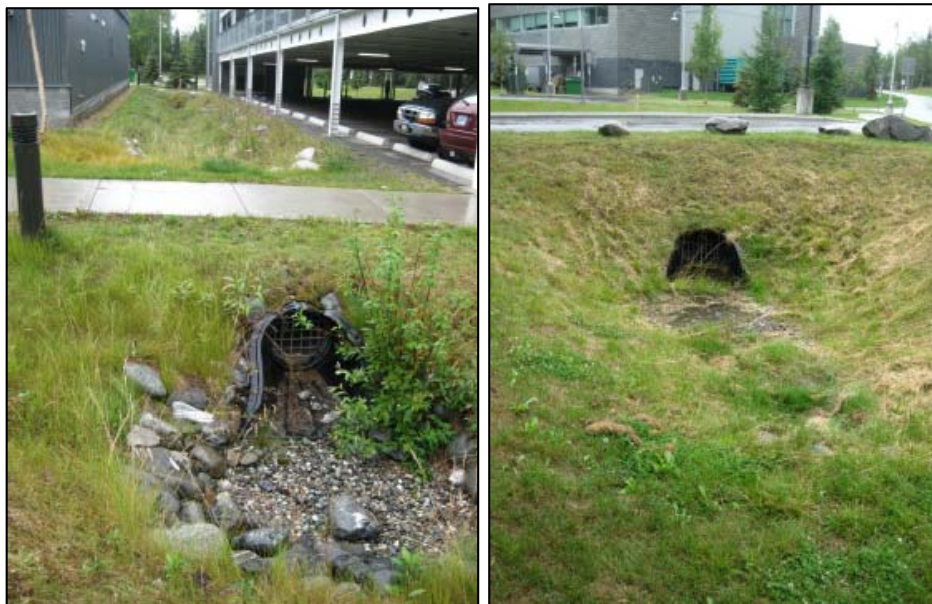
**Figure 48: UAA Science Center Parking Area Bioswales**

The bioswales' performance varied. In one location, the bioswale was receiving runoff from adjacent areas and appeared to be functioning well. In other locations, the bioswales did not appear to be receiving much inflow. It was noted that water from an adjacent sidewalk and plaza area was directed to a catch basin connected to a storm drain system instead of being routed to the bioswale. It was also noted a down drain from the parking structure appeared to be routed directly to a piped storm drain system instead of flowing onto an adjacent vegetated area. This piped storm drain may outlet to a bioswale downstream, but it was unclear why the runoff was directed into a pipe. Generally, the vegetation looked healthy and well-maintained. Site photos are provided in Figure 48.

In this facility, a good bioswale design appears to be underutilized by inconsistent site grading and drainage. Although it is not clear why this occurred at this site, underutilization can often result from overlooking GI during initial site layout. GI is generally most successful when it is a central part of the initial site layout and the facility grading and drainage plans.

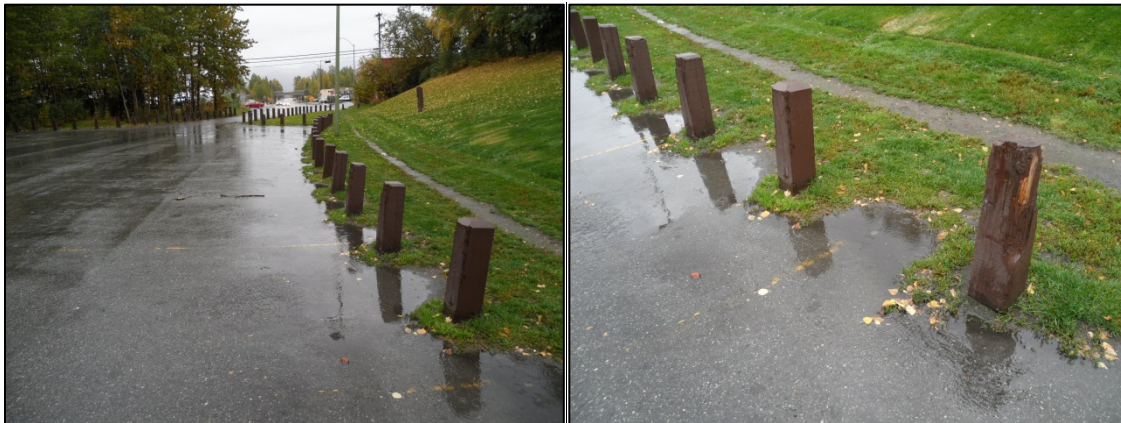
There was no surface water standing or ponding inside the rain garden. Vegetation looks healthy and somewhat overgrown. Some tall grass-like plants have either fallen down or been laid down by wildlife (moose).

Overall, the rain garden looks good.

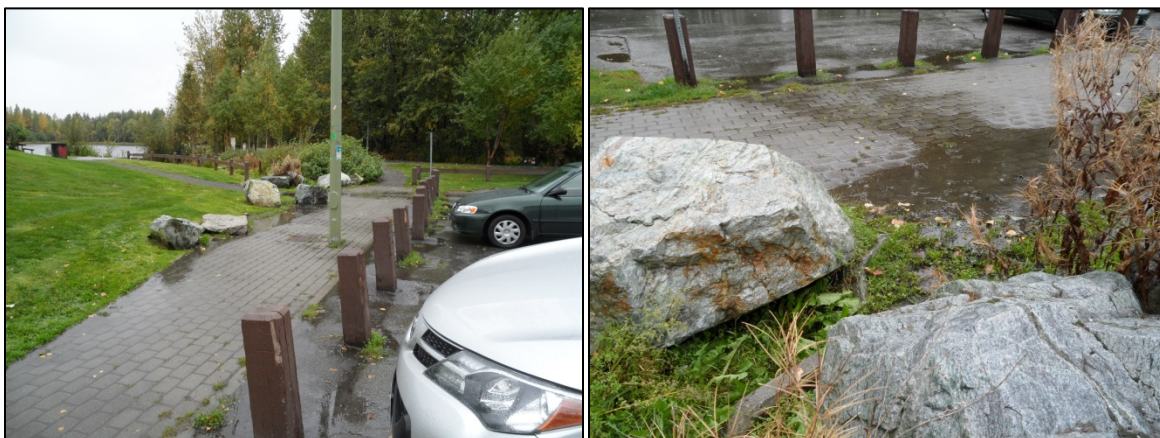
*Left: Water flow toward the inlet. Right: Ponding at the inlet.*

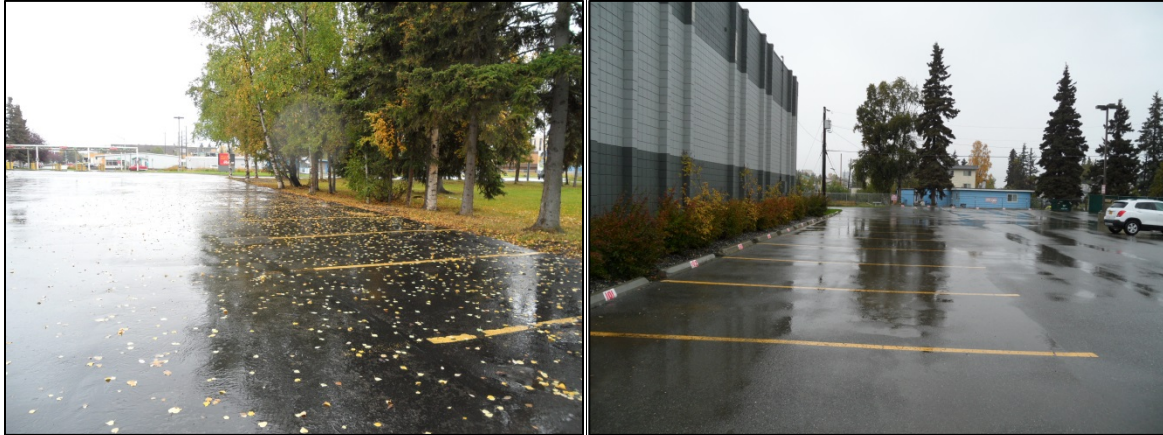
Observations: The site was visited because it was reported to have vegetation accepting runoff from the parking lot. However, upon inspection, water from the parking lot is sloped away from existing vegetation. Storm inlet are collecting runoff. Not considered an LID/GI site.

*Parking lot on either side of the building*

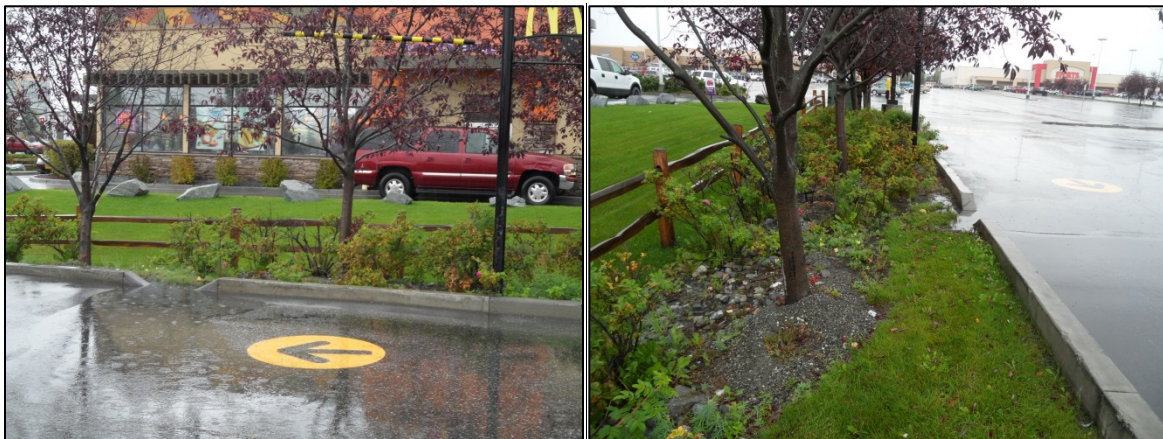
Most of the system appears to be working very well. On the north side of Taco Bell, a considerable amount of water is bypassing the system via a man-made foot path that has created a depression. On the south side of MacDonald's, localized ponding is occurring because one of the parking lot outlets is not flowing well. The facility is also receiving some water from the property to the south, though it does not appear to be designed to do so.

*Taco Bell Parking Lot*

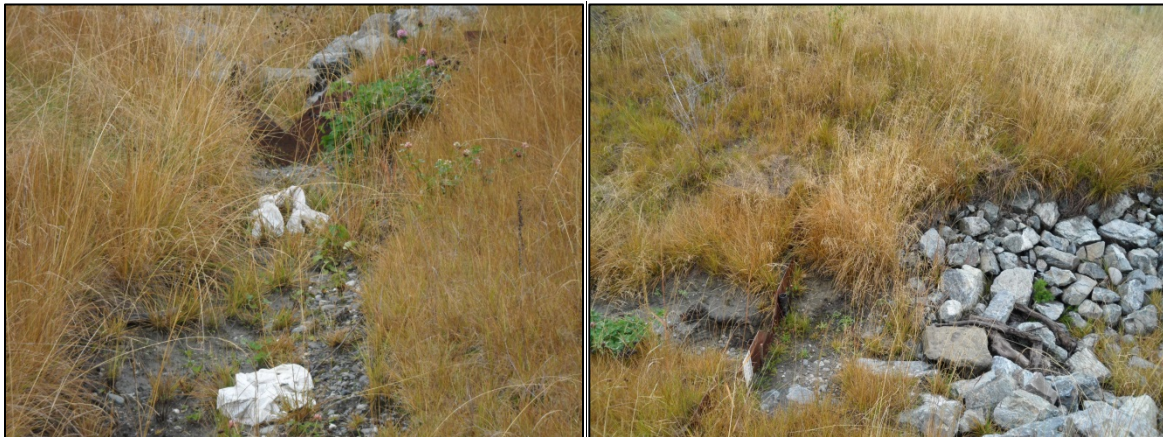
*Facility outlet*

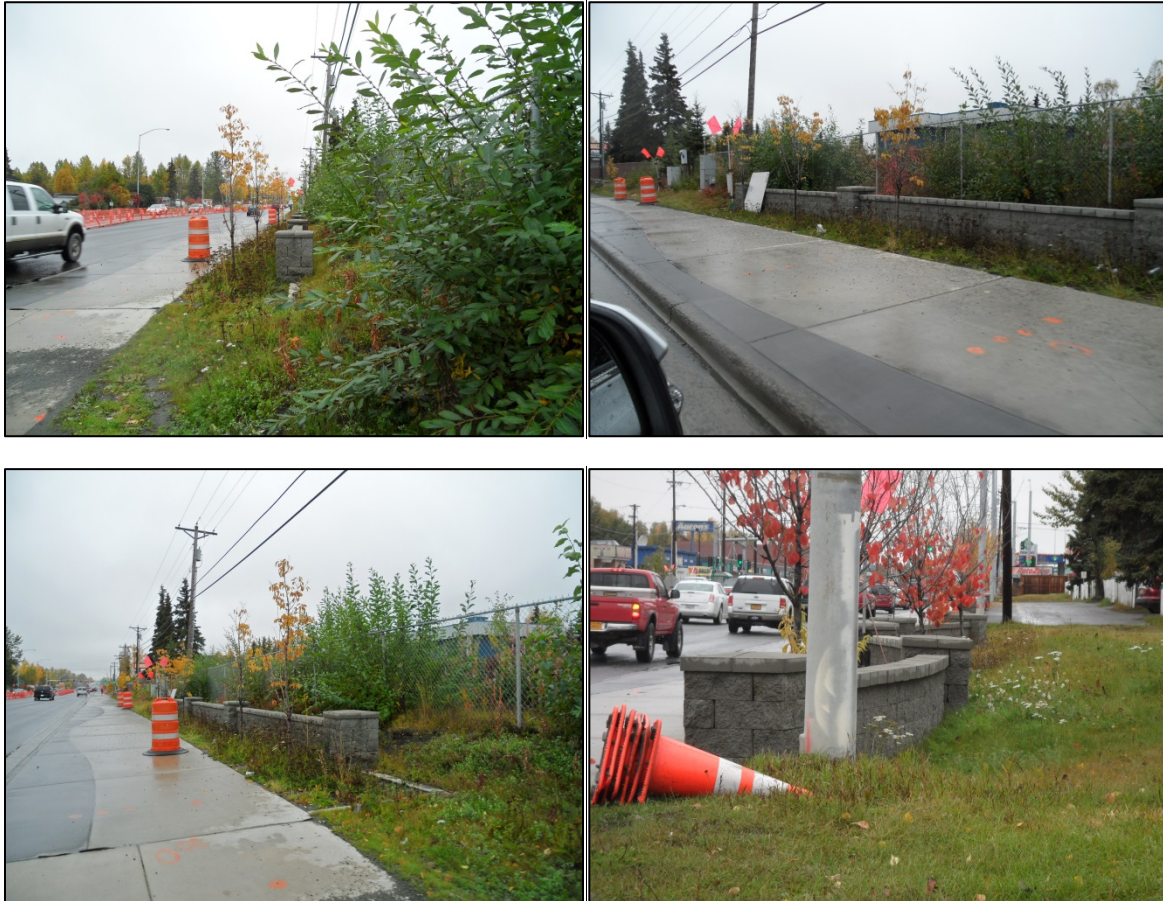
The landscape beds along the Muldoon corridor are in poor condition. Vegetation in most places is not healthy. The placement of the landscape areas and associated landscape walls is not promoting capture and infiltration of water, and in some cases are actually impeding the flow of water from adjacent areas to the landscaped areas. In many cases, adjacent natural vegetation looks healthier than the planted areas.

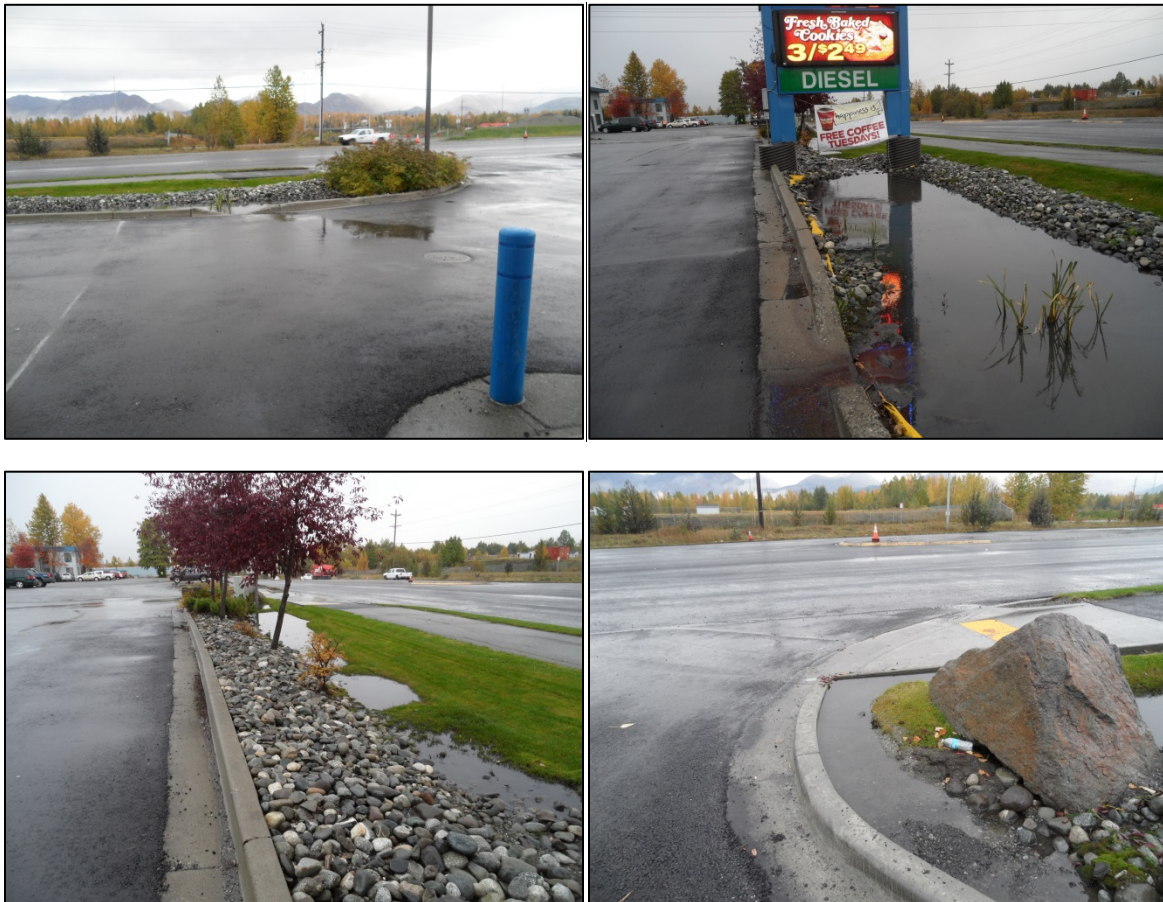
Observations: The majority of the gas station parking lot was sheet flowing to the rock/vegetation landscaping area adjacent to the OSH. Standing water depths in the landscaping were 9 to 12 inches on the south side, and 5 inches on the north side. The facility does not appear to have an outlet, and was very close to overflowing the curb line on the north side. The limited vegetation looked to be in good condition.

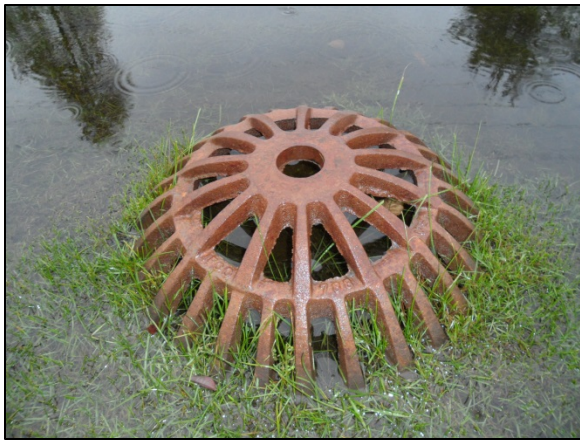
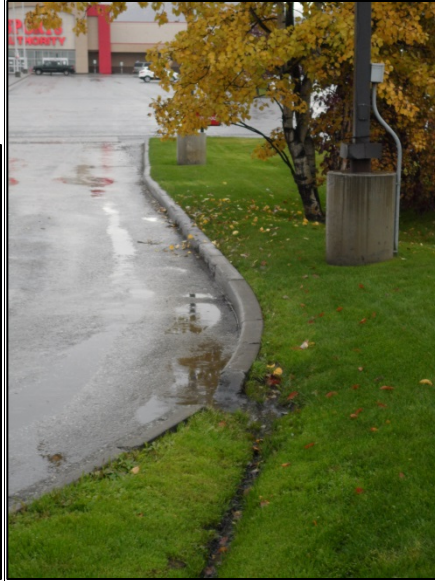
*Left: Grass growing through the beehive inlet. Right: Water entering vegetation from parking lot near the McDonald's drive-through area.*

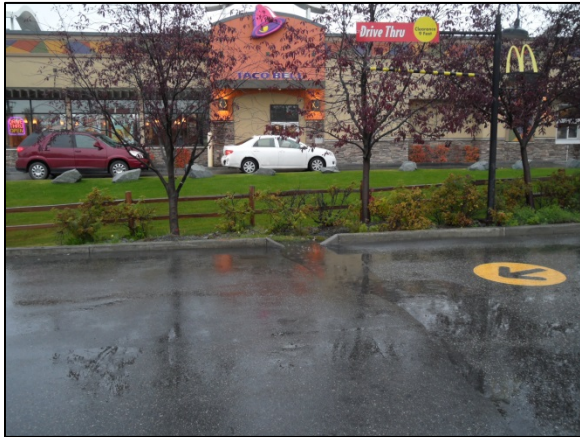
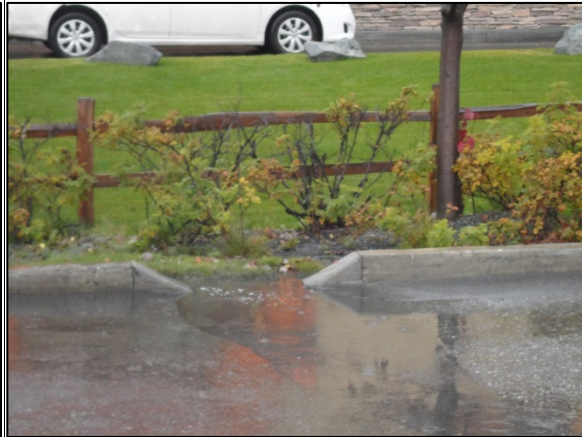
*Left and Right: Water entering the vegetation from the parking lot via curb cuts.*

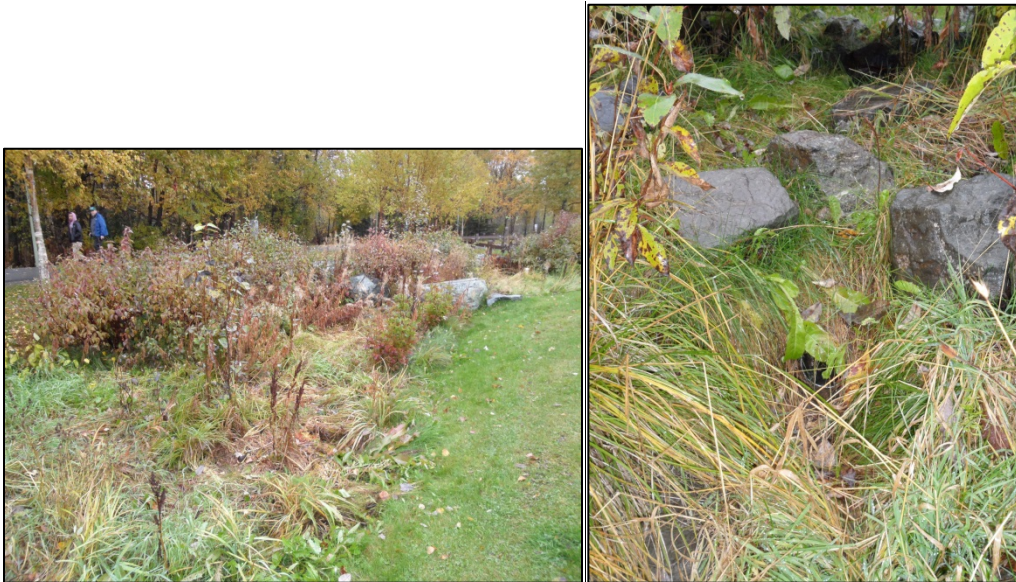
*Left: Vegetation inside the rain garden. Right: Underdrain outfall area*

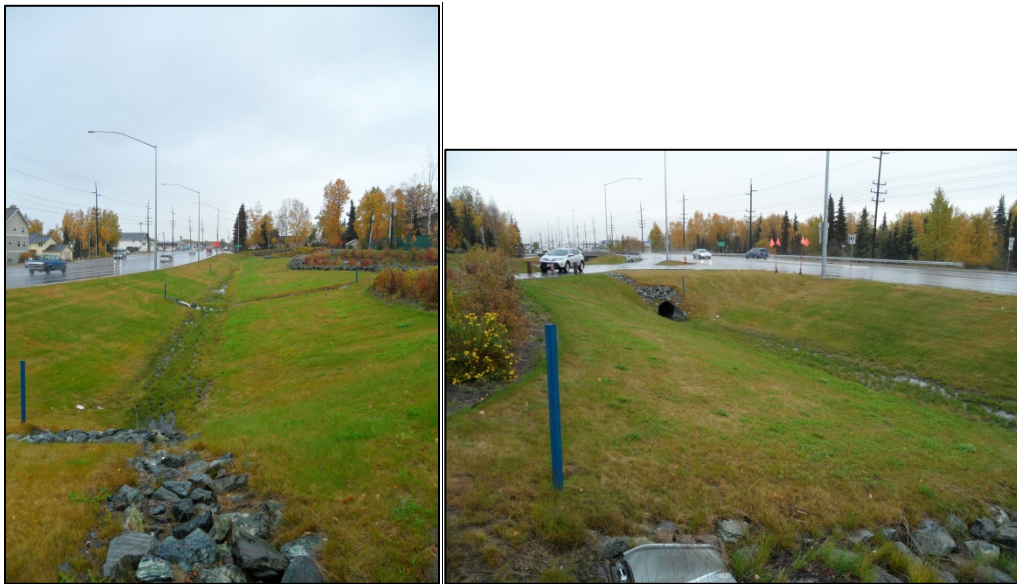
Observations: Water was steadily flowing into the bioswale from 4 of the 5 storm drains that outfall to the swale. At the far west storm drain outfall, vegetation continued to partially block the outfall, causing ponding in the storm drain pipe, but did not appear to be problematic. There was standing water in the swale that was flowing slowly toward the swale outlet on the east side. Water was flowing slowly into the bioswale outlet pipe. The bioswale vegetation was mowed fairly short. Overall performance is expected to be improved if the grass were allowed to grow taller. Water from the system was not flowing into Campbell Creek, east of the outlet. Instead, it was ponding upstream of the creek, which is apt to be further improving water quality.

*Overview of bioswale.*

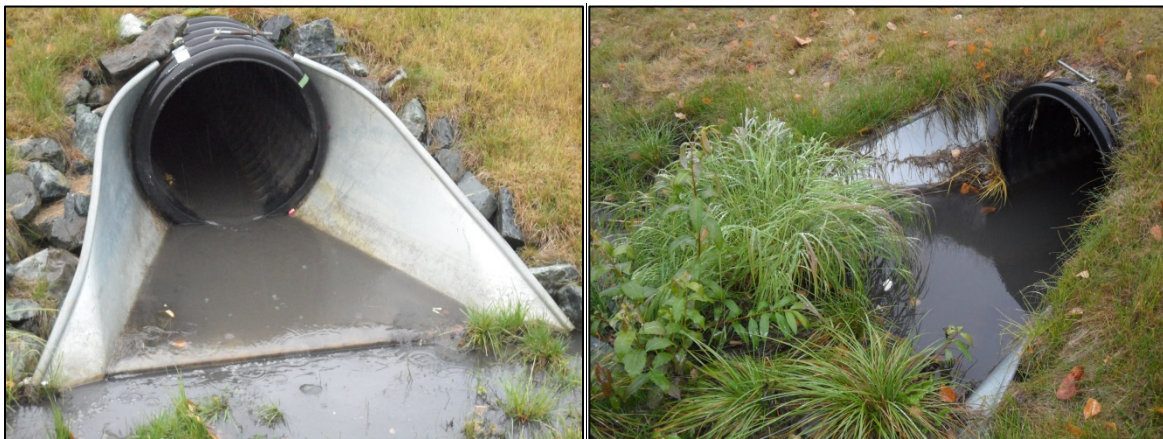
*Inflow to bioswale and ponding at storm drain inflow pipe.*

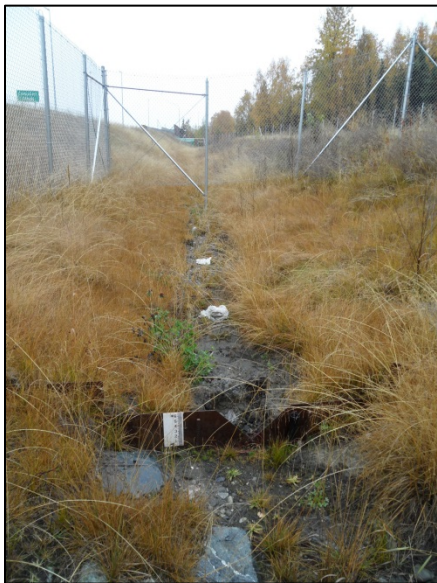
*Facility outlet*

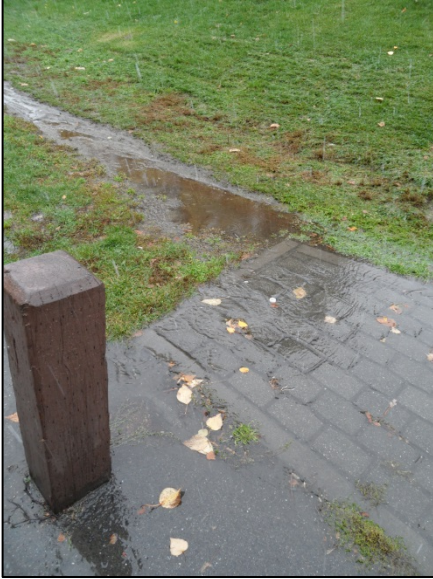
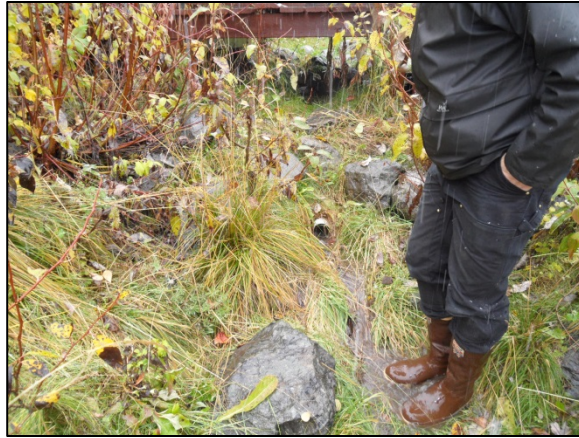
Observations: Heavy concentrated flow as observed flowing from the parking lot and into the rain garden. Surface ponding in the upper half of the rain garden was observed to be approx. 2 to 4 inches deep. Significant ponding was observed at the rain garden inlet. The ponding appeared to be from the thick vegetated mat on the rain garden surface, not from water coming to the surface from the rain garden layers. No ponding was visible at the lower end of the rain garden. The underdrain pipe was flowing about half full with a steady stream of water flowing into Taku Lake.

*Left: Significant concentrated flow running toward the rain garden. Right: Outlet flow*

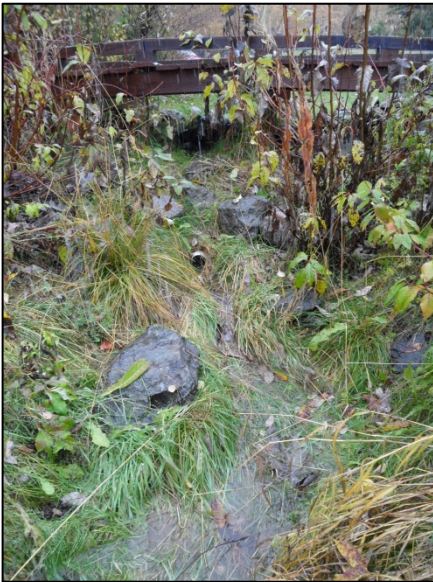
*Outlet flow running to Taku Lake*

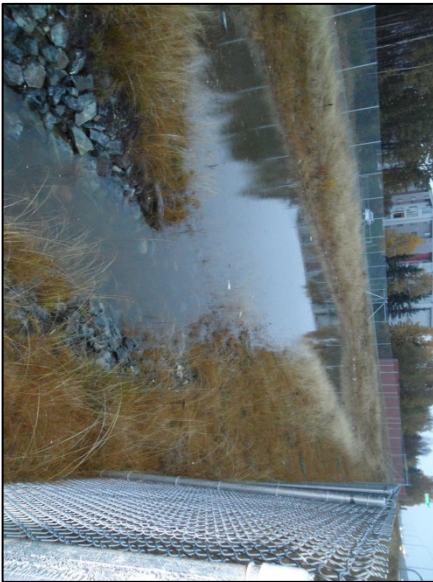
*Facility overview*

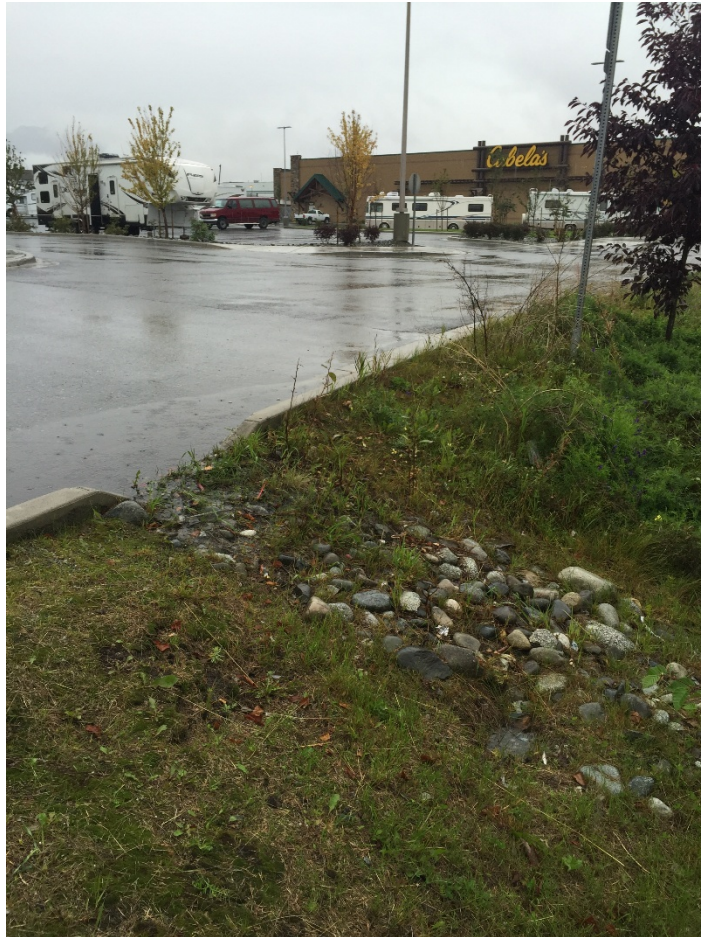
East side of pond – connector road from Target to Cabelas.

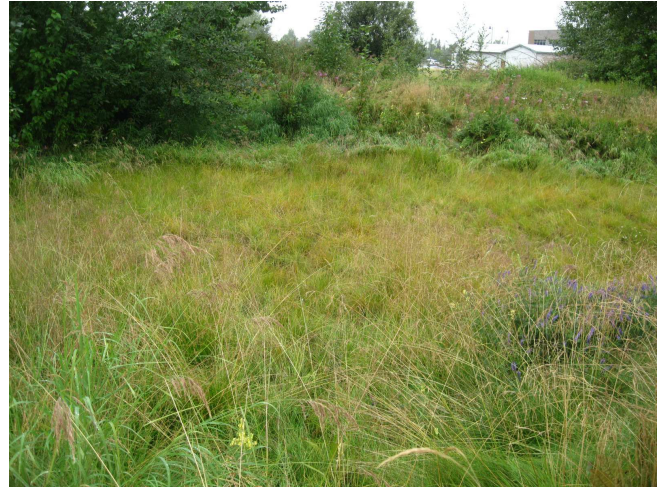
2 pond

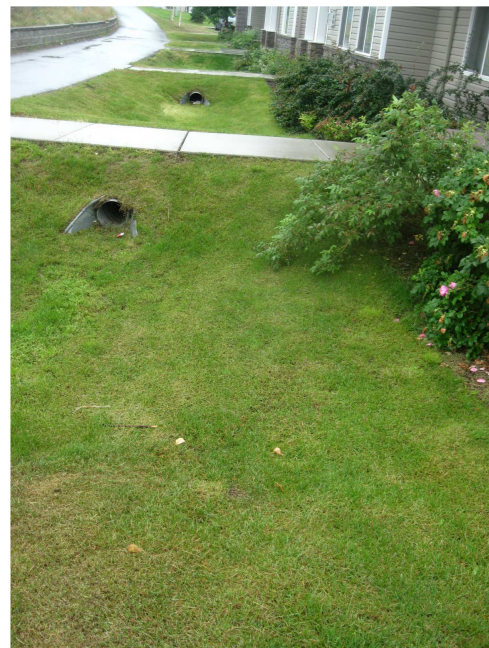
4 West portion of north east-west swale

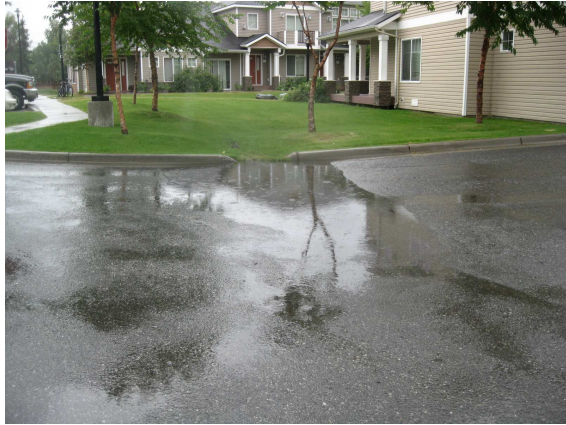
5 Field inlet area

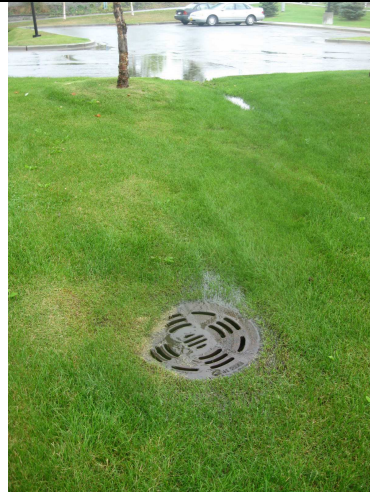
6 Close-up of field inlet area

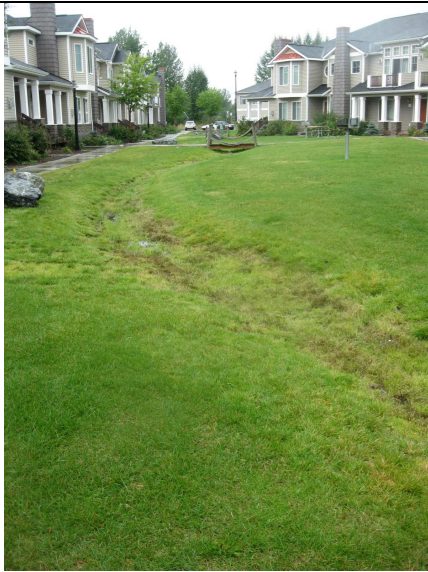
7 East end of east-west swale between groups of buildings

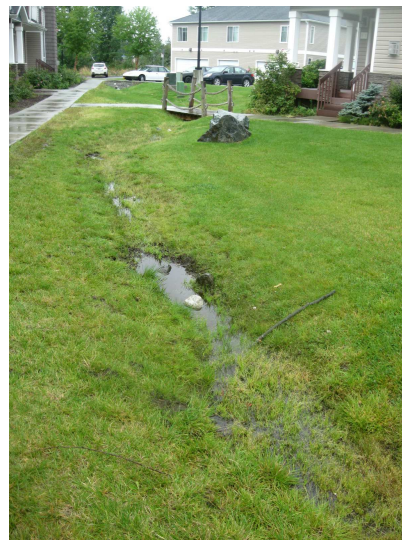
8 West end of east-west swale between groups of buildings

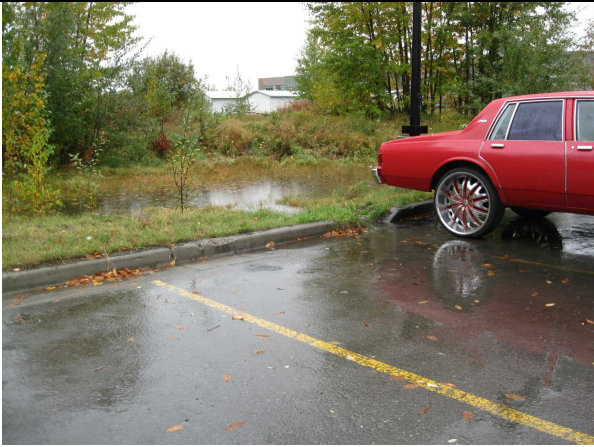
1 pond

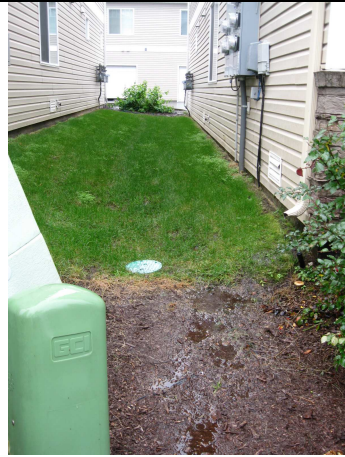
2 South-North Swale between bldgs

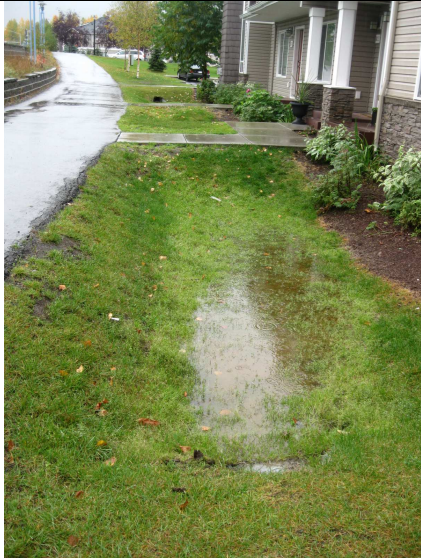
3 East portion of north east-west swale

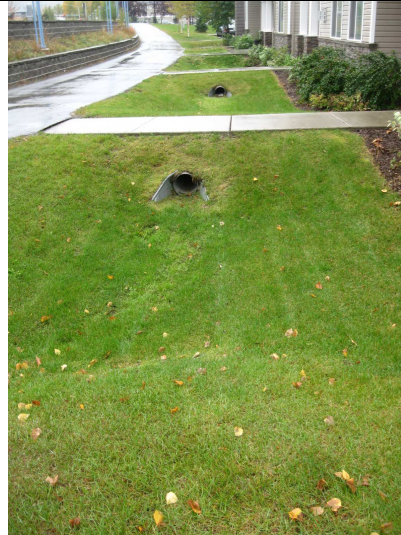
4 West portion of North east-west swale

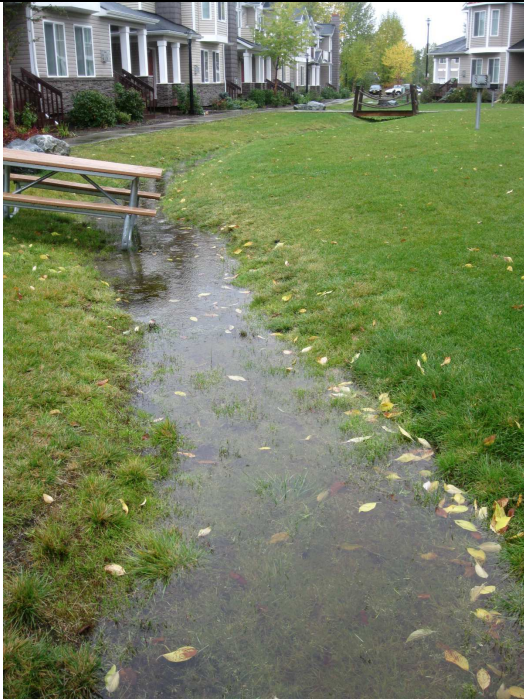
7 East-west swale between groups of buildings

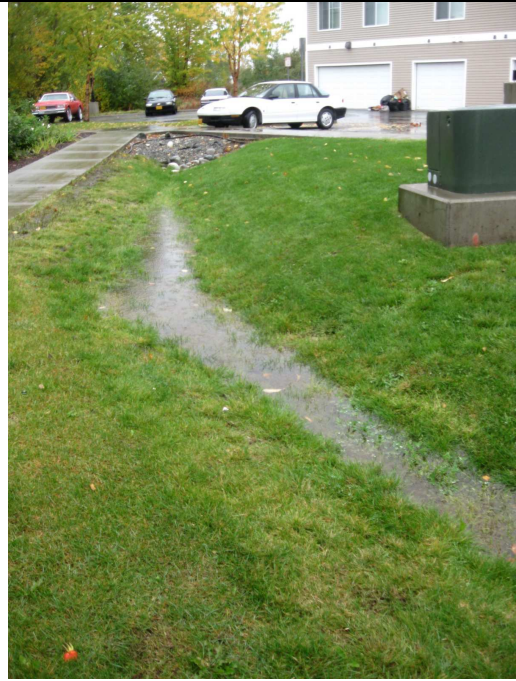
8 East-west swale between groups of buildings
