SUBJECT: APDES Inspection of ANC Taxiway Z West Improvements, Authorization Number
AKR10H0AH

APDES INSPECTION REPORT

Name of Project: ANC Taxiway Z West Improvements

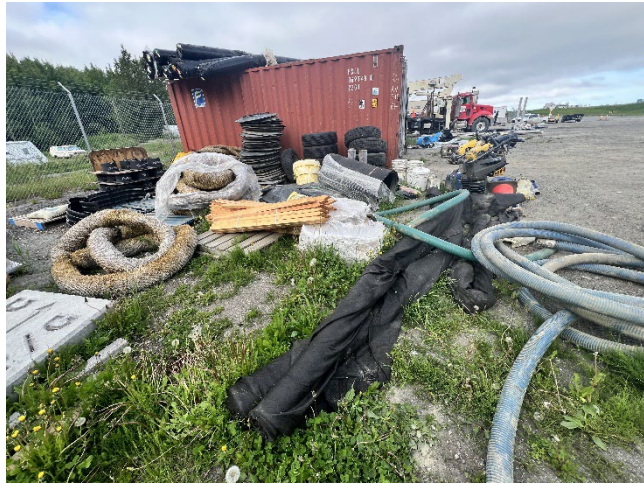
Photo 09

Material storage area

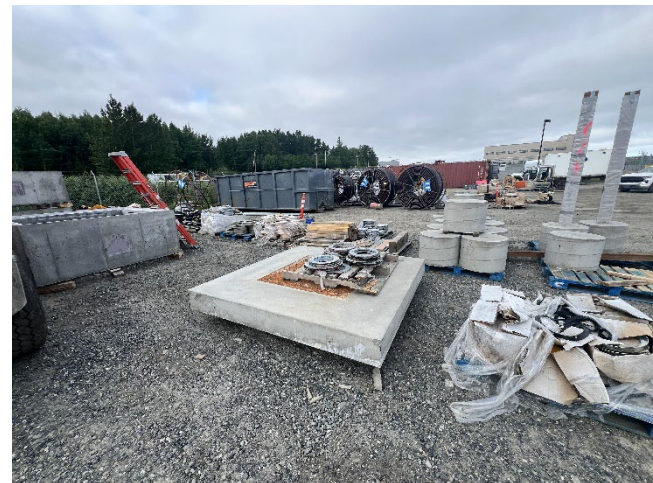
Photo 12

Material storage area

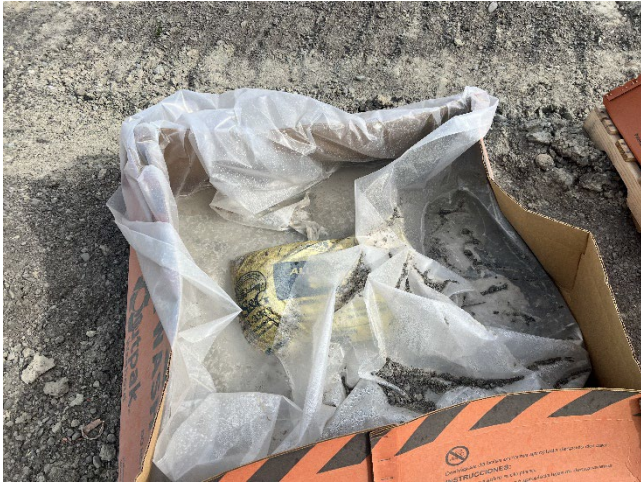
Concrete washouts	Concrete washout detail
Photo 19	Photo 20

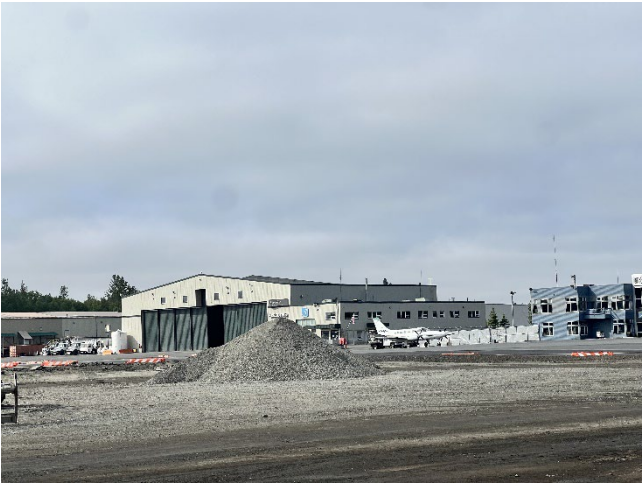
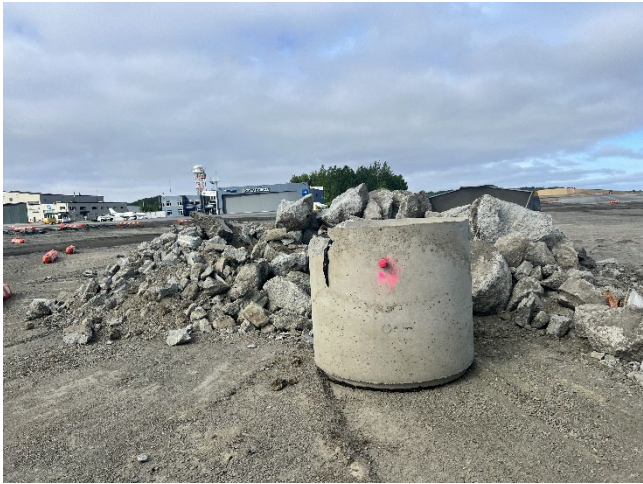
Gravel stockpile	Debris from old centerline stockpiled until it can be hauled away
Photo 23	Photo 24

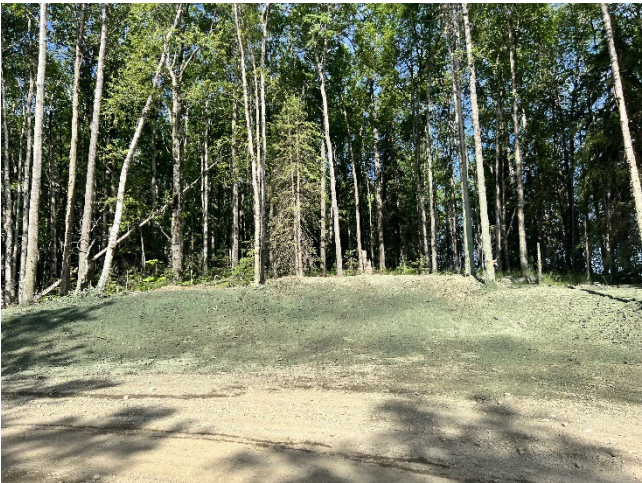
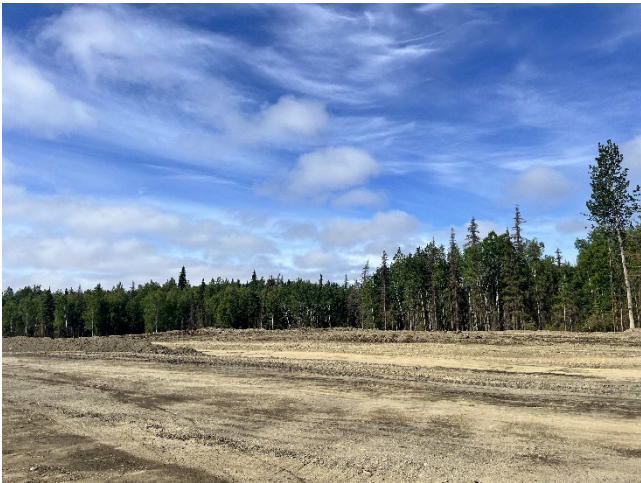
Trackwalking and hydroseed along access road to fill site	Fill site for uncontaminated soils

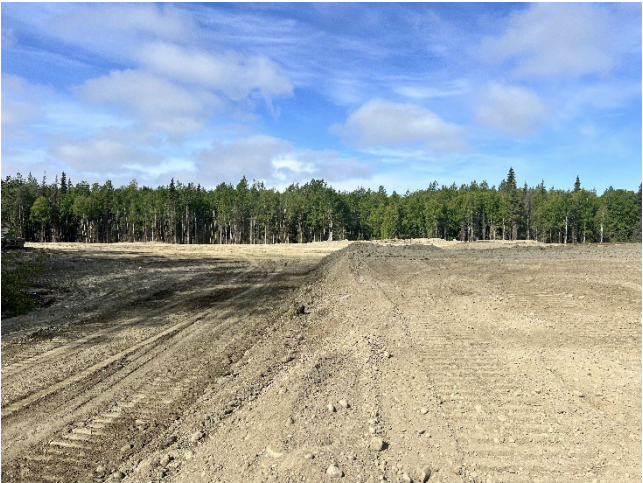
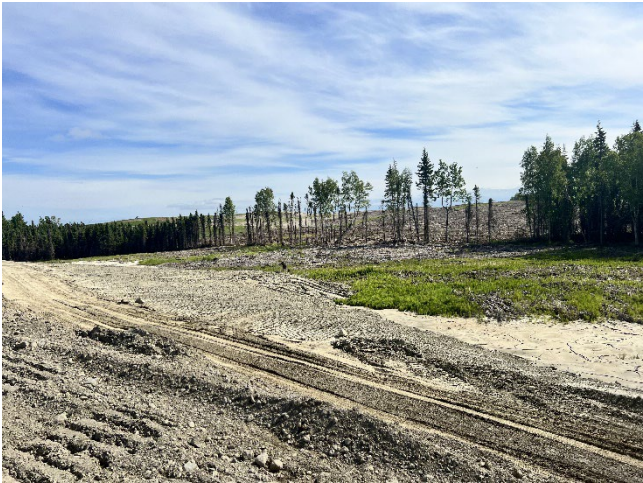
Uncontaminated soil fill	Trees separate this project's fill site from adjacent project
Photo 39	Photo 40

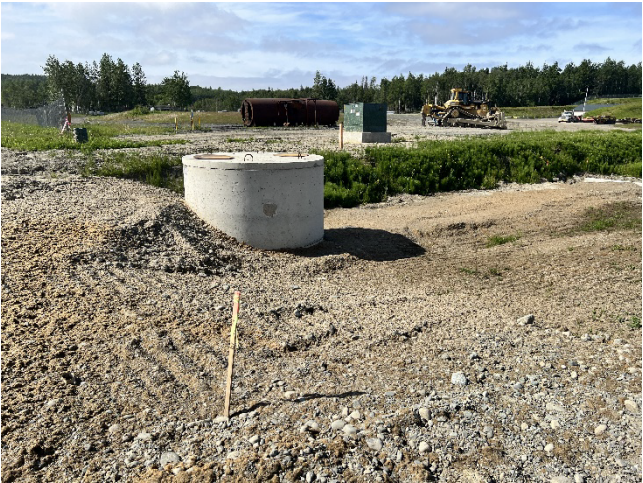
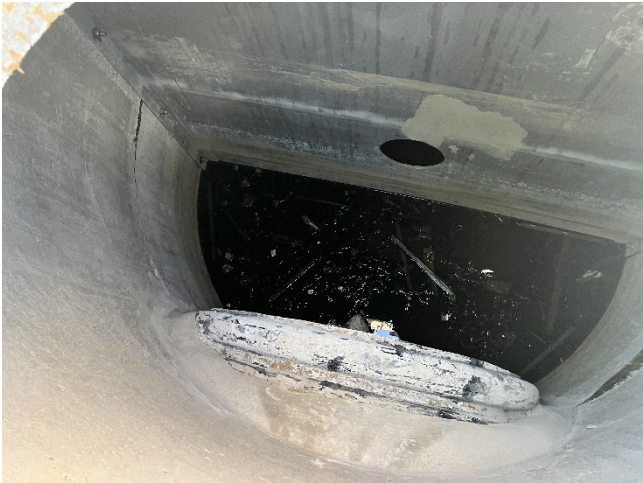
Stormwater flow control will be below final grade	Interior of flow control
Photo 43	Photo 44

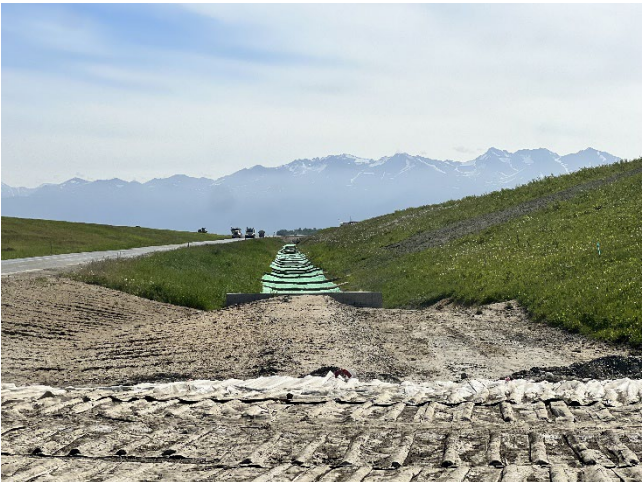
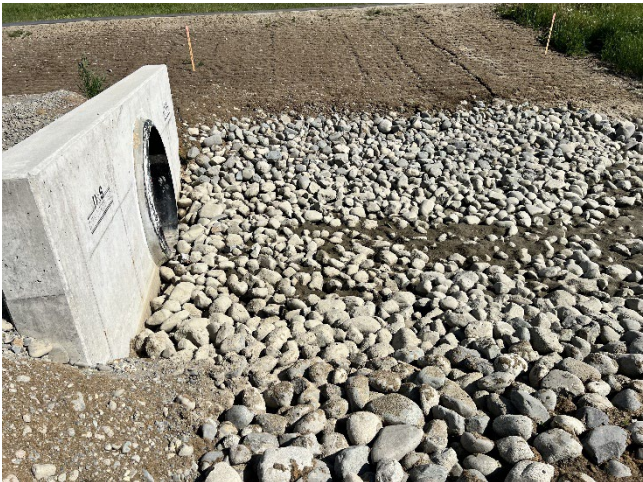
Looking upgradient of flow control	Upgradient of flow control

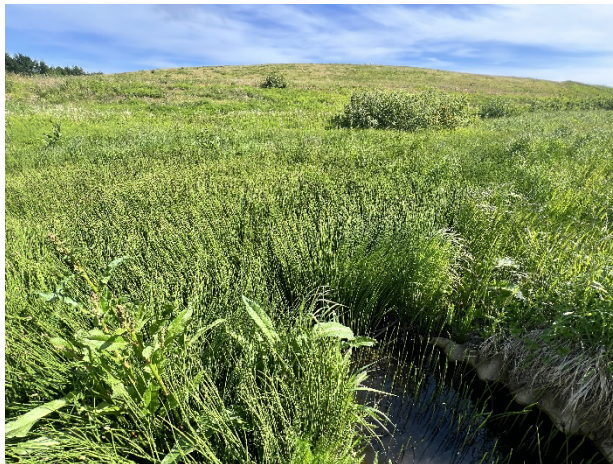
Photo 47

Downgradient of culvert

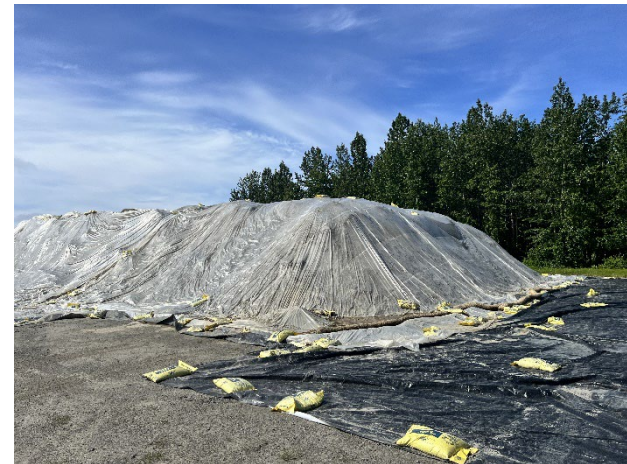
Photo 48

Temporary PFAS cell

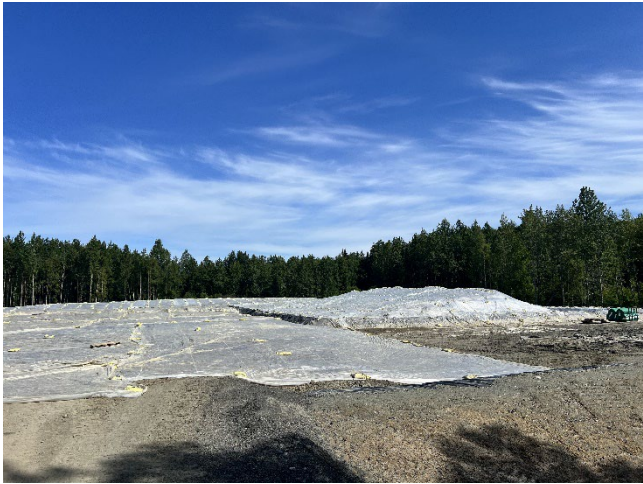
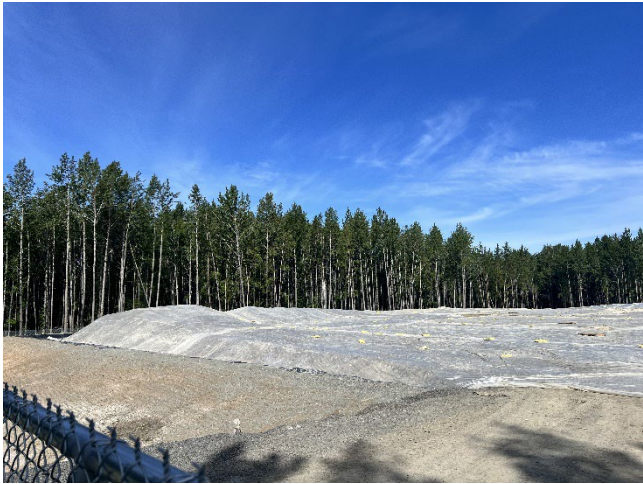
Long-term PFAS cell	Long-term PFAS cell
Photo 51	Photo 52

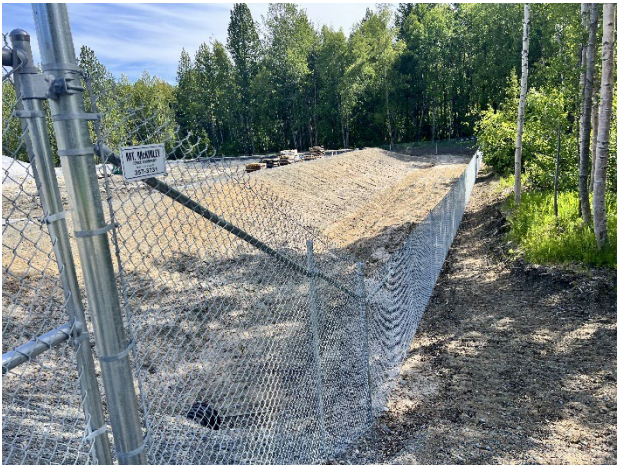
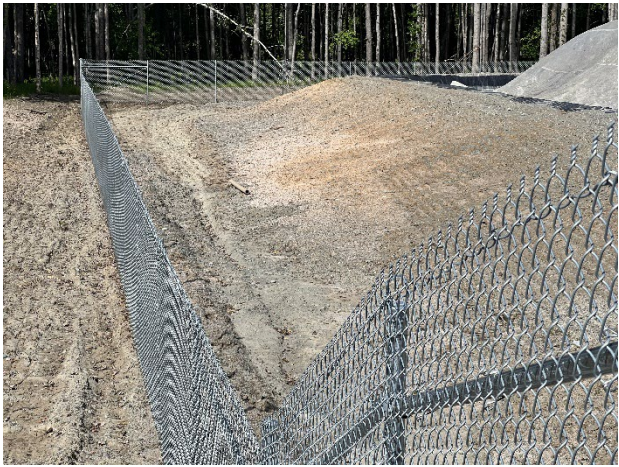
Long-term PFAS cell	Long-term PFAS cell

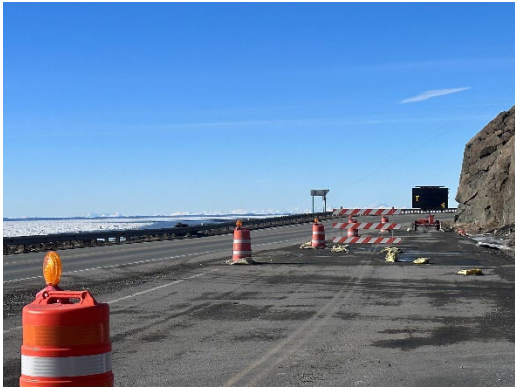
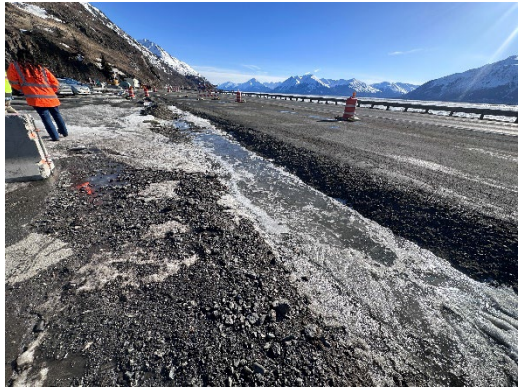
Project Traffic Control (Looking North)	Project Traffic Control (Looking South)
Photo 09	Photo 10

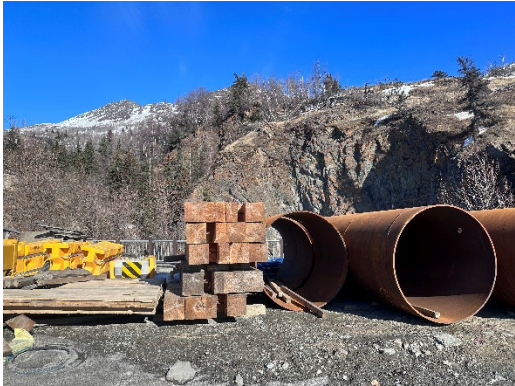
Construction Staging Area	Employee Trailer and Construction Equipment
Photo 11	Photo 12

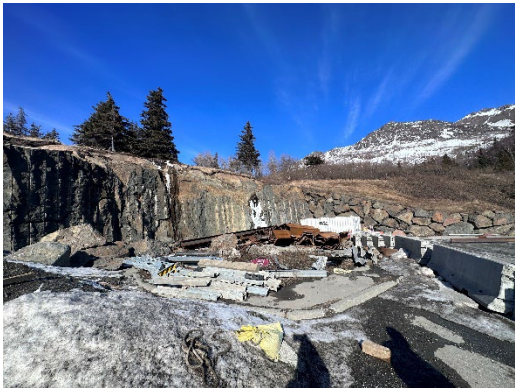
Staging Area	Connex in Staging Area

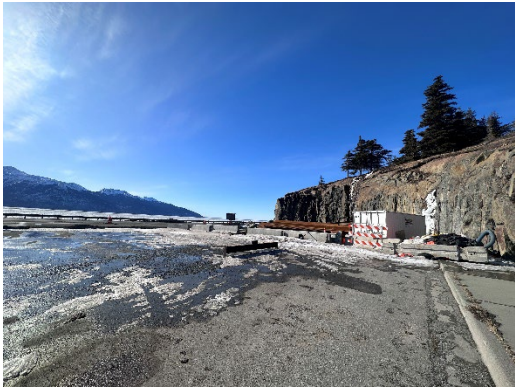
Parking Lot/Staging Area (Looking North)	Debris
Photo 21	Photo 22
